INSPECTION REPORT

For the Property at:
123 NO ROAD
NOWHERE, ON H2OH20

Prepared for: JOHN DOE
Inspection Date: Saturday, October 5, 2019
Prepared by: Daniel Ducheneaux

RE: Report No. 1015, v.4
123 No road
Nowhere, ON
H2OH20

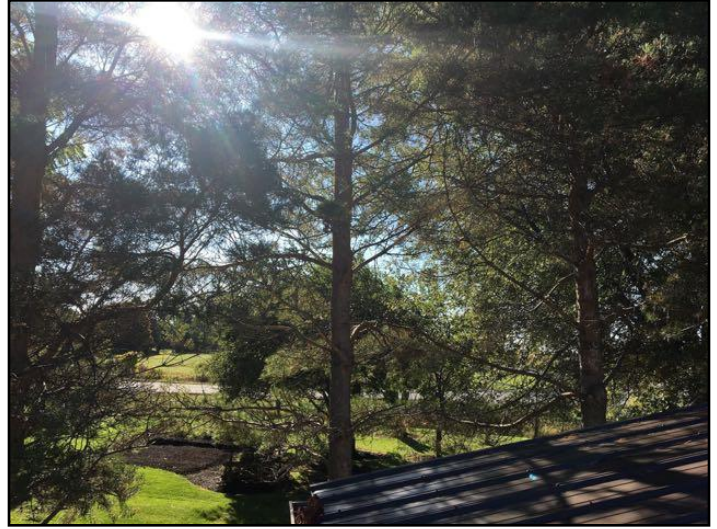
- Trees to close the roof

Implication(s): Wear of roofing material/clogging of gutters

2. Too close to roof

Task: Improve

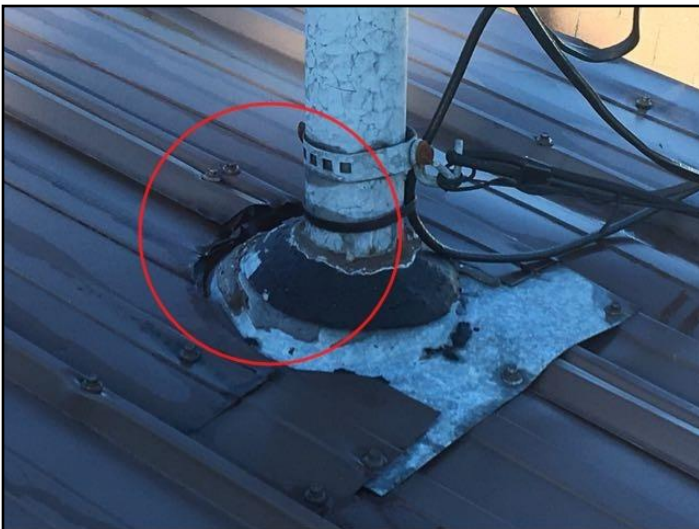
Condition: • Vulnerable areas. Gaps and patching noted.

Implication(s): Leakage/damage to structure and contents

3. Vulnerable areas. Some patching noted.

Task: Monitor

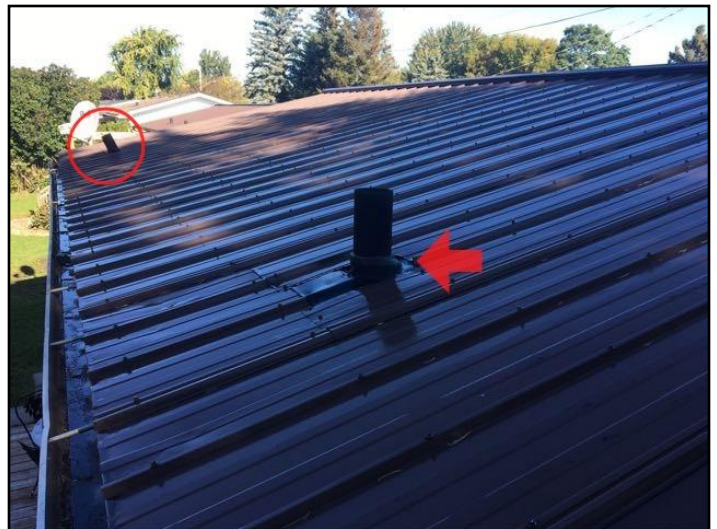
4. Vulnerable areas. Open gaps

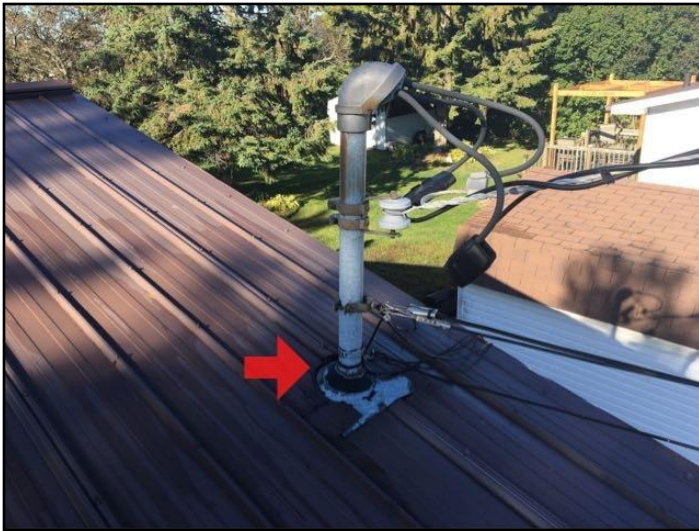
5. Vulnerable areas. Some patching noted.

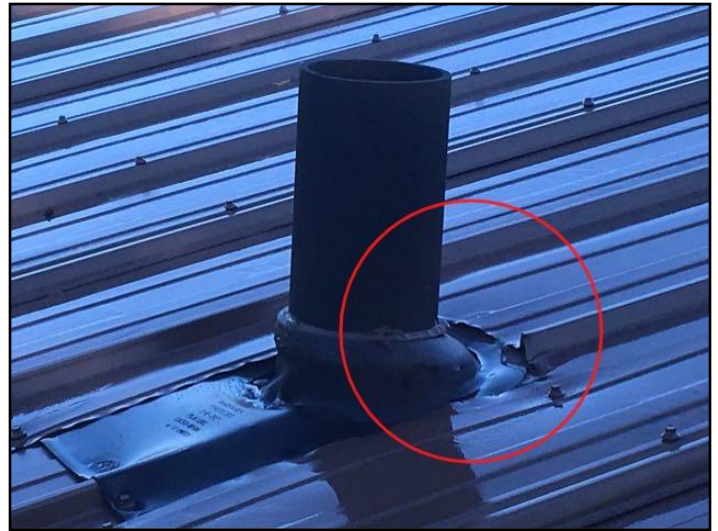
6. Vulnerable areas. Open gaps

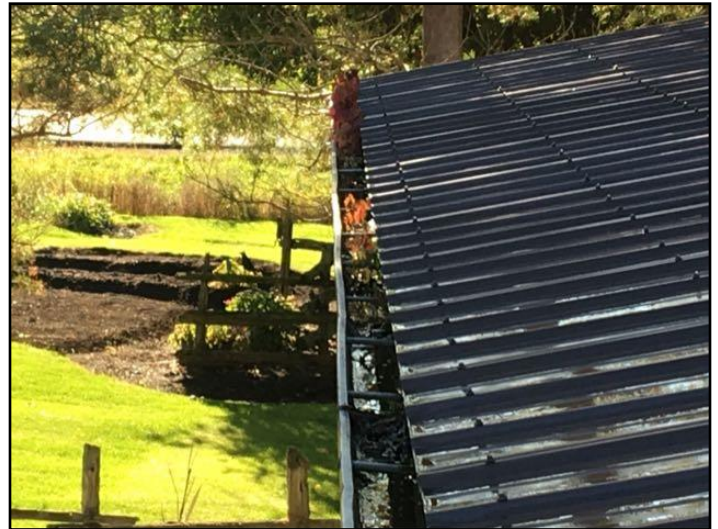
Condition: • [Clogged](#)

Implication(s): Chance of water damage to contents, finishes and/or structure

10. Clogged

Task: Clean

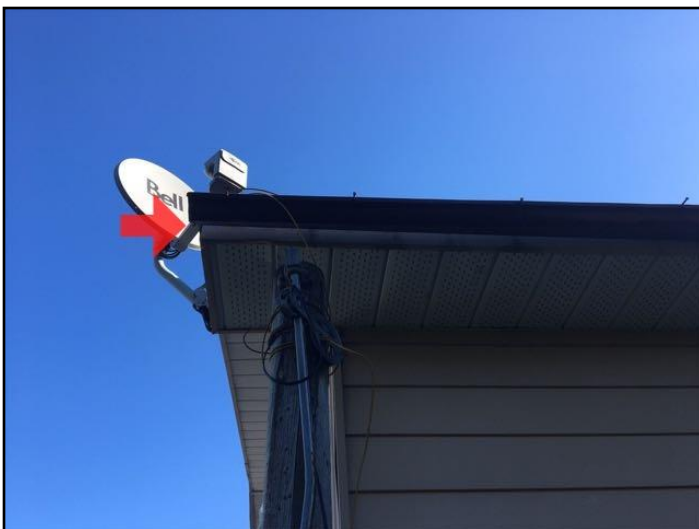
Condition: • Loose

11. Loose

Task: Repair

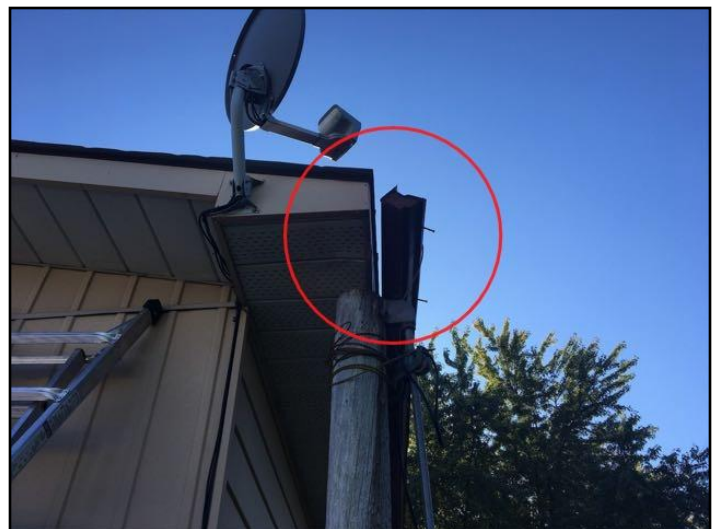
12. Loose

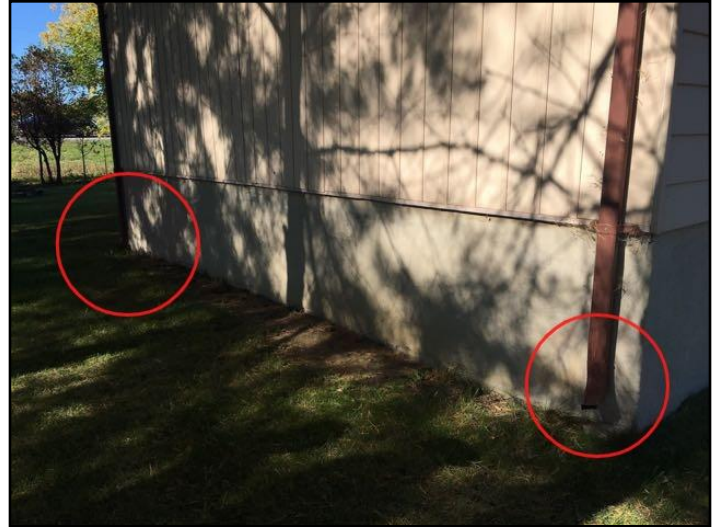
Condition: • [Discharge too close to building](#)

Implication(s): Chance of water damage to contents, finishes and/or structure

14. Discharge too close to building

Task: Improve

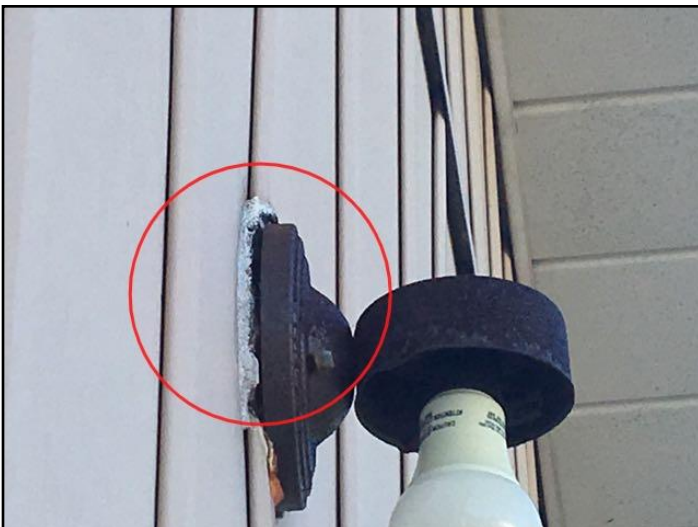
Condition: • [Caulking missing or deteriorated](#)

Implication(s): Chance of water damage to contents, finishes and/or structure | Material deterioration

15. Caulking - deteriorated, loose or missing

Task: Repair or replace

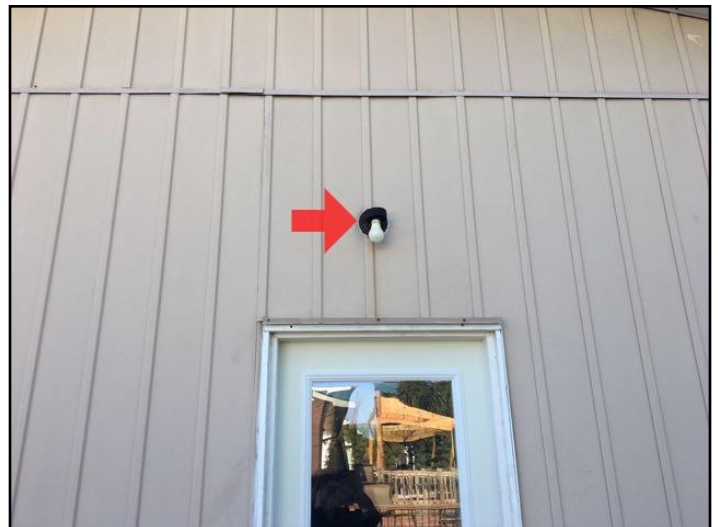
16. Caulking - deteriorated, loose or missing

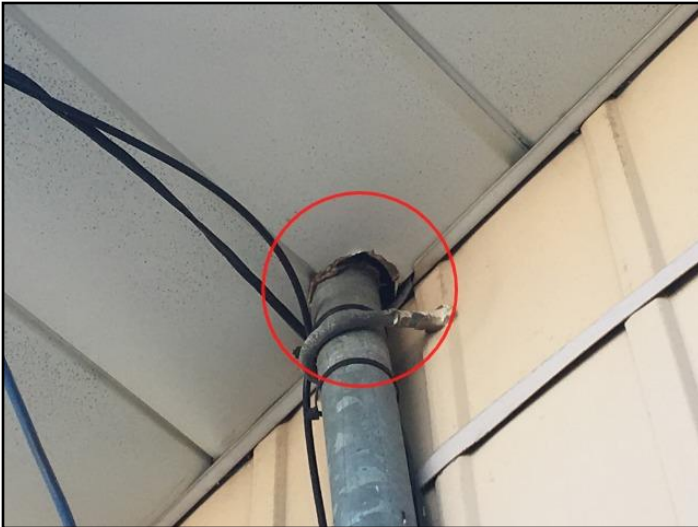
Open gap at electrical mast penetration

Implication(s): Chance of water damage to contents, finishes and/or structure | Material deterioration

17. Caulking missing or deteriorated

Task: Provide

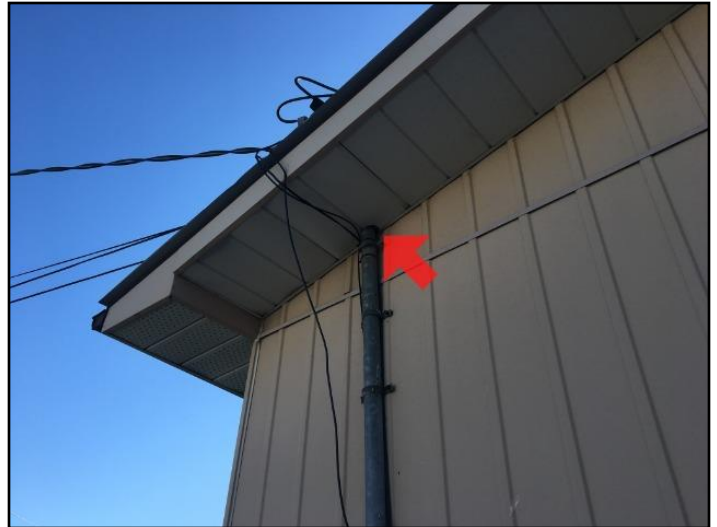
18. Caulking missing or deteriorated

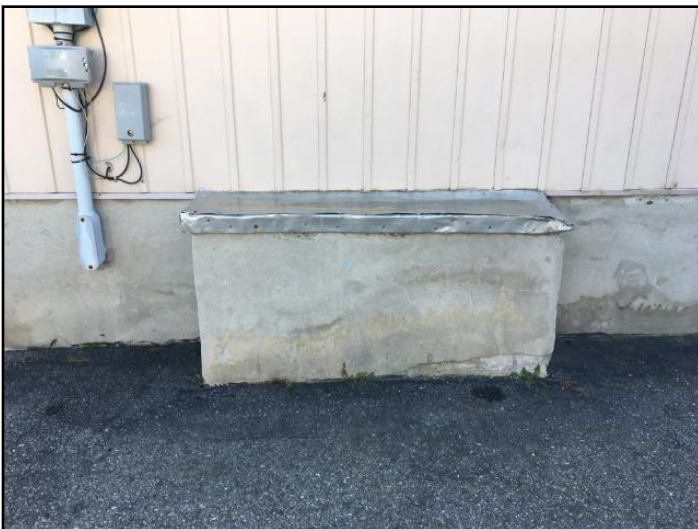
Condition: • [Caulking missing or deteriorated](#)

Implication(s): Chance of water damage to contents, finishes and/or structure | Material deterioration

19. Caulking missing or deteriorated

Task: Repair/provide

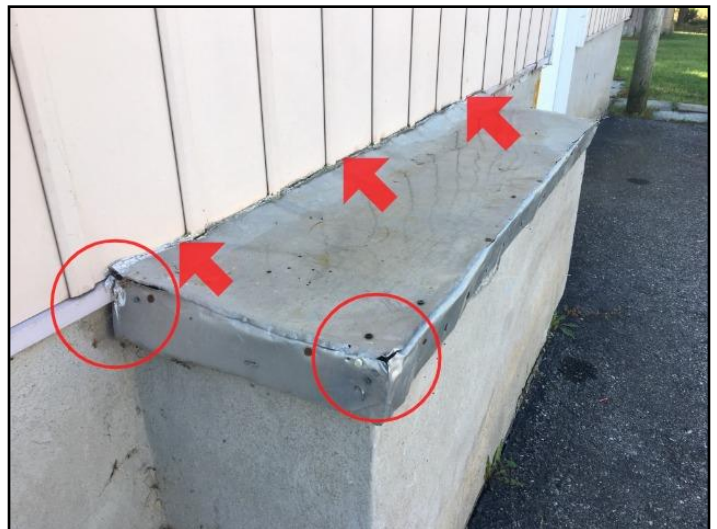
20. Caulking missing or deteriorated

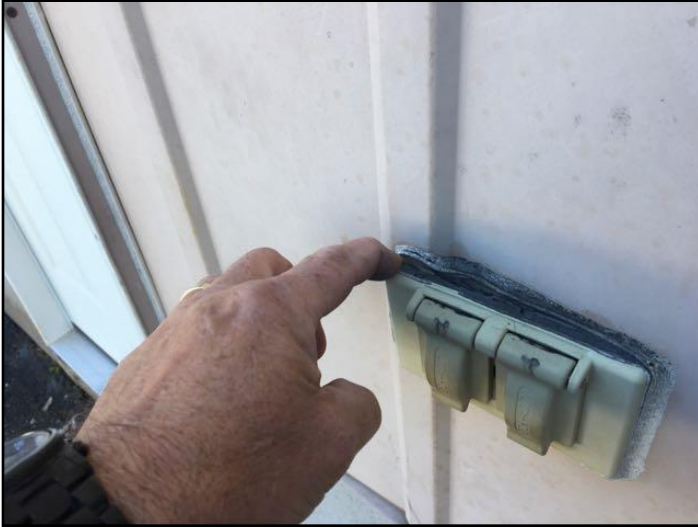
Condition: • [Caulking missing or deteriorated](#)

Implication(s): Chance of water damage to contents, finishes and/or structure | Material deterioration

21. Caulking missing, deteriorated or loose

Task: Repair Provide

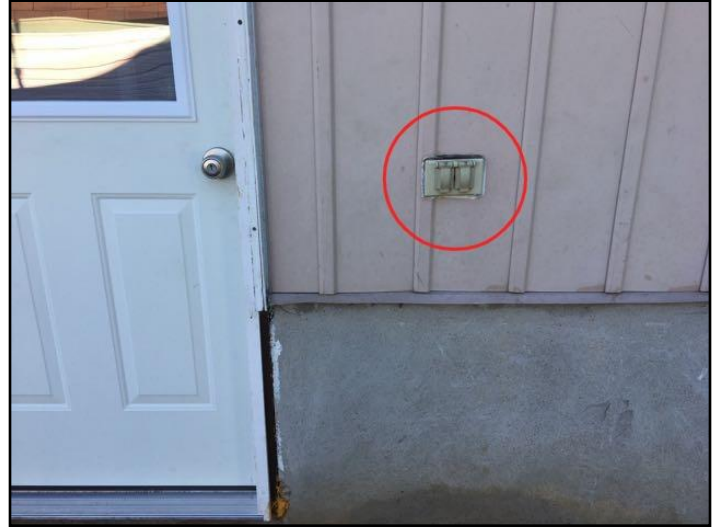
22. Caulking missing, deteriorated or loose

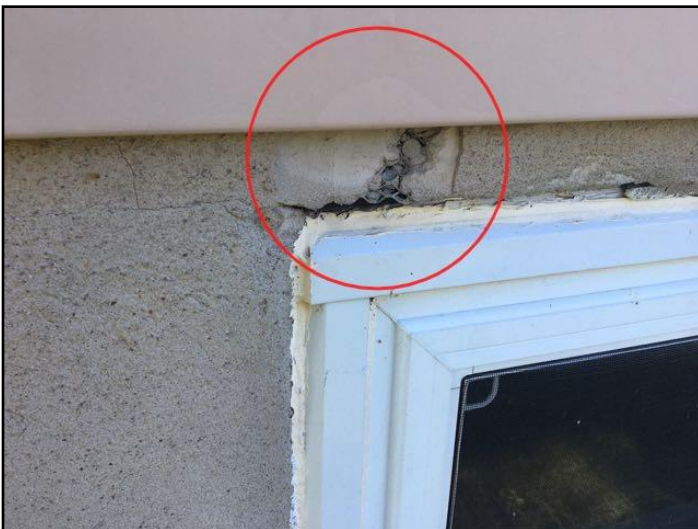
Condition: • [Parging damaged or missing](#)

Implication(s): Chance of damage to structure | Shortened life expectancy of material

23. Parging missing/deteriorated

Task: Repair

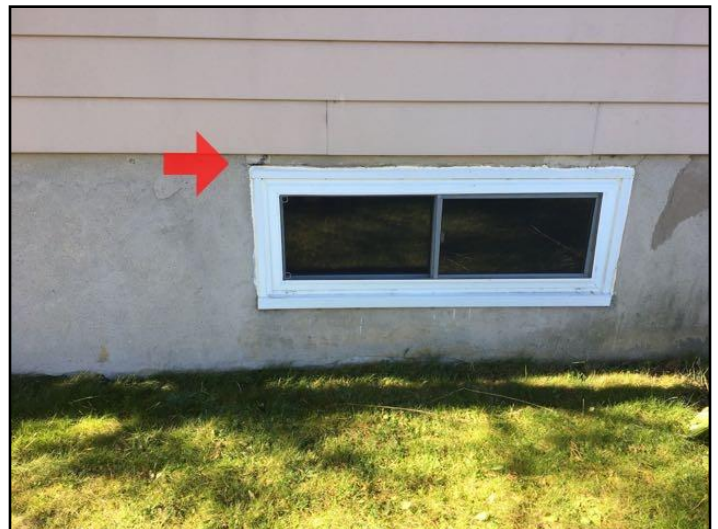
24. Parging missing/deteriorated

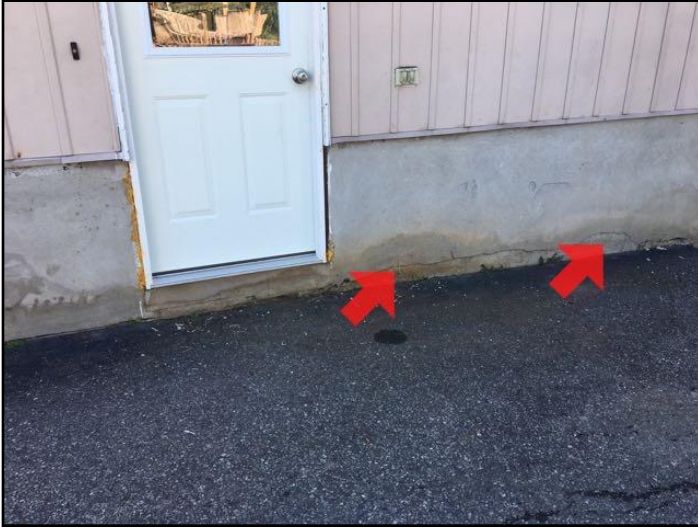
Condition: • [Parging damaged or missing](#)

Implication(s): Chance of damage to structure | Shortened life expectancy of material

25. Parging damaged or missing

Task: Repair

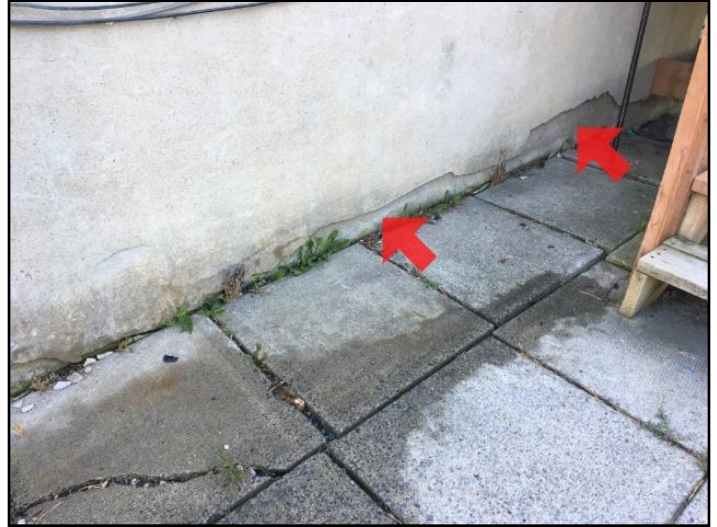
26. Parging damaged or missing

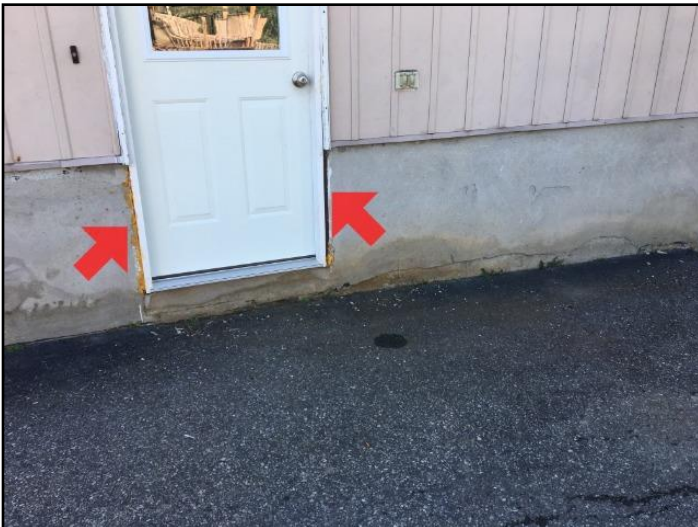
Condition: • [Missing](#)

Implication(s): Chance of damage to finishes and structure

27. Trim missing

Task: Provide

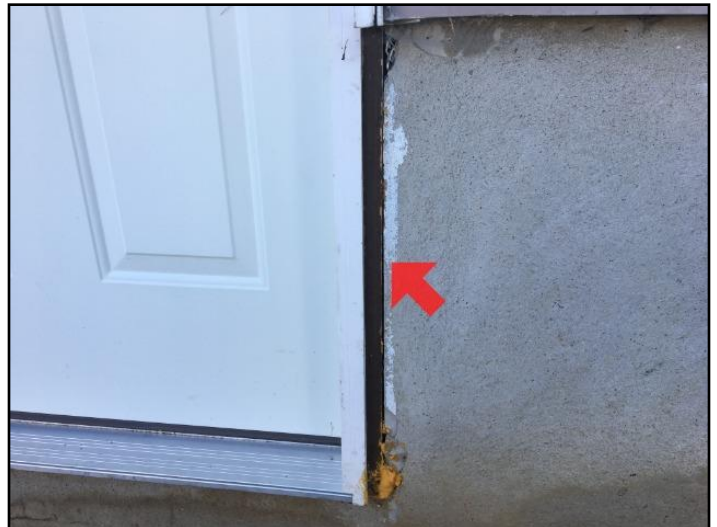
28. Trim missing

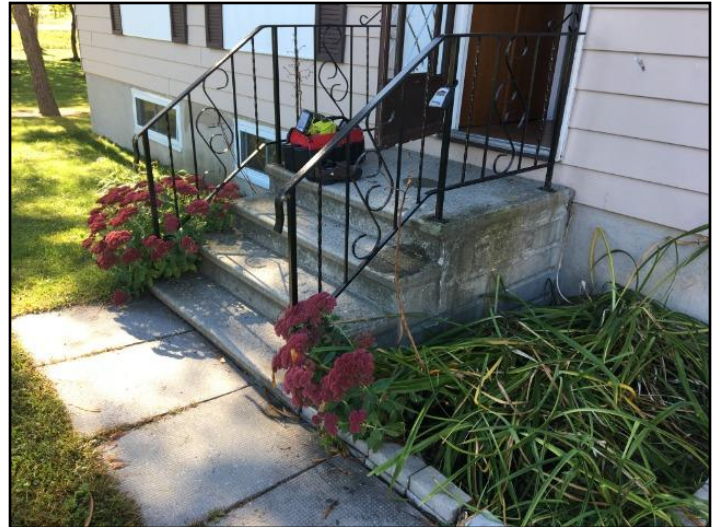
Condition: • Front porch shows sign of settlement

Implication(s): Structure movement

30. Settlement

Task: Monitor

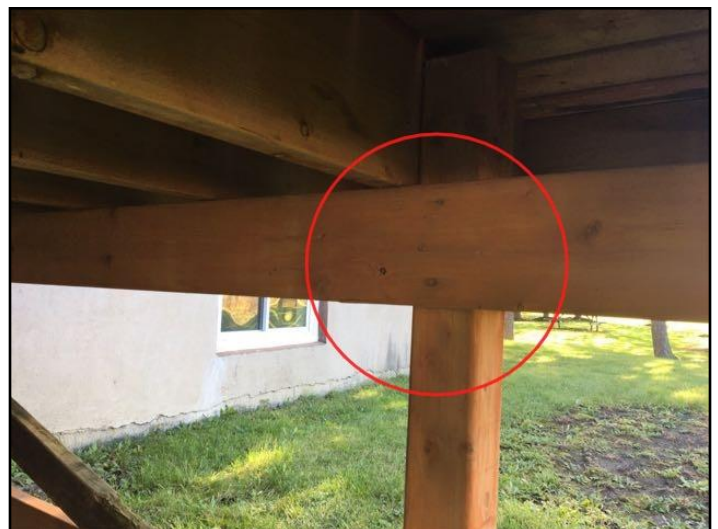
Condition: • [Connections weak](#)

Weak connections to posts noted throughout

Implication(s): Weakened structure | Chance of structural movement

32. Connections weak

Task: Improve

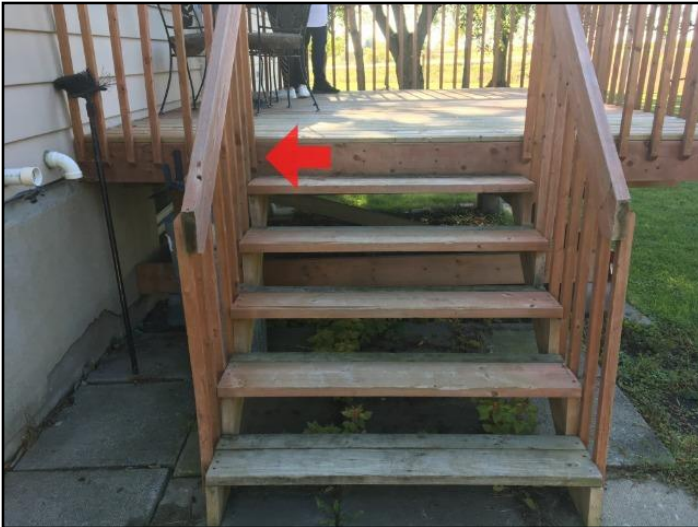
33.

Condition: • Connection weak at upper stair to deck

Implication(s): Fall hazard/Personal injury

Task: Repair

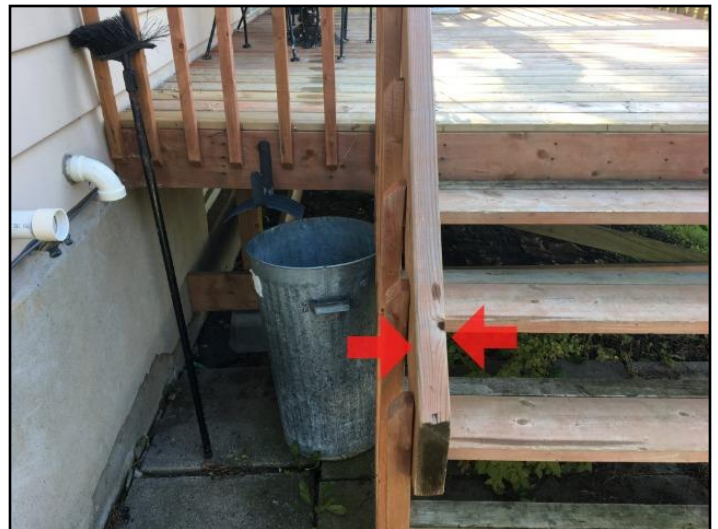
Condition: • Handrail hard to hold

Implication(s): Fall hazard

36. Hard to hold

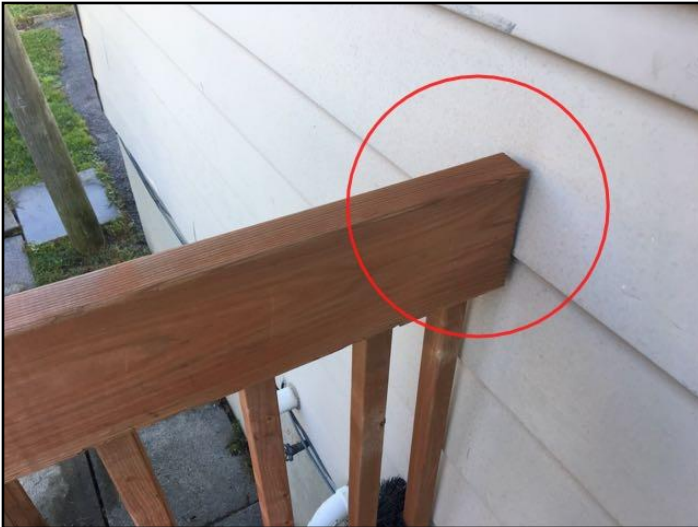
Condition: • [Loose](#)

Guardrail is loose and not secured to house

Implication(s): Fall hazard

37. Loose

Task: Repair

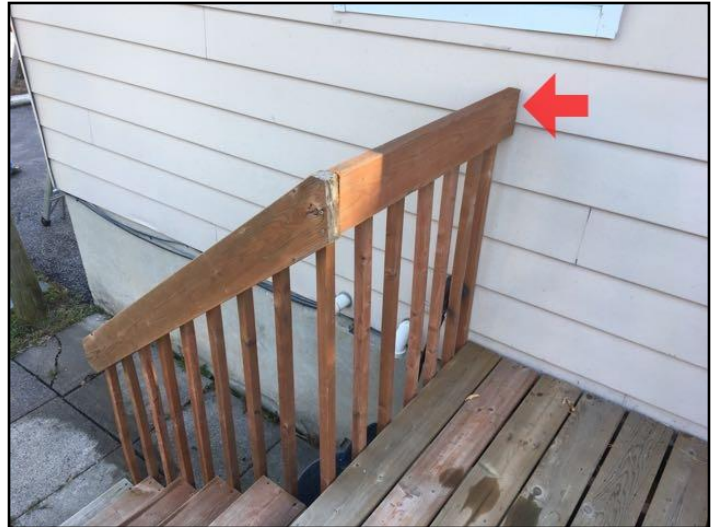
38. Loose

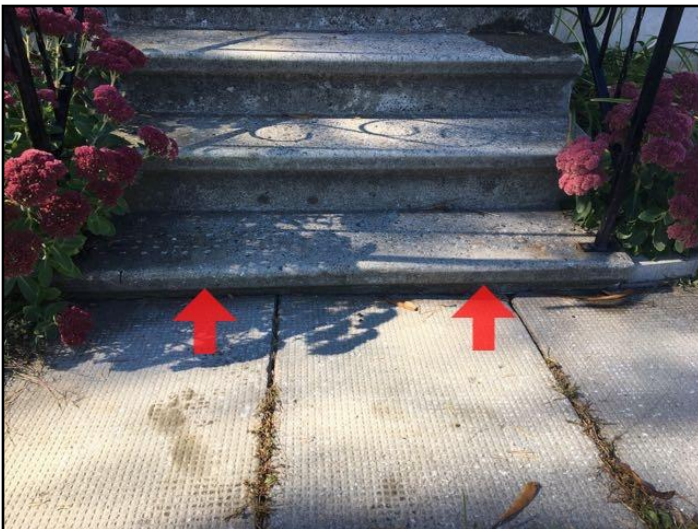
Condition: • [Trip hazards](#)

39. Trip hazards/Step not uniform

Task: improve

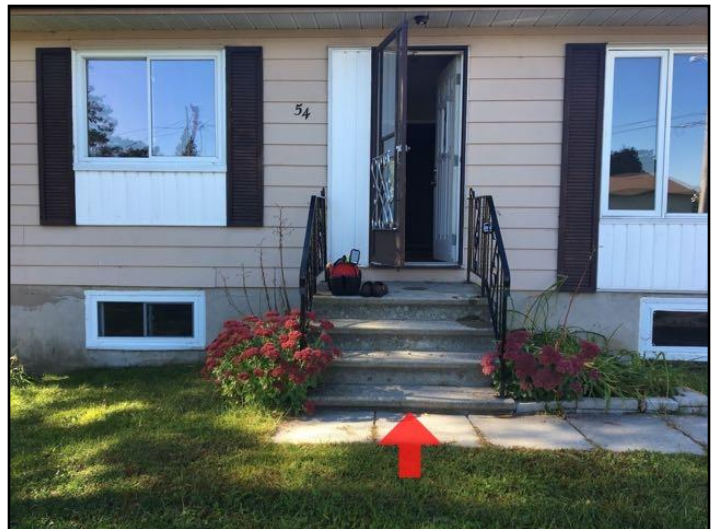
40. Trip hazards/Step not uniform

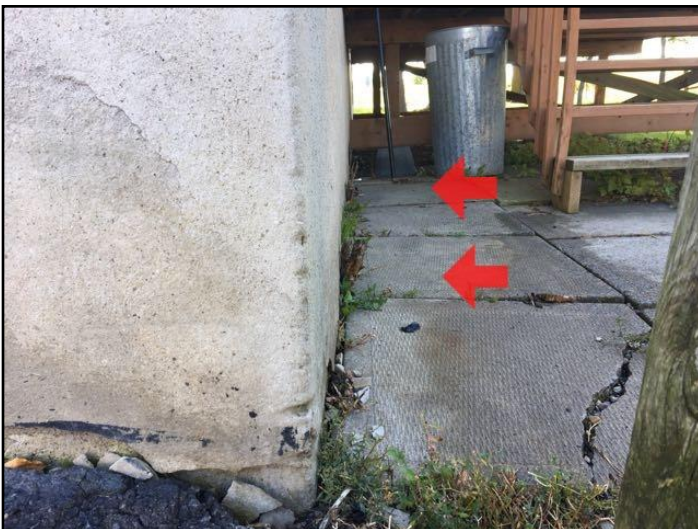
Condition: • [Improper slope or drainage](#)

Patio stones have settled causing water to drain towards foundation. Signs of efflorescence were visible on the interior foundation wall.

Implication(s): Chance of water damage to contents, finishes and/or structure

41. Improper slope or drainage

Task: Repair/Improve

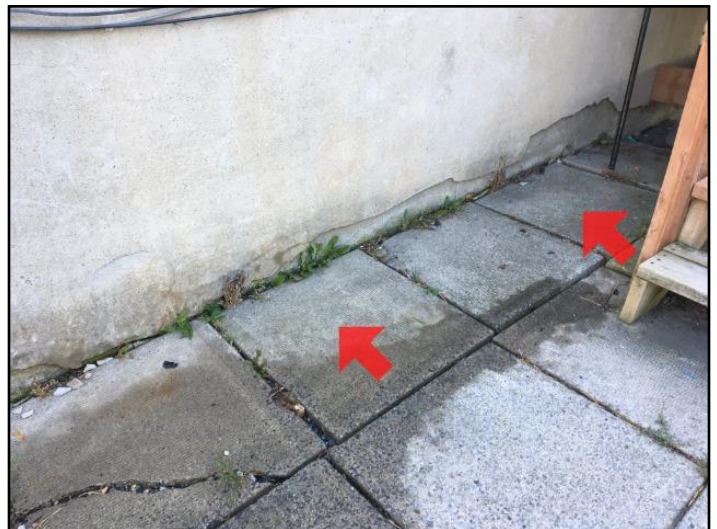
42. Improper slope or drainage

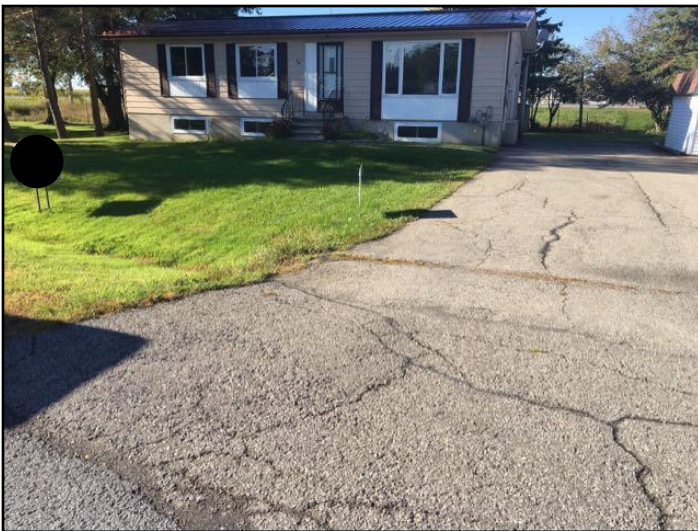
Condition: • [Cracked or damaged surfaces](#)

Implication(s): Trip or fall hazard

44. Cracked or damaged surfaces

Task: Repair

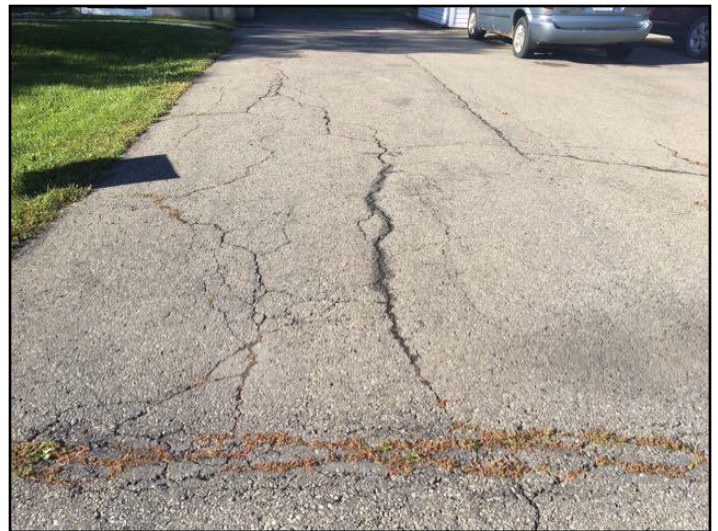
45. Cracked or damaged surfaces

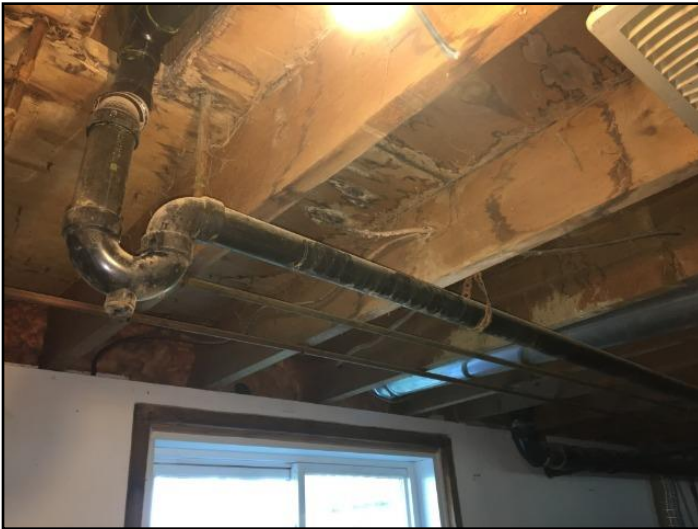
Condition: • Rot

Severe moisture was noted at sub-floor under bathroom. moisture was at 66%.

46. Rot/Water damage

Task: Repair

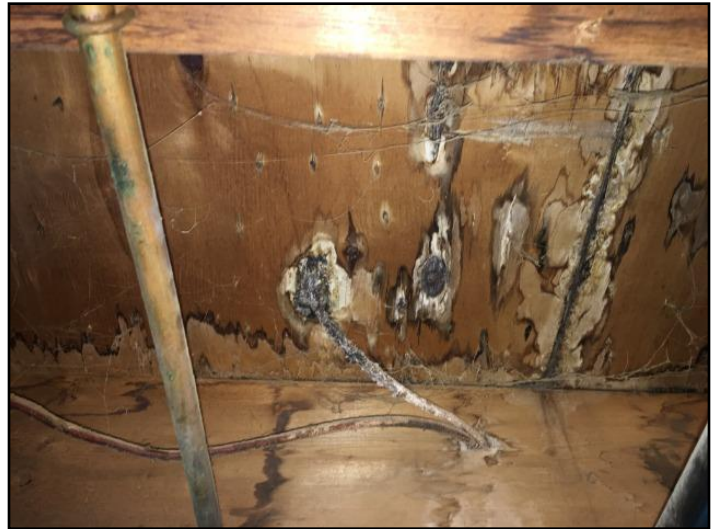
47. Rot/Water damage

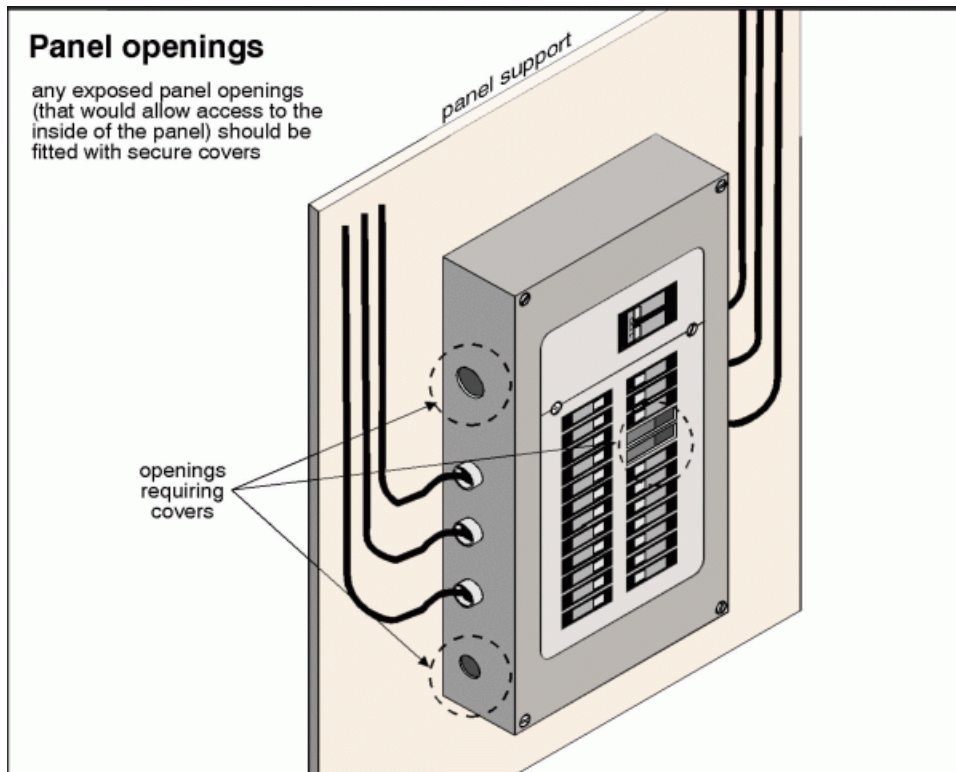
SERVICE BOX, GROUNDING AND PANEL \ Service box**Condition:** • [Unprotected openings](#)

Implication(s): Electric shock**Location:** North Basement**Task:** Correct**Time:** Immediate

48. Unprotected openings

Further evaluation of electrical system by a specialist

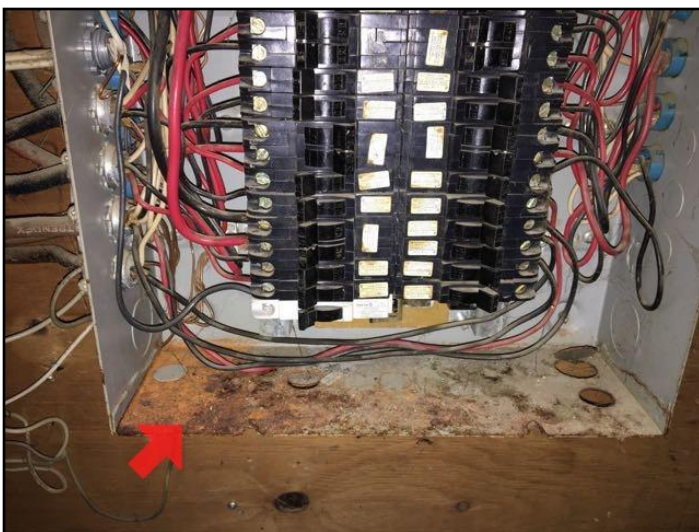
Condition: • [Rust or water in panel](#)

Rust in panel may indicate present or previous moisture or water infiltration

Implication(s): Electric shock | Fire hazard

50. Rust in panel

Task: Further evaluation

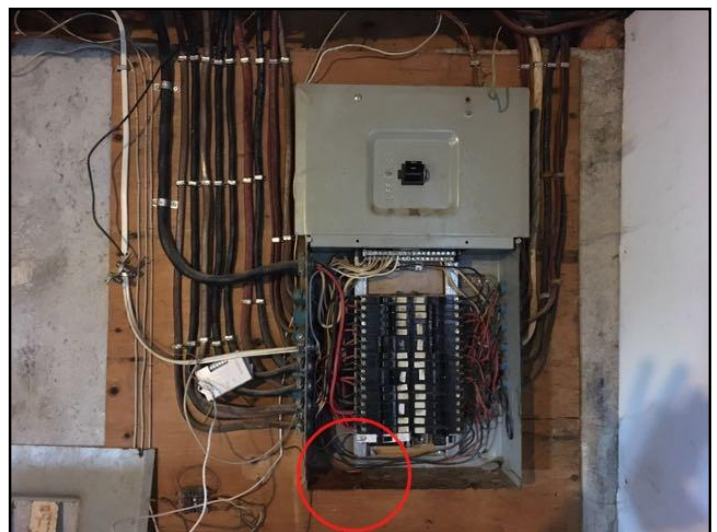
51. Rust in panel

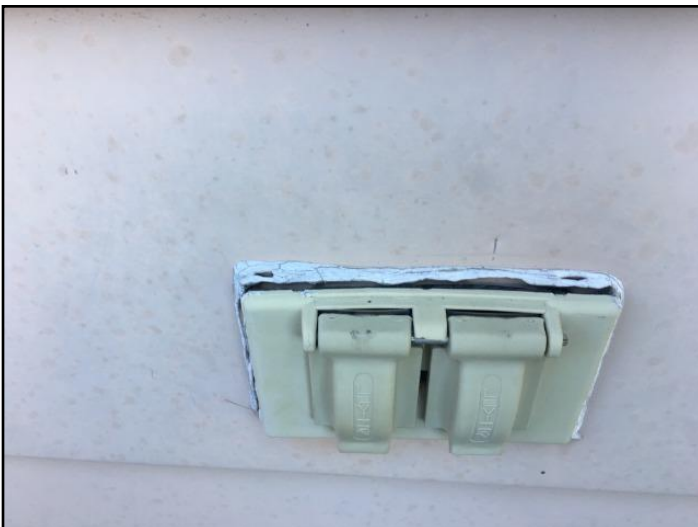
Condition: • Defective. GFCI recommended

Implication(s): Electrical shock/fire hazard

55. Defective

Task: Replace

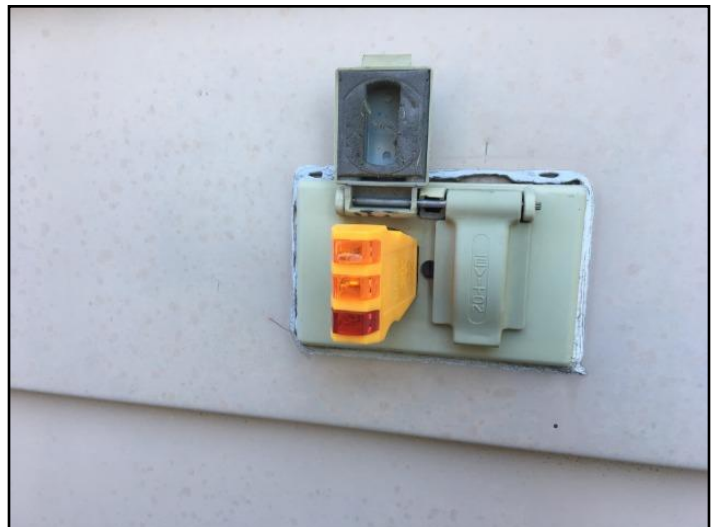
56. Defective

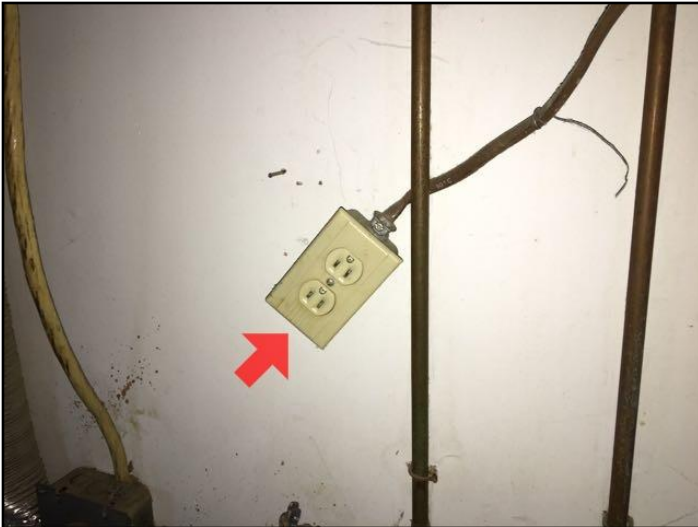
Condition: • [Loose](#)

Implication(s): Electric shock | Fire hazard

57. Loose/not secured

Task: Repair/correct

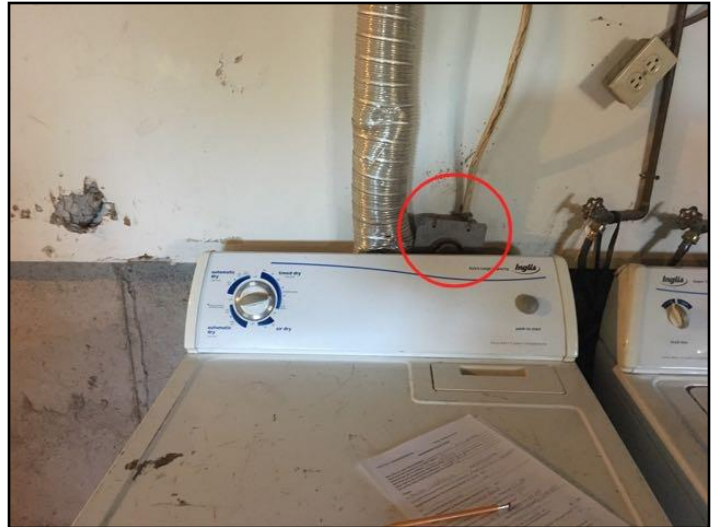
58. Loose/notsecured

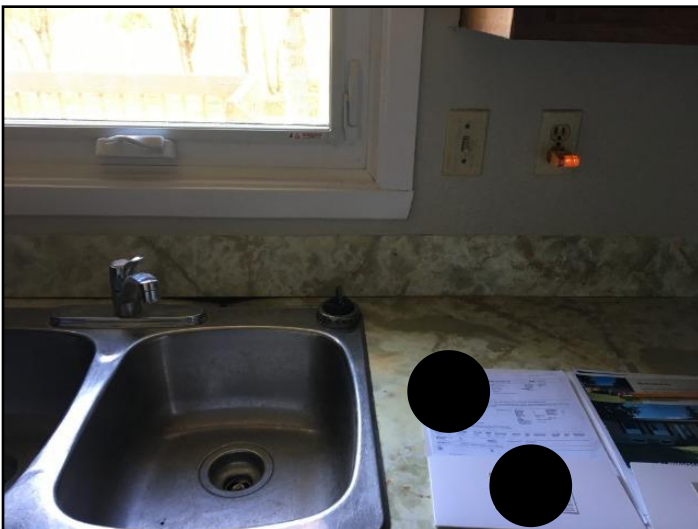
Condition: • [GFCI/GFI needed \(Ground Fault Circuit Interrupter\)](#)

59. GFCI/GFI needed (Ground Fault Circuit...

Task: Replace

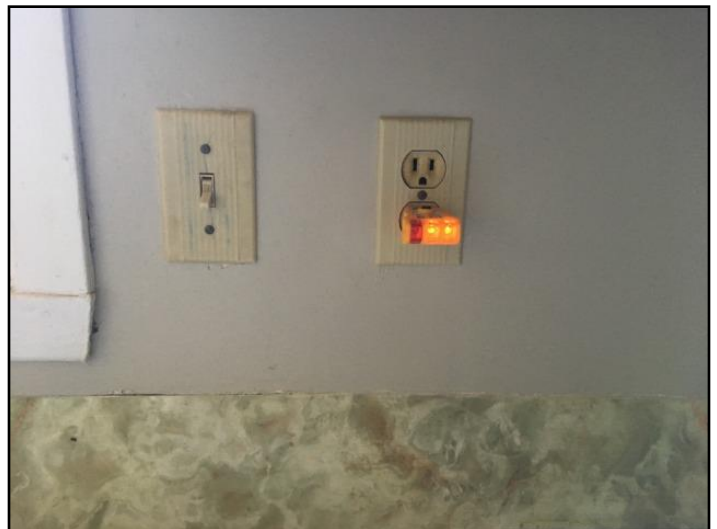
60. GFCI/GFI needed (Ground Fault Circuit...

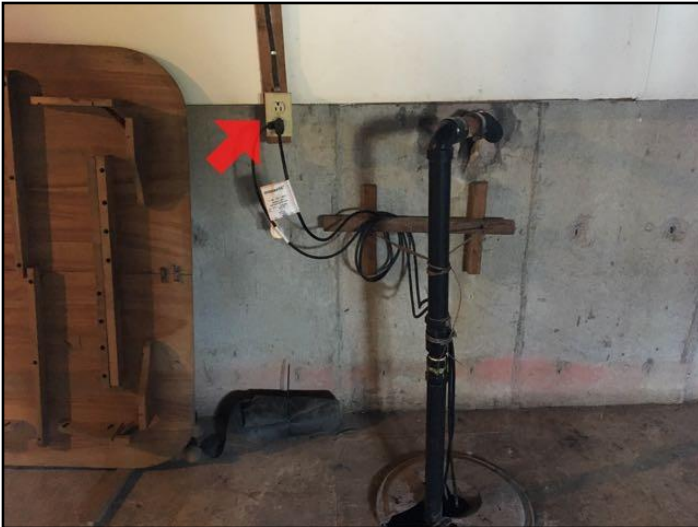
Condition: • [No GFCI/GFI \(Ground Fault Circuit Interrupter\)](#)

Missing GFCI at sump pump

Implication(s): Electric shock**Location:** Northeast Basement**Task:** Replace**Time:** Immediate

61. No GFCI/GFI (Ground Fault Circuit...

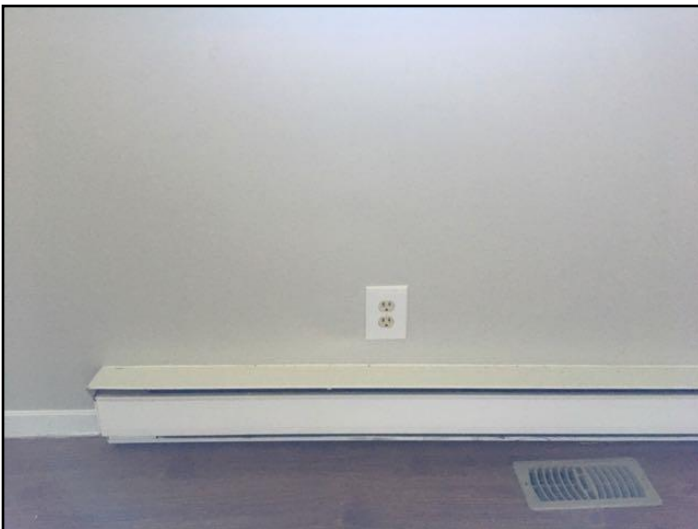
DISTRIBUTION SYSTEM \ Outlets (receptacles) - number or location**Condition:** • [Above electric baseboard heaters](#)**Implication(s):** Increased fire hazard**Location:** Throughout First Floor Bedrooms**Task:** Correct**Time:** Immediate

63. Receptacle poor location

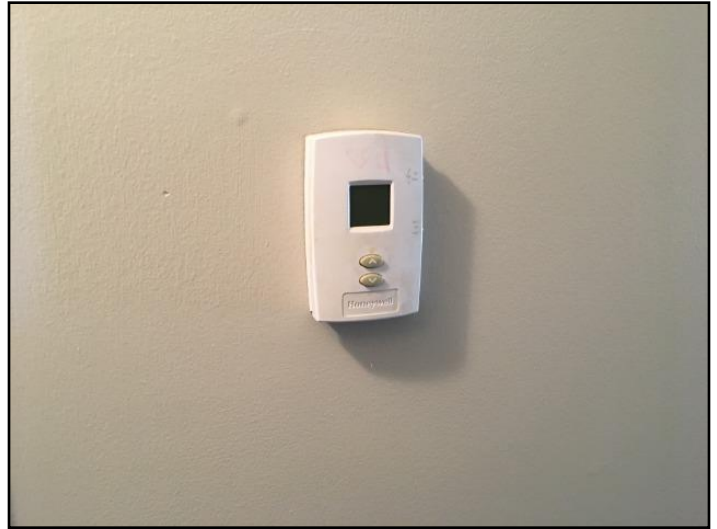
Condition: • Inoperative. Heating system was shut off

66. Inoperative

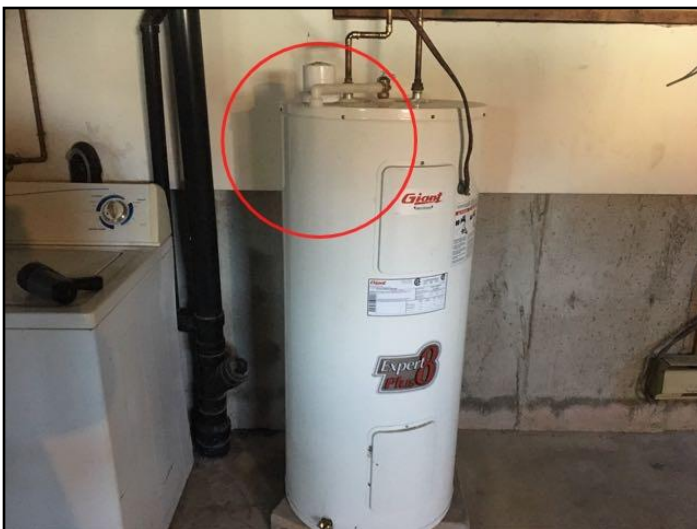
Condition: • [Discharge tube missing](#)

67. Discharge tube missing

Task: Provide

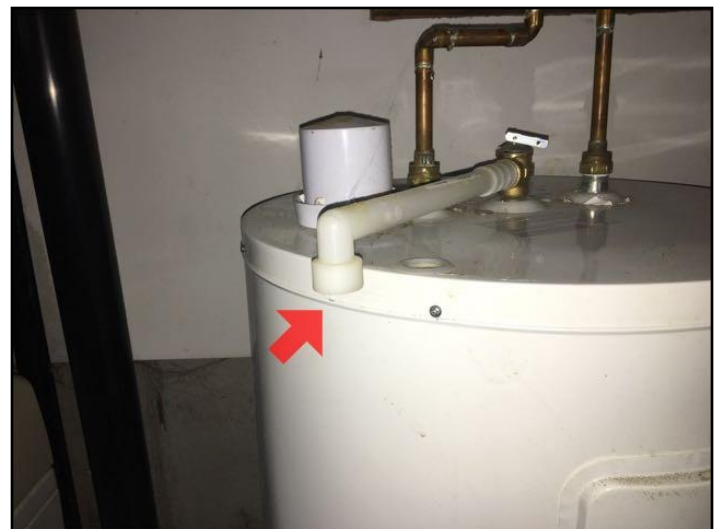
68. Discharge tube missing

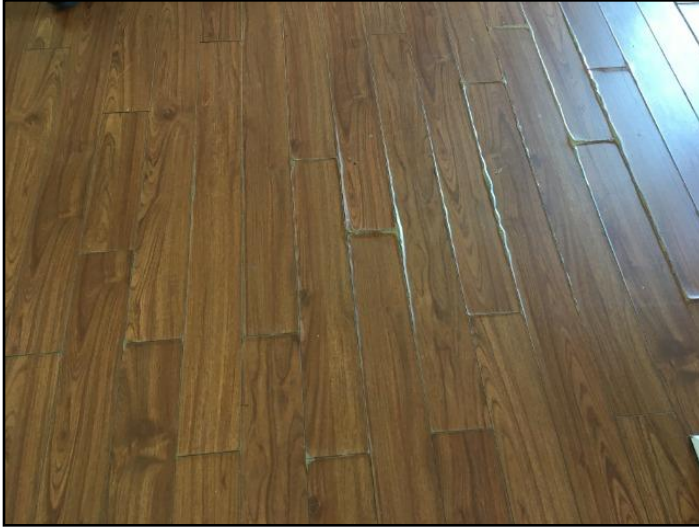
Condition: • Damaged/worn

69. Damage

Task: Replace

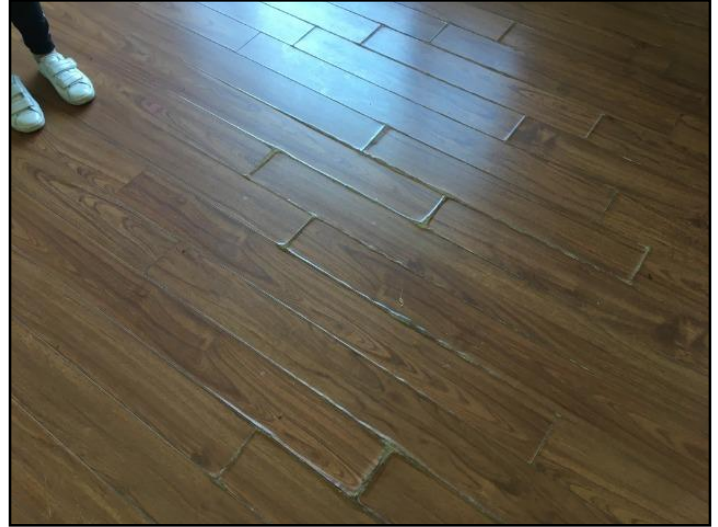
70. Damage

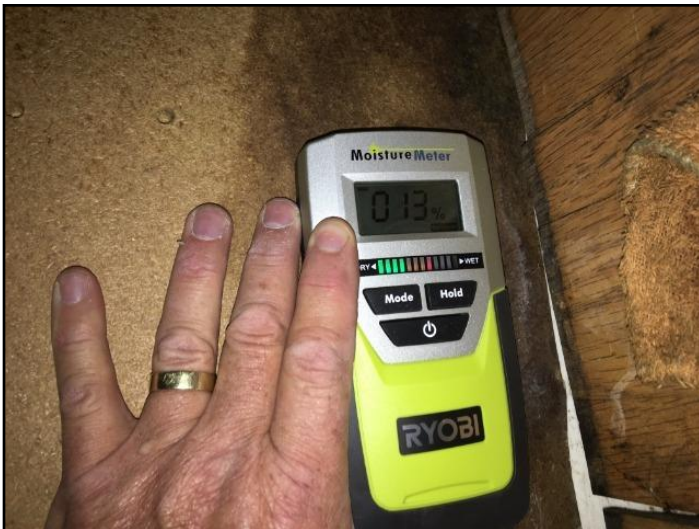
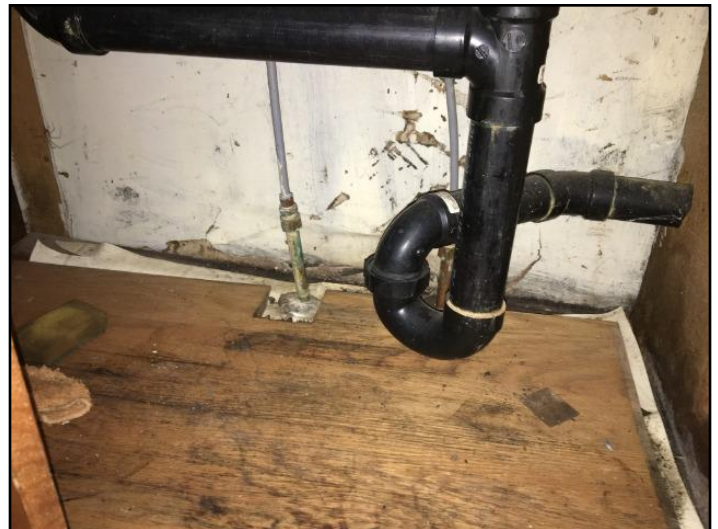
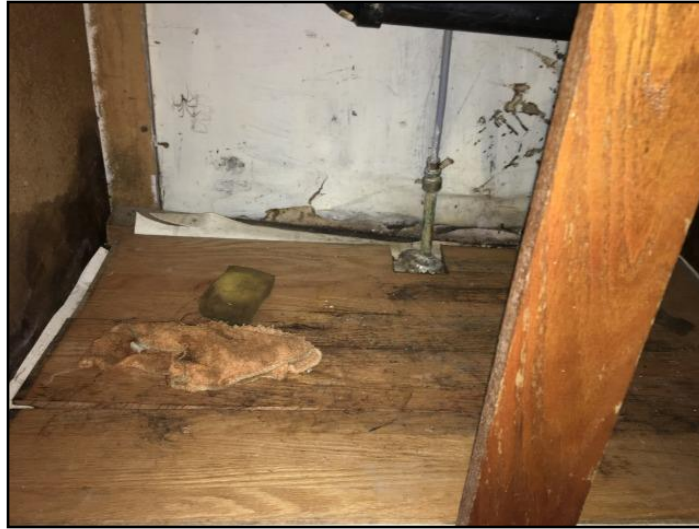
Condition: • [Water damage](#)

Water damage/moisture noted under kitchen sink. Moisture levels were at 13 % at time of inspection.

Implication(s): Material deterioration

72. Water damage

73. Water damage

74. Water damage

Task: Monitor
