INSPECTION REPORT

For the Property at:
123 NO ROAD
NOWHERE, ON H2OH20

Prepared for: JOHN DOE
Inspection Date: Saturday, October 5, 2019
Prepared by: Daniel Ducheneaux

RE: Report No. 1015, v.4
123 No road
Nowhere, ON
H2OH20

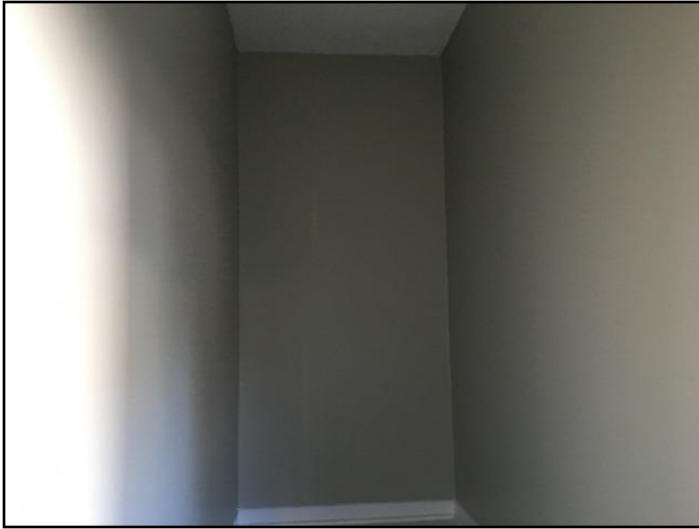
Condition: • [Missing](#)

Basement staircase has inadequate lighting and is missing a light switch at the bottom

Implication(s): Trip or fall hazard | Inadequate lighting

75. Missing

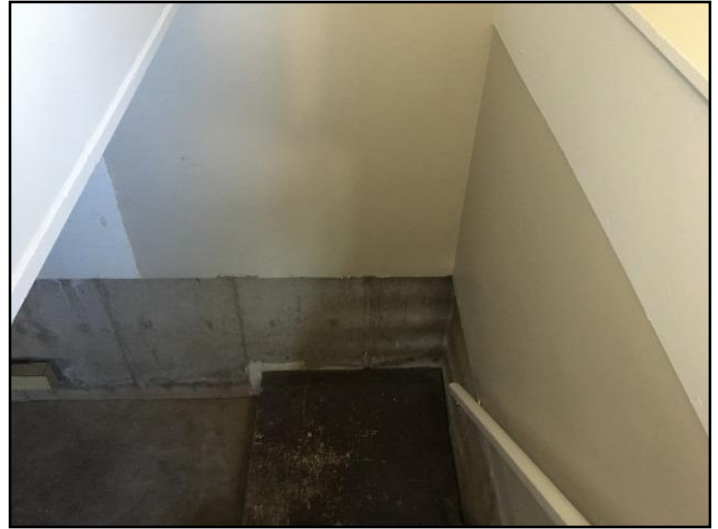
76. Missing

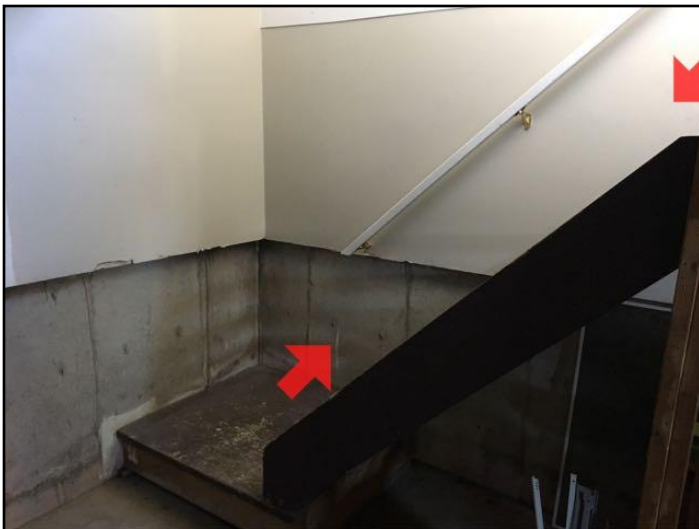
Condition: • [Missing](#)

Implication(s): Fall hazard

77. Missing guardrail

Task: Provide

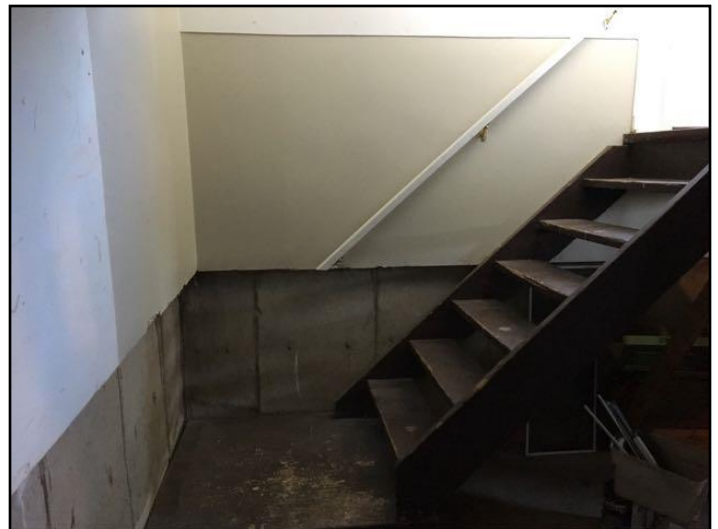
78. Missing guardrail

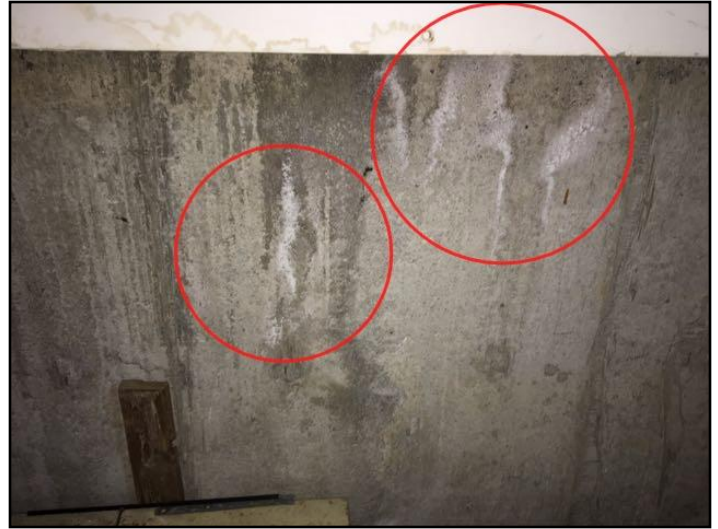
Condition: • [Efflorescence](#)

Implication(s): Chance of water damage to contents, finishes and/or structure

80. Efflorescence

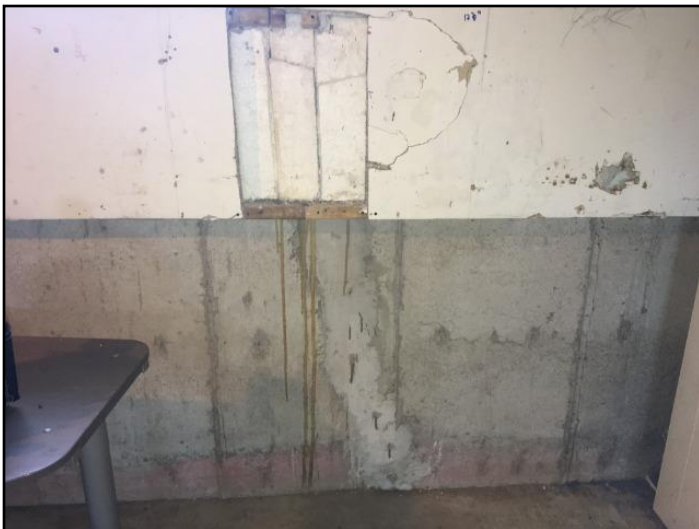
Condition: • [Prior repairs](#)

Implication(s): Chance of water damage to contents, finishes and/or structure

81. Prior repairs

Task: Monitor

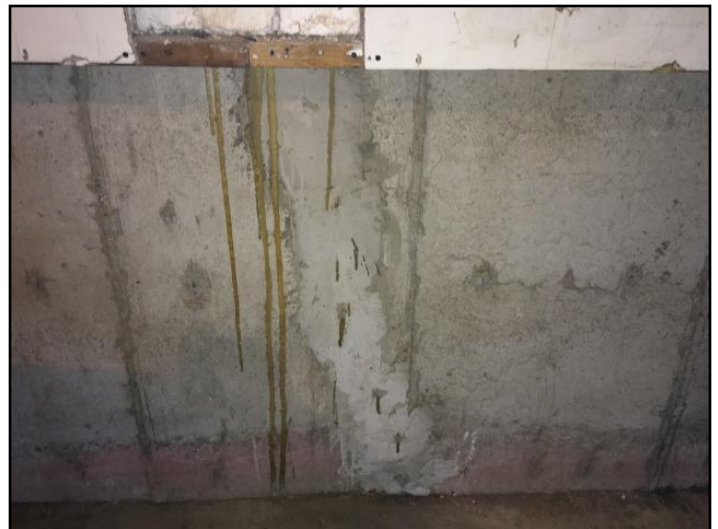
82. Prior repairs

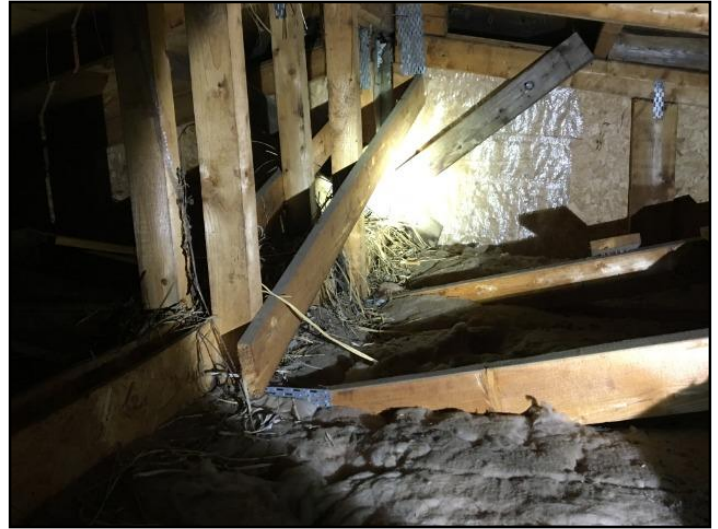
Condition: • Signs of animal entry present in the attic. Unsure of type but this should be monitored.

Implication(s): Insulation damage/inconvenience/nuisance

84. Animal/pest entry
