Your Inspection Report

123 No Road St-
Albert, ON K0B 3Z0

Thursday, June 11, 2024

RE: Report No. 1144, v.2
123 No Road
St-Albert, ON
K0B 3Z0

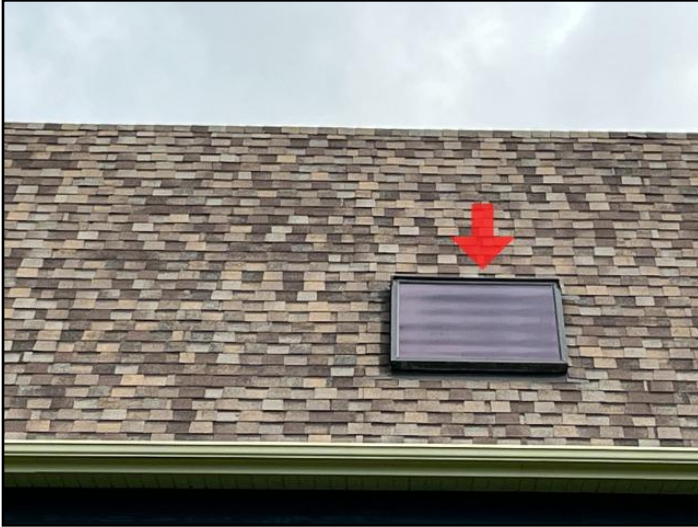
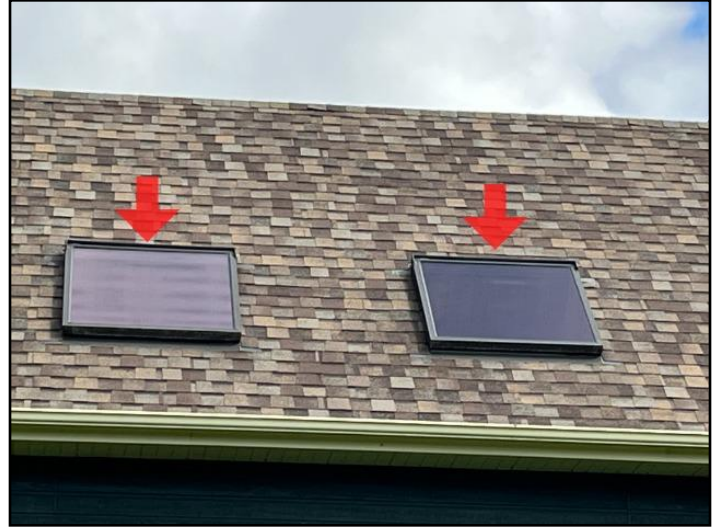
1. Condition: • [Vulnerable areas](#)

Implication(s): Chance of water damage to structure, finishes and contents

Location: Triple garage-at South

1. Vulnerable areas

2. Vulnerable areas

Task: Monitor

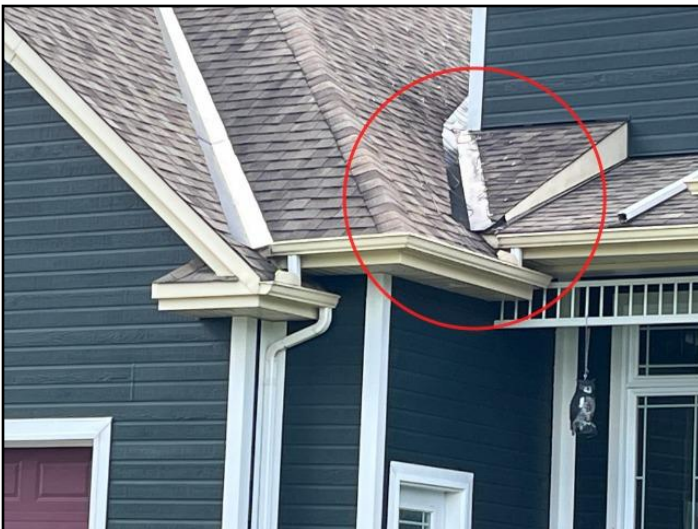
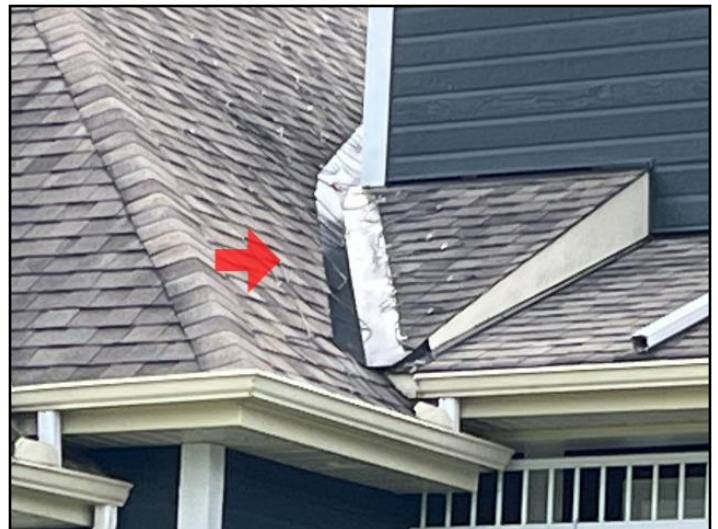
2. Condition: • [Vulnerable to ice damming](#)

Implication(s): Chance of water damage to structure, finishes and contents

Location: House-at North

3. Vulnerable to ice damming

4. Vulnerable to ice damming

Task: Monitor

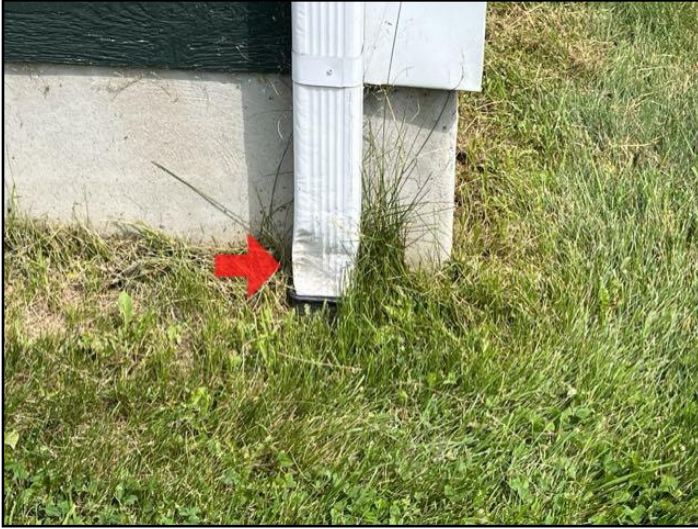
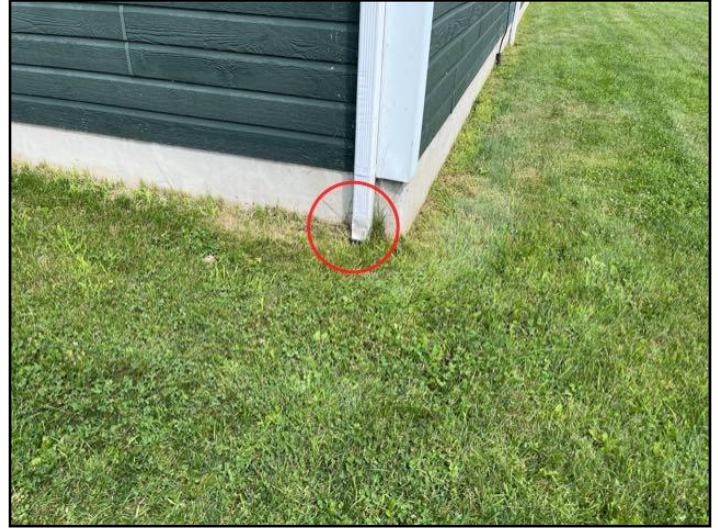
3. Condition: • [Damage](#)

Implication(s): Chance of water damage to structure, finishes and contents

Location: Southeast corner-Triple garage

5. Damage

6. Damage

Task: Repair or Replace

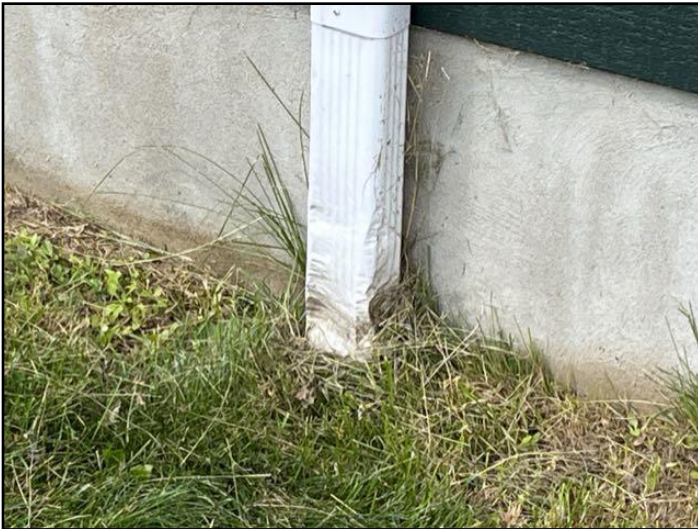
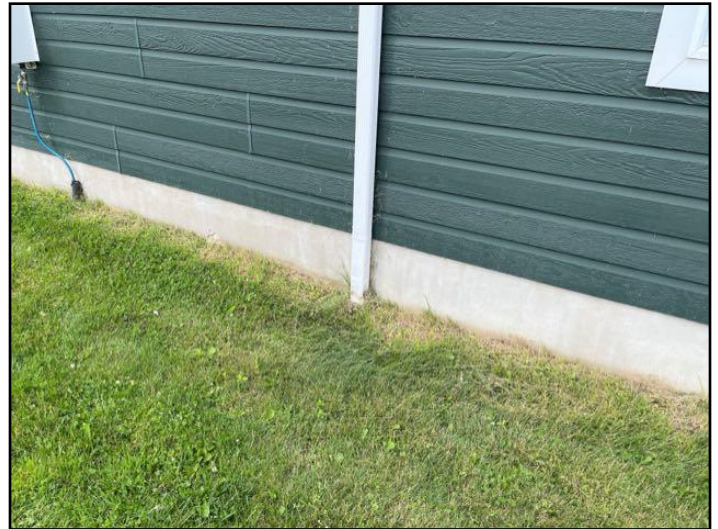
4. Condition: • [Damage](#)

Implication(s): Chance of water damage to structure, finishes and contents

Location: East-Triple garage

7. Damage

8. Damage

Task: Repair or Replace

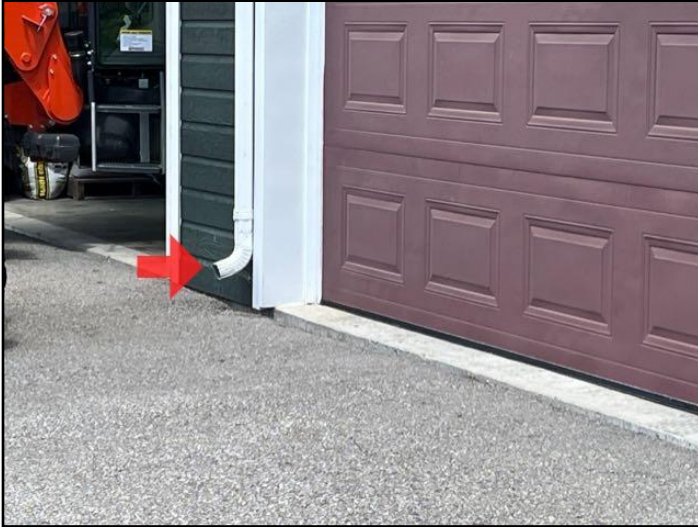
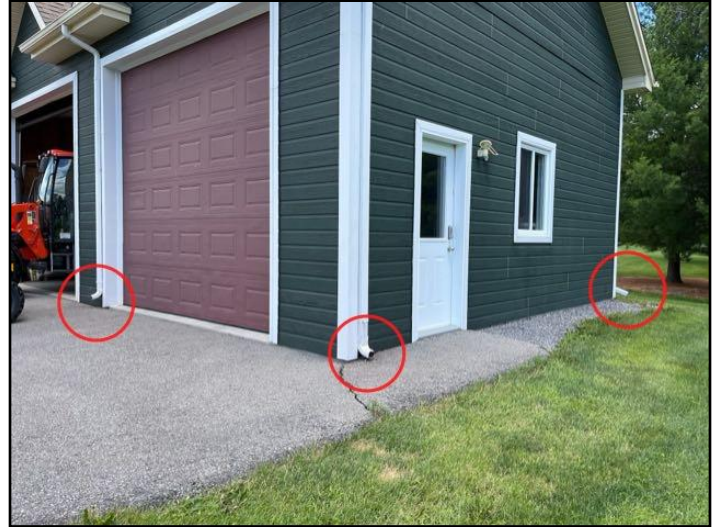
5. Condition: • [Discharge too close to building](#)

Implication(s): Chance of water damage to structure, finishes and contents

Location: Detached double garage at East of property-Throughout

9. Discharge too close to building

10. Discharge too close to building

Task: Correct

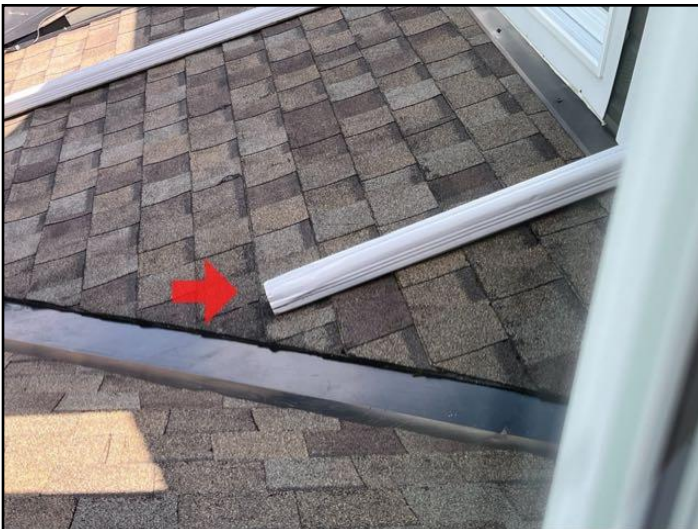
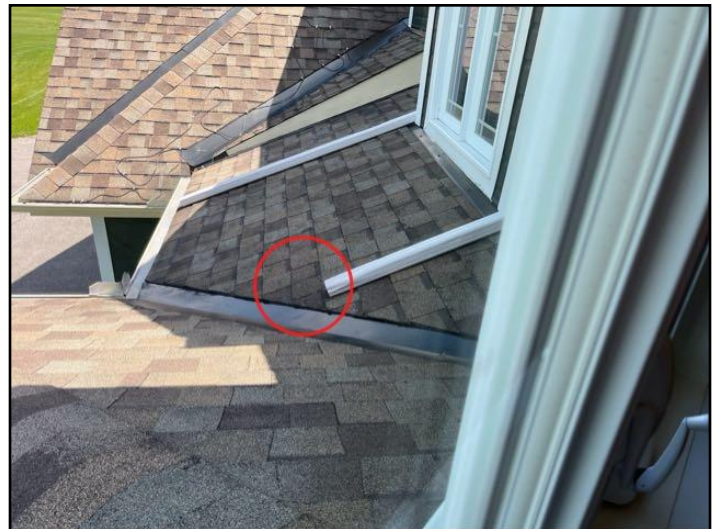
6. Condition: • [Discharge onto roofs](#)

Minor improvement required

Implication(s): Chance of water damage to structure, finishes and contents

Location: House-at North side

11. Discharge onto roofs

12. Discharge onto roofs

Task: Correct/Improve

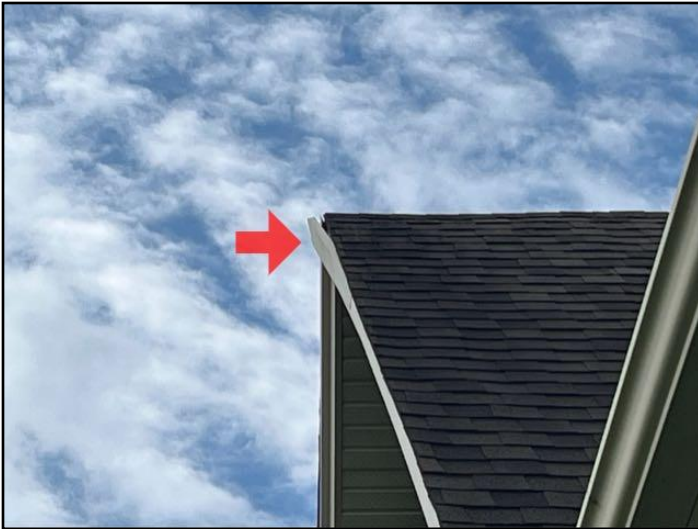
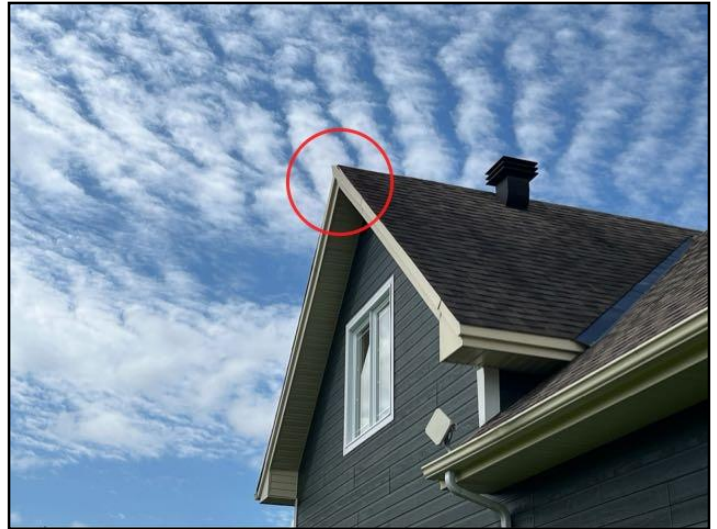
7. Condition: • [Loose or missing pieces](#)

Implication(s): Chance of water damage to structure, finishes and contents | Chance of pests entering building

Location: Triple Garage-at Southeast

13. Loose

14. Loose

Task: Repair

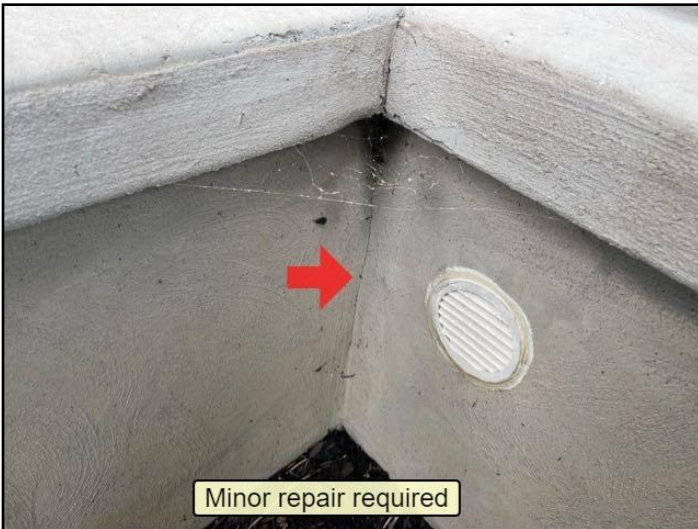
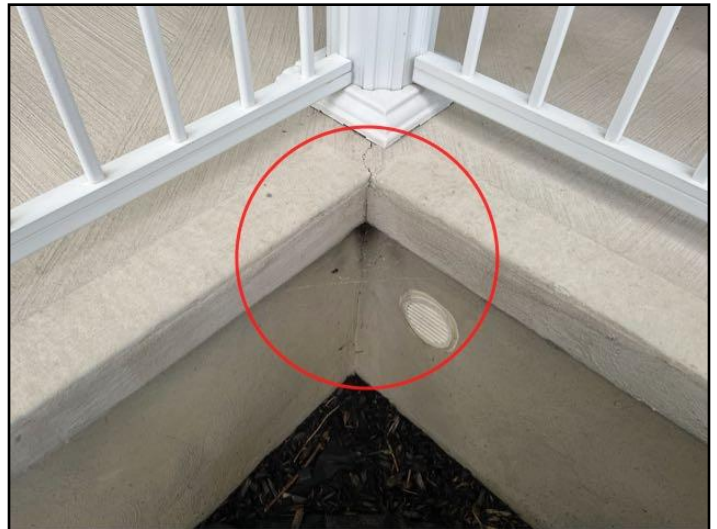
8. Condition: • [Masonry or concrete cracking](#)

Implication(s): Weakened structure

Location: Northwest porch

15. Cracked

16. Cracked

Task: Repair/Monitor

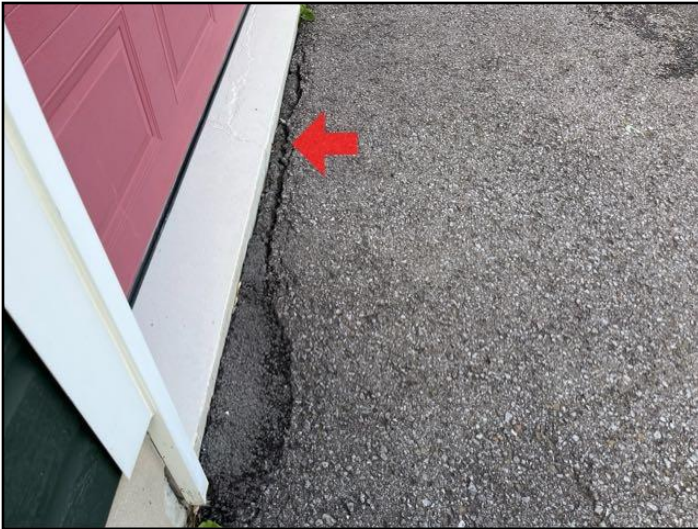
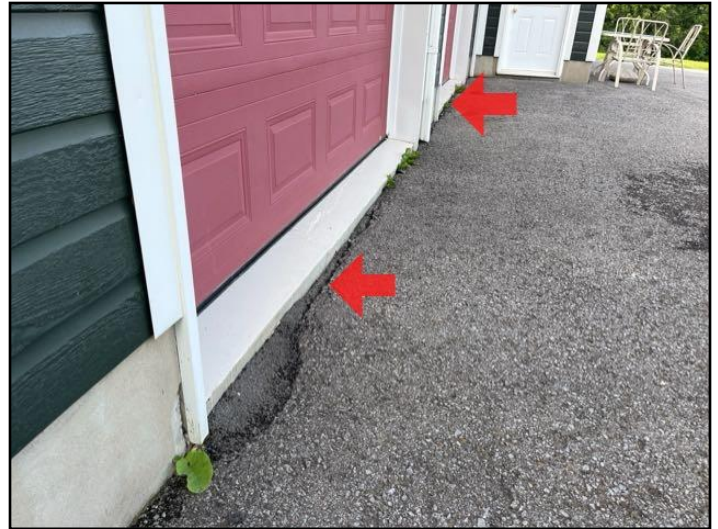
9. Condition: • Cracked or damaged surfaces

Implication(s): Trip or fall hazard - Material deterioration

Location: Triple garage- side throughout

17. Cracked

18. Cracked

Task: Repair/Monitor

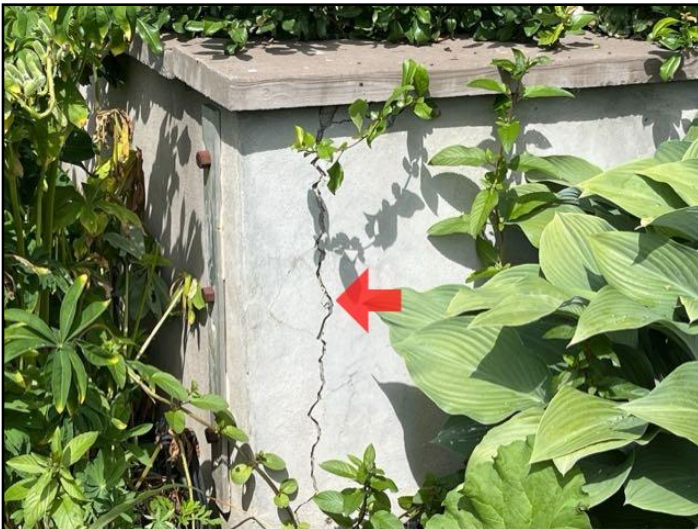
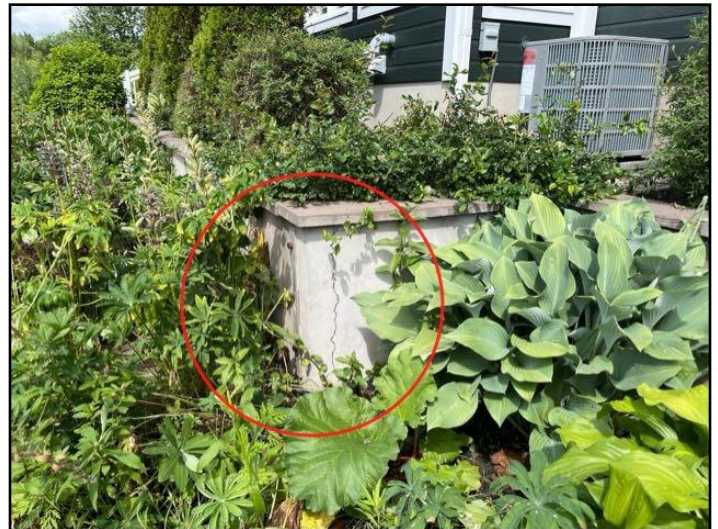
10. Condition: • [Cracked](#)

Implication(s): Weakened structure | Chance of movement

Location: House-at South

19. Cracked

20. Cracked

Task: Repair/Monitor

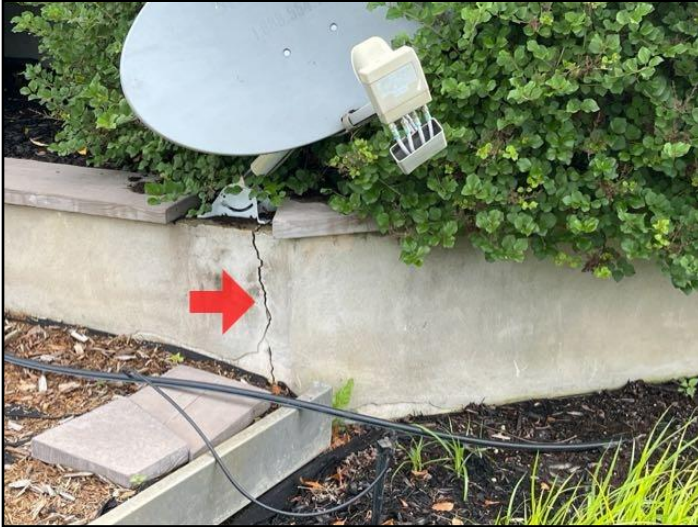
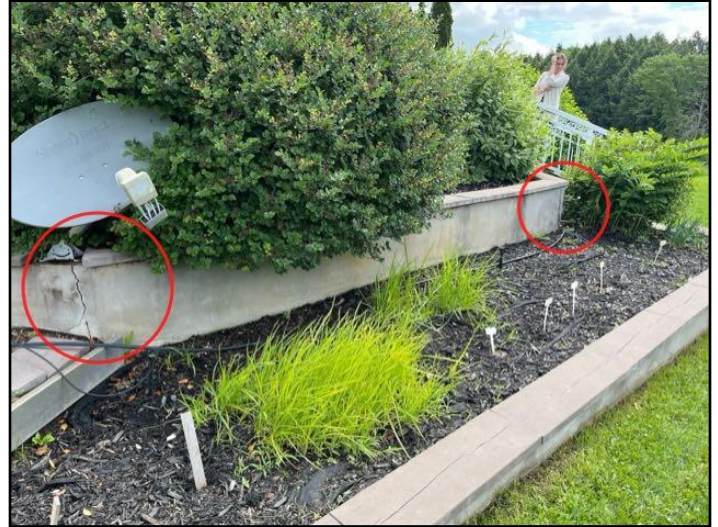
11. Condition: • [Cracked](#)

Implication(s): Weakened structure | Chance of movement

Location: House-at Southwest

21. Cracked

22. Cracked

Task: Repair/Monitor

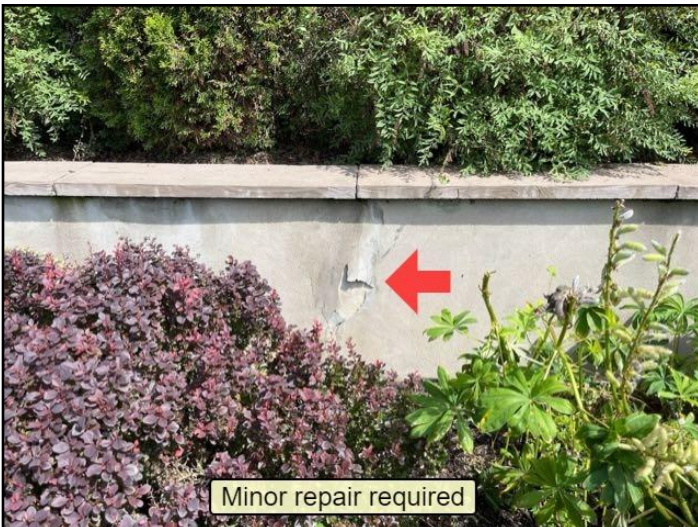
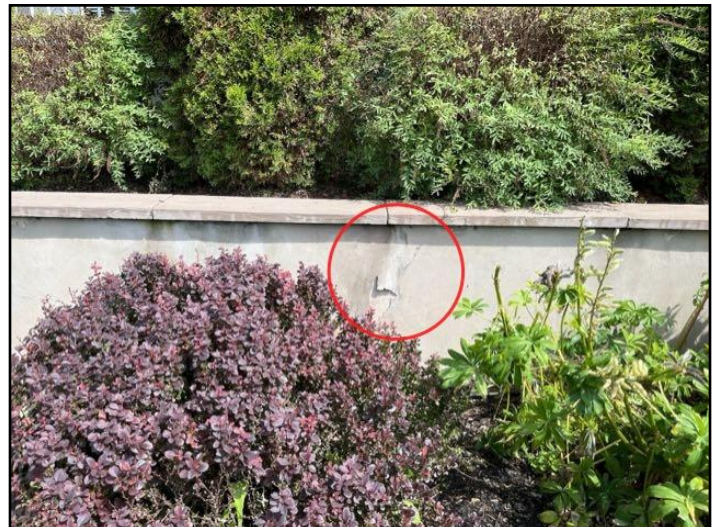
12. Condition: • Damage

on surface

Implication(s): Weakened structure, Chance of movement

Location: House-at South

23. Damage

24. Damage

Task: Repair/Monitor

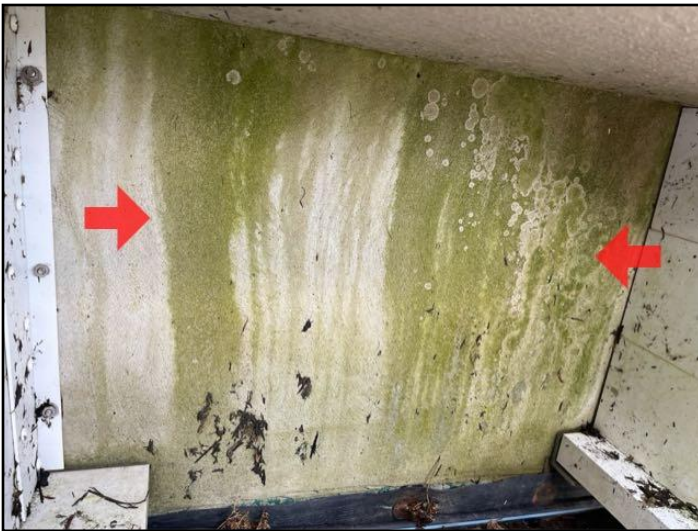
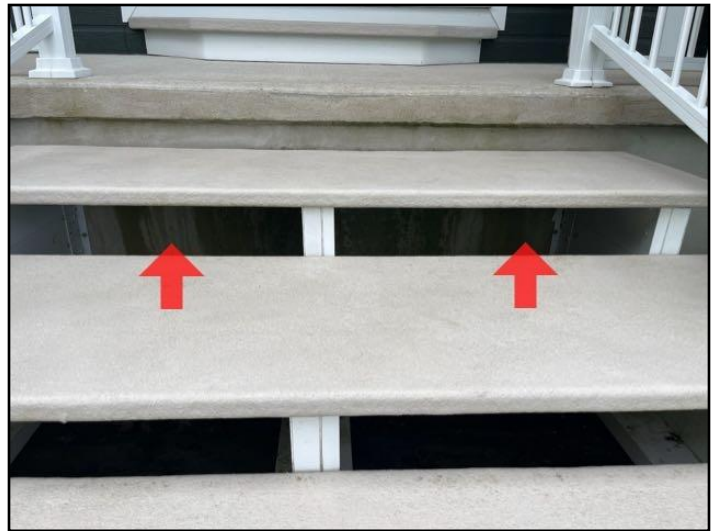
14. Condition: • Signs of water dampness

Implication(s): Material deterioration

Location: North porch-Under steps

25. Water dampness-possible green algae

26. Water dampness-possible green algae

Task: Correct condition/Monitor

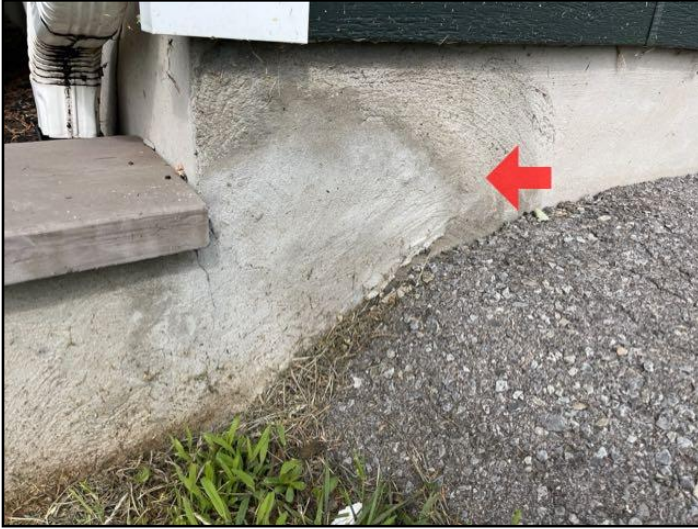
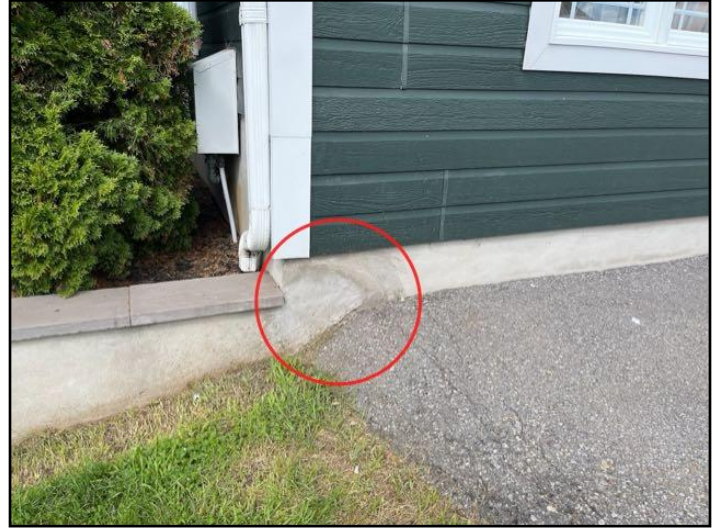
15. Condition: • [Prior repairs](#)

Implication(s): Weakened structure

Location: House-at Southeast corner

27. Prior repairs

28. Prior repairs

Task: Monitor

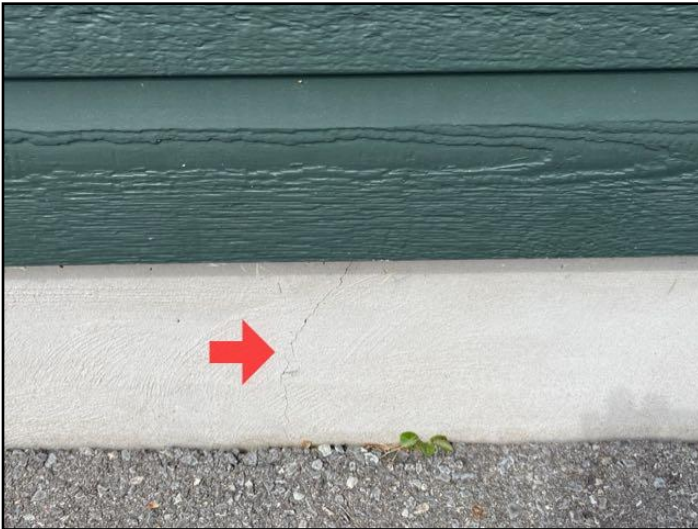
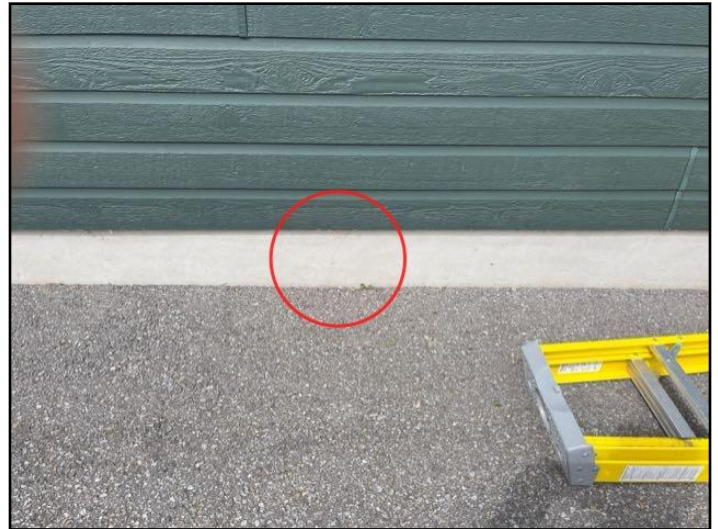
16. Condition: • Parging cracked

Implication(s): Chance of damage to structure | Shortened life expectancy of material

Location: Northeast-at attached garage

29. Parging cracked

30. Parging cracked

Task: Repair/Monitor

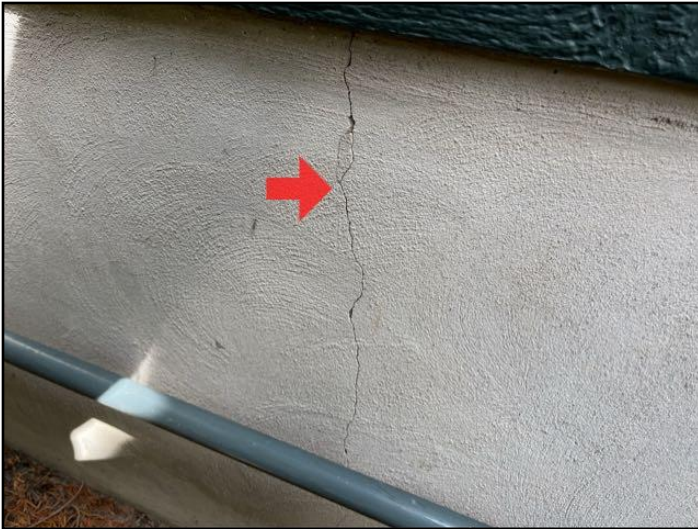
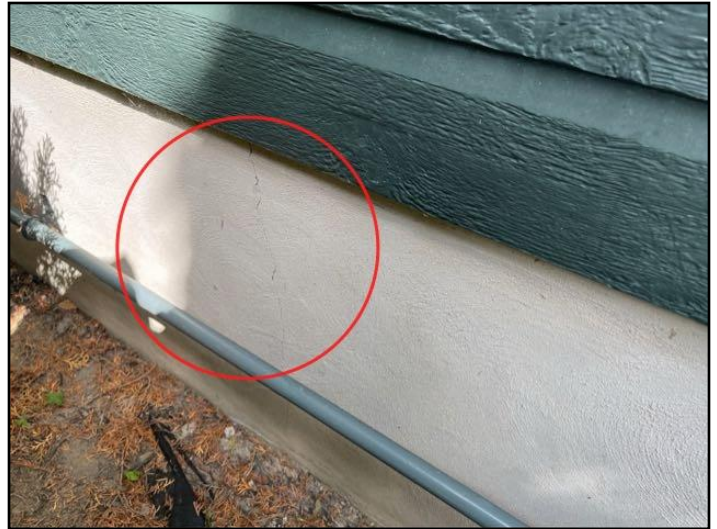
17. Condition: • Parging cracked

Implication(s): Chance of damage to structure | Shortened life expectancy of material

Location: House- at Southeast

31. Parging cracked

32. Parging cracked

Task: Repair/Monitor

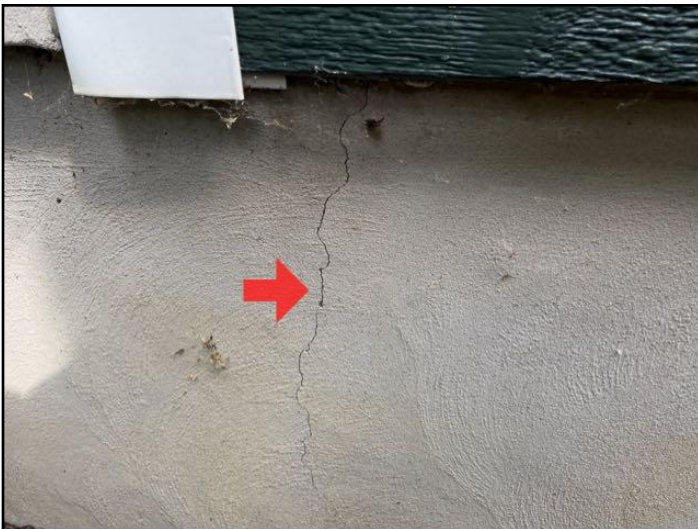
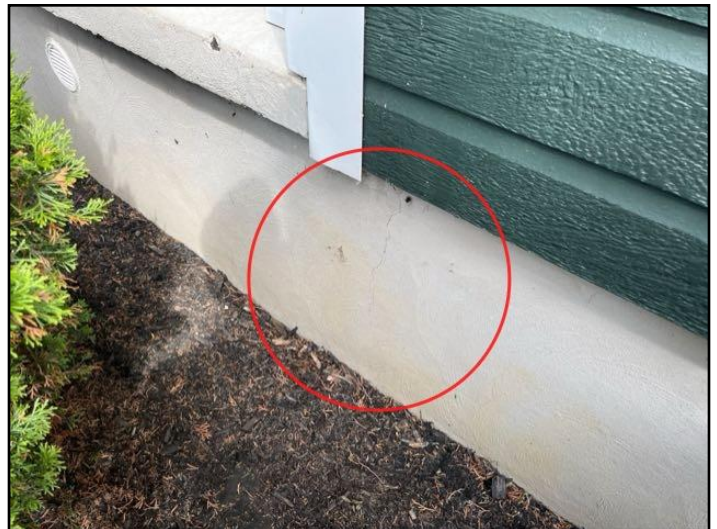
18. Condition: • Parging cracked

Implication(s): Chance of damage to structure | Shortened life expectancy of material

Location: House-at South

33. Parging cracked

34. Parging cracked

Task: Repair/Monitor

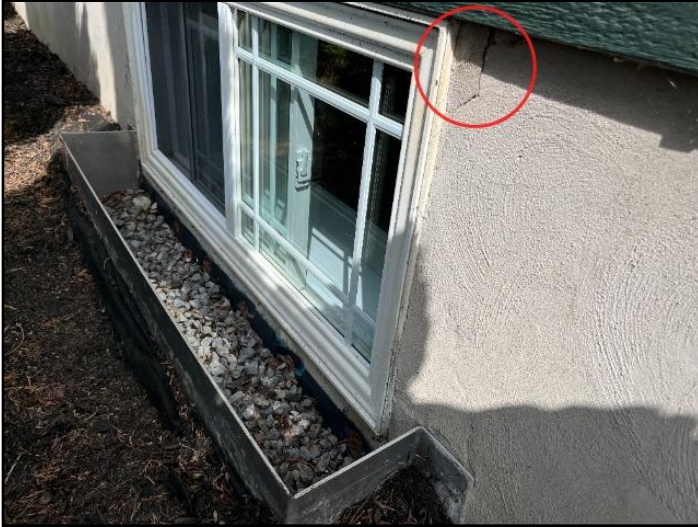
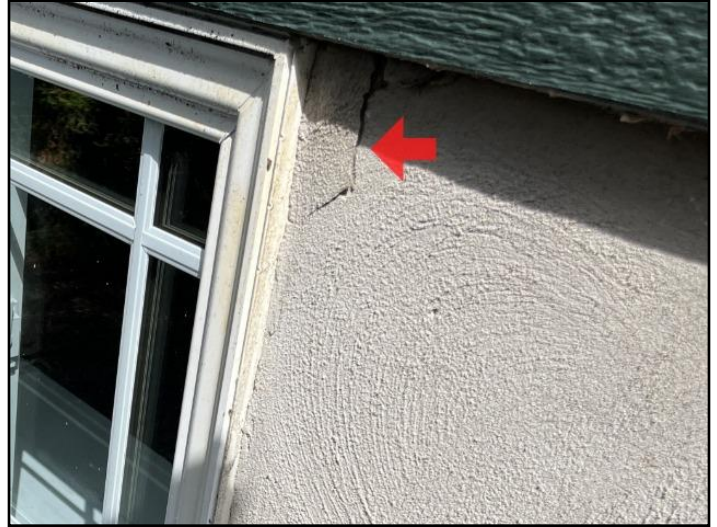
19. Condition: • Parging cracked

Implication(s): Chance of damage to structure | Shortened life expectancy of material

Location: House-at South

35. Parging cracked

36. Parging cracked

Task: Repair/Monitor

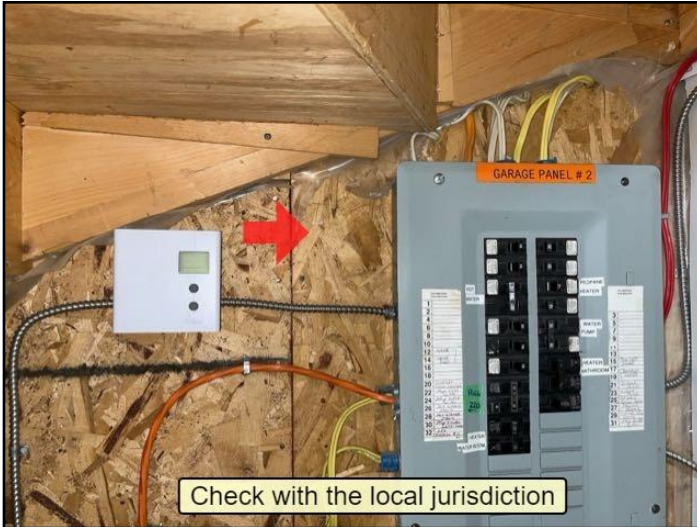
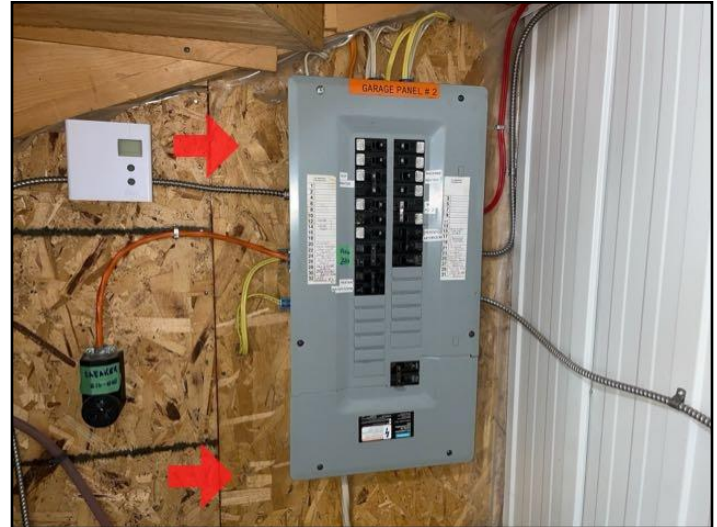
SERVICE BOX, GROUNDING AND PANEL \ Distribution panel**20. Condition:** • [Inappropriate mounting surface](#)**Implication(s):** Fire hazard**Location:** Triple garage-at East**Task:** Verify/Correct**Time:** Immediate/if required

**37. Inappropriate mounting surface**

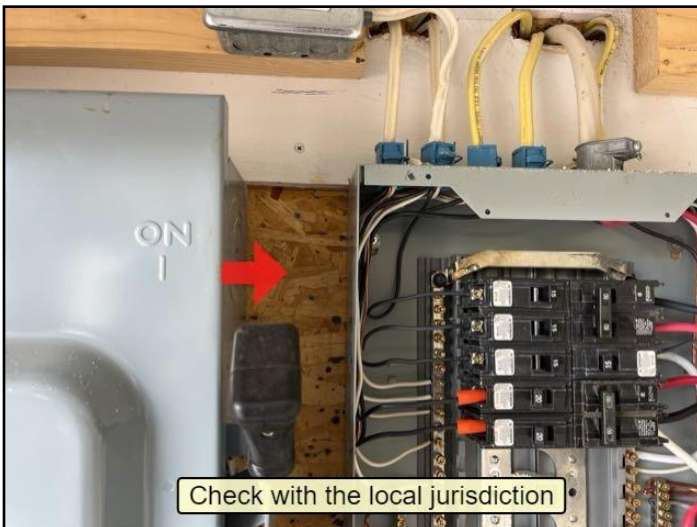
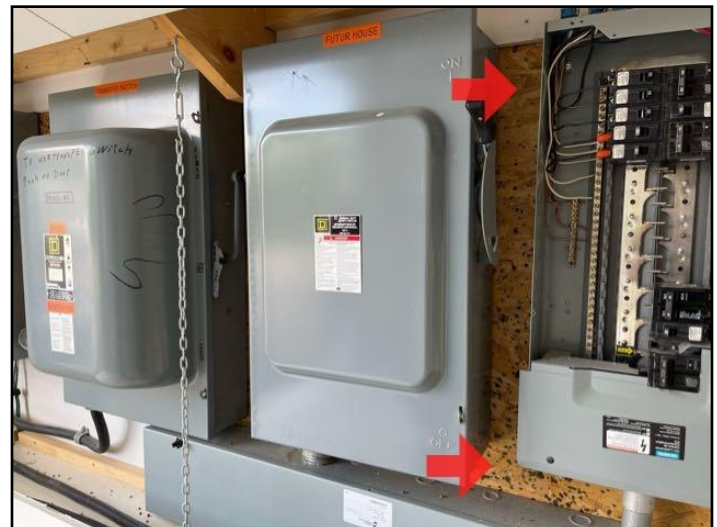
**38. Inappropriate mounting surface****21. Condition:** • [Inappropriate mounting surface](#)**Implication(s):** Fire hazard**Location:** Triple garage-at Northwest**Task:** Verify/Correct**Time:** Immediate/if required

**39. Inappropriate mounting surface**

**40. Inappropriate mounting surface**

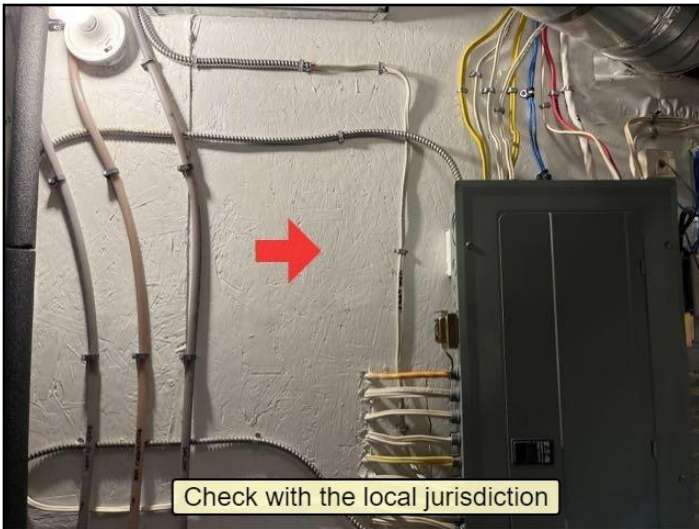
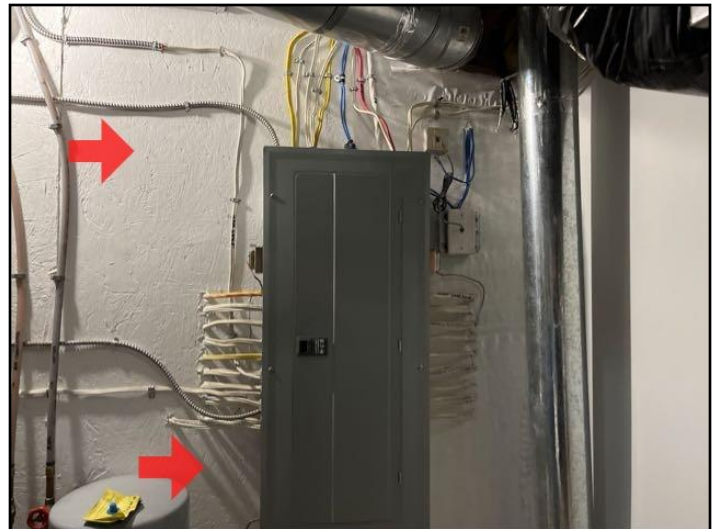
22. Condition: • [Inappropriate mounting surface](#)

in house

Implication(s): Fire hazard

Location: Northeast basement

41. Inappropriate mounting surface

42. Inappropriate mounting surface

Task: Verify/Correct

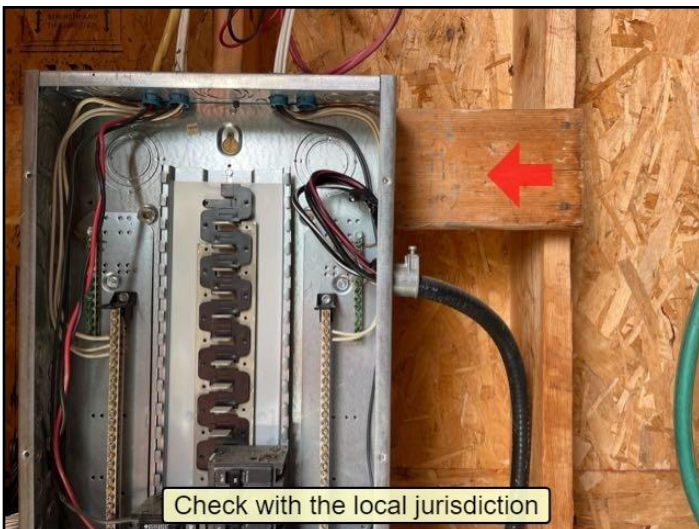
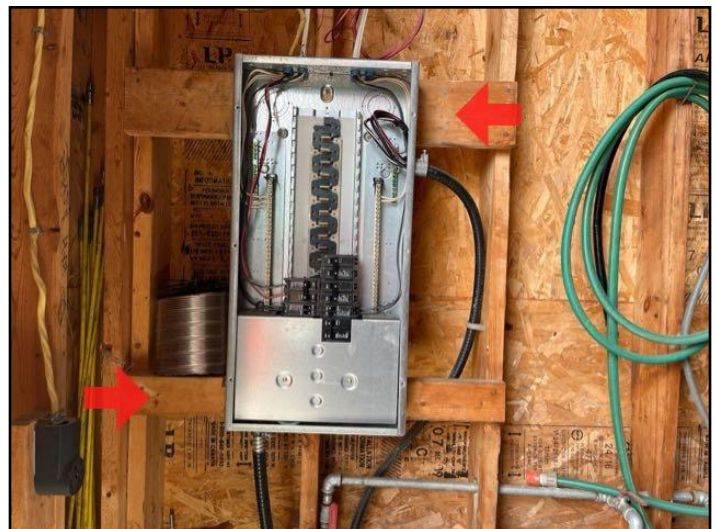
23. Condition: • [Inappropriate mounting surface](#)

Implication(s): Fire hazard

Location: Detached double garage at East of property-Northwest wall

43. Inappropriate mounting surface

44. Inappropriate mounting surface

Task: Verify/Correct

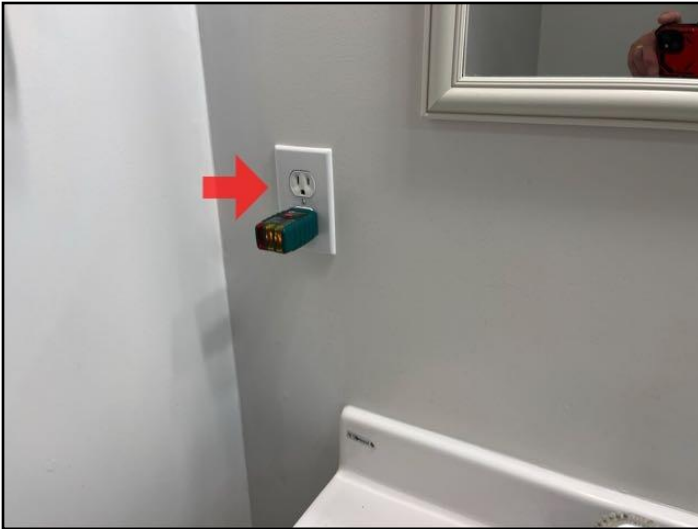
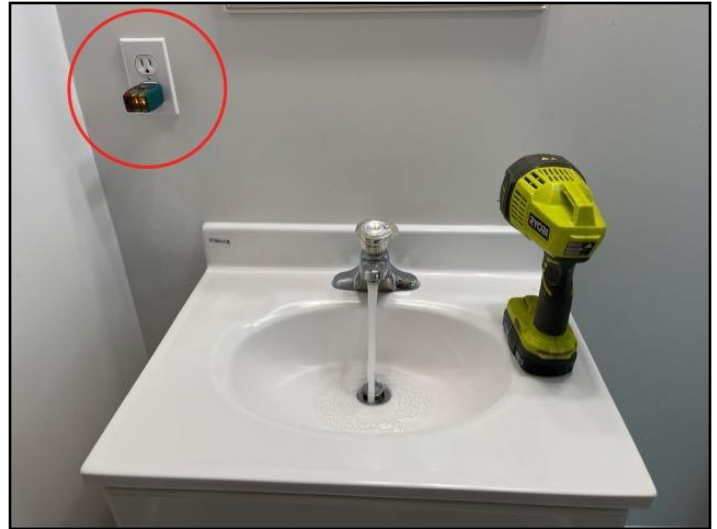
24. Condition: • [GFCI/GFI needed \(Ground Fault Circuit Interrupter\)](#)

Implication(s): Electric shock

Location: Triple garage-East main floor bathroom

45. GFCI/GFI needed (Ground Fault Circuit...

46. GFCI/GFI needed (Ground Fault Circuit...

Task: Replace

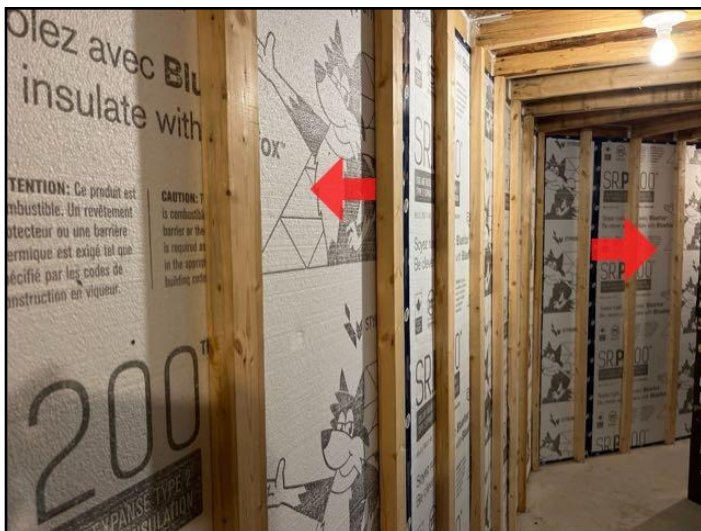
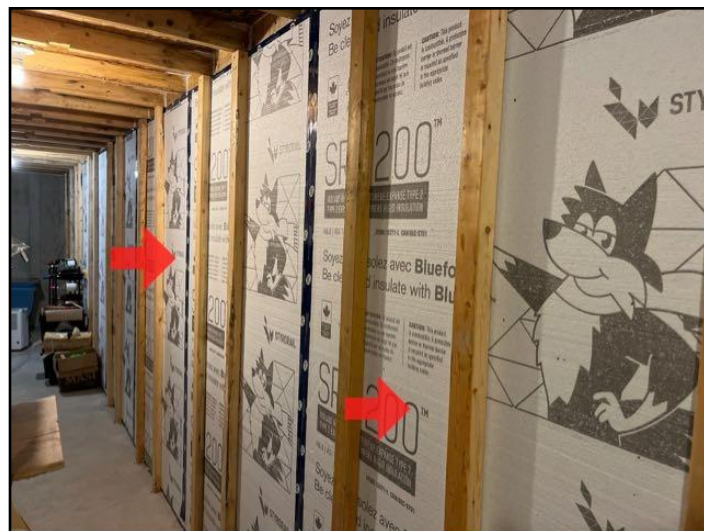
28. Condition: • [Exposed combustible insulation](#)

Implication(s): Fire hazard

47. Exposed combustible insulation

48. Exposed combustible insulation

Task: Protect or remove

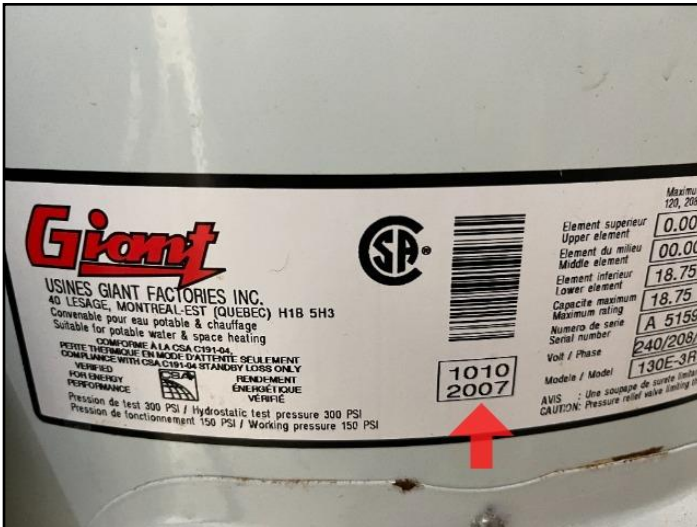
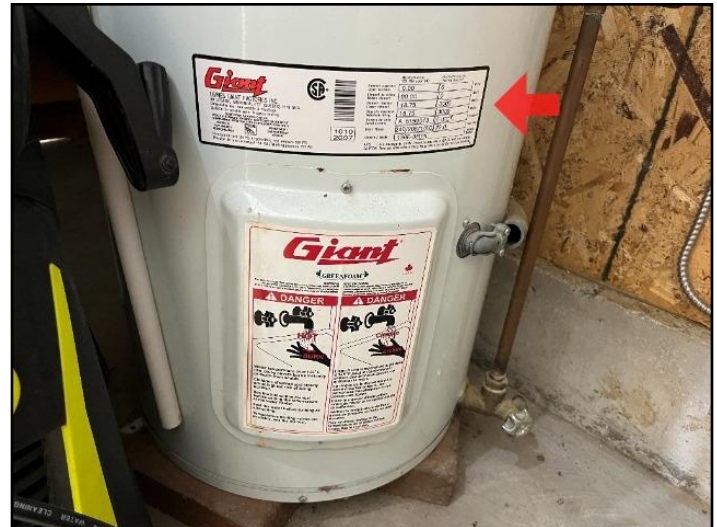
29. Condition: • Past life expectancy

Implication(s): Chance of water damage to structure, finishes and contents | No hot water

49. 16 years

50. 16 years

Task: Monitor/Replace

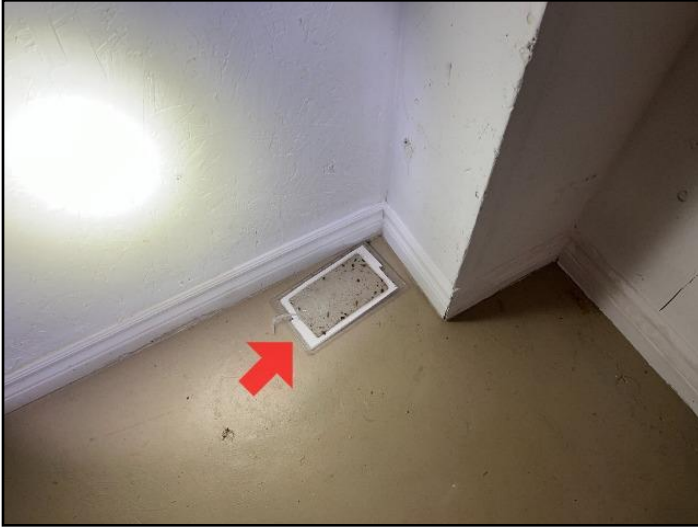
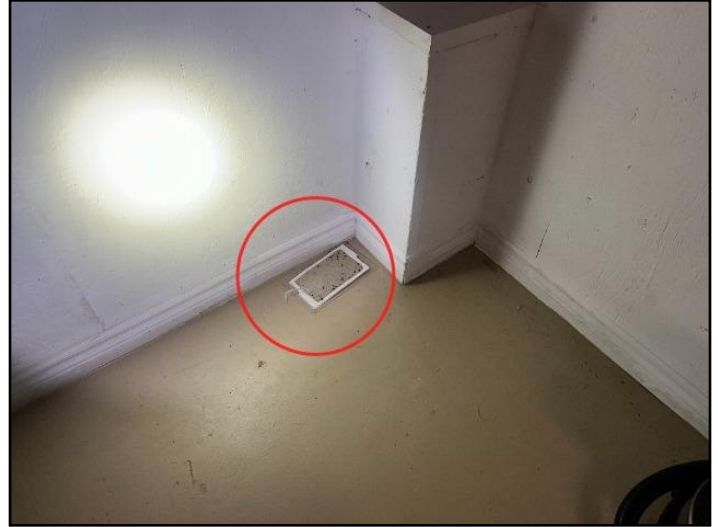
30. Condition: • Evidence of animal/vermin activity

Implication(s): Nuisance - Health hazard

51. Evidence of animal/vermin activity

52. Evidence of animal/vermin activity

Task: Monitor

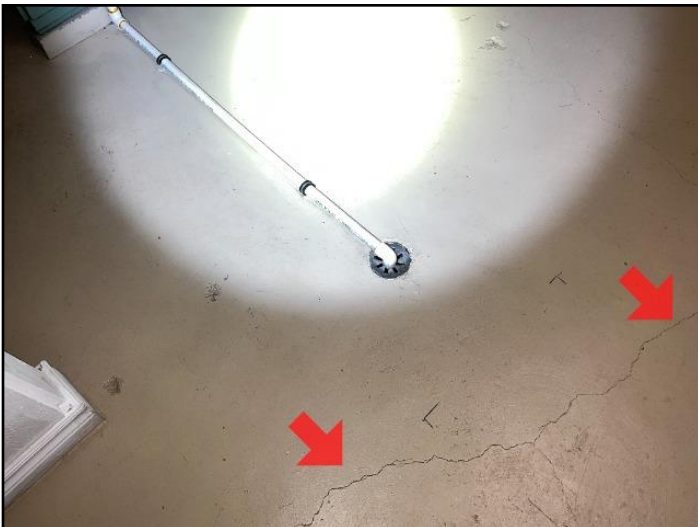
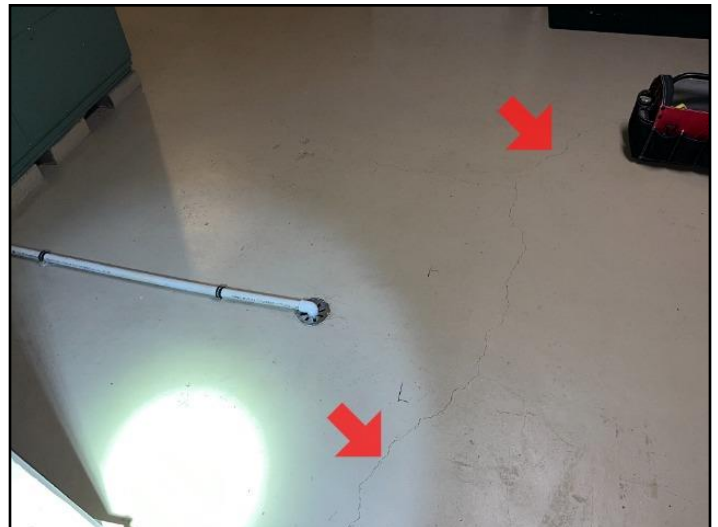
31. Condition: • Cracked

Implication(s): Chance of water damage to structure, finishes and contents

53. Cracked

54. Cracked

Task: Monitor

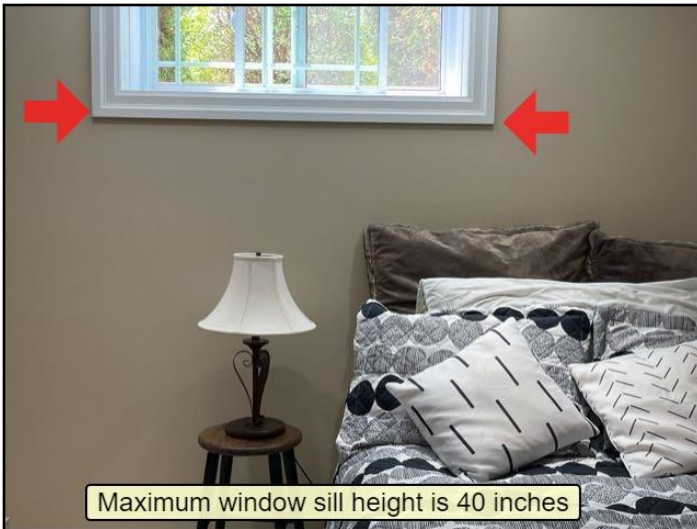
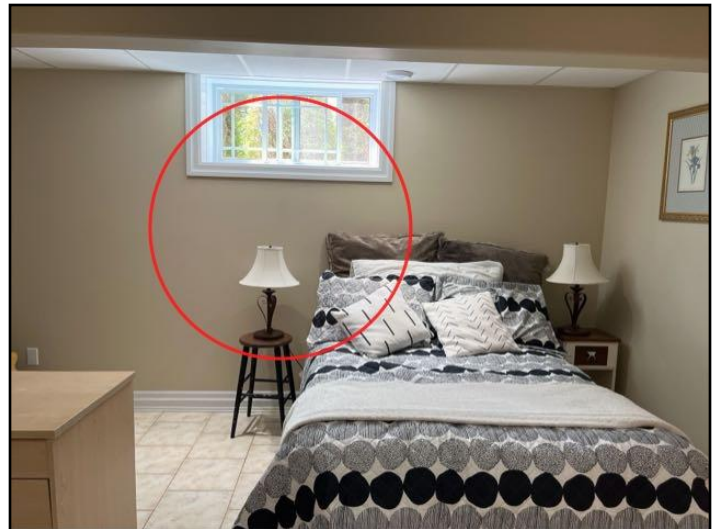
32. Condition: • Window sill too high

55. Window sill too high

56. Window sill too high

Task: Correct/Maintain
