Your Inspection Report

123 No Road St-
Albert, ON K0B 3Z0

Thursday, June 11, 2024

RE: Report No. 1144, v.2
123 No Road
St-Albert, ON
K0B 3Z0

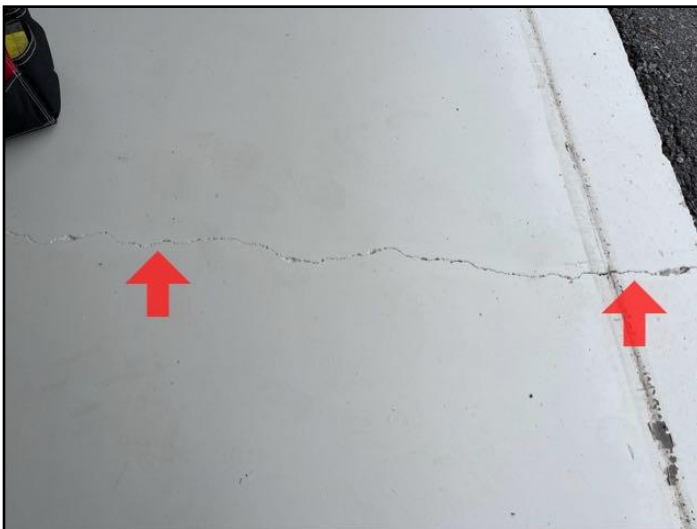
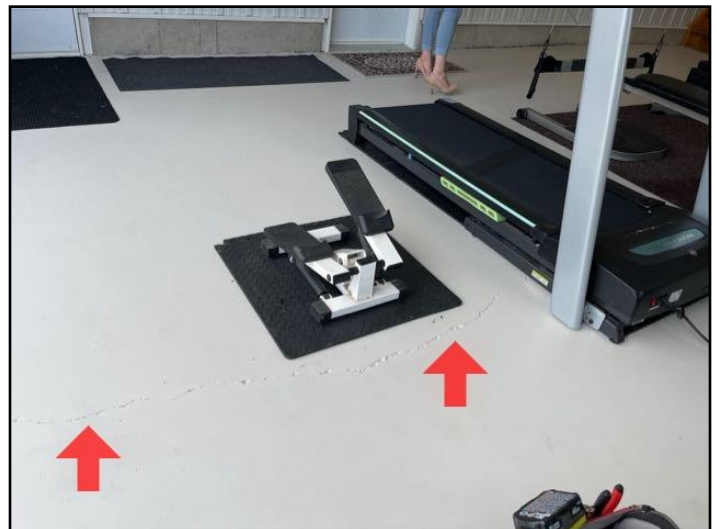
33. Condition: • [Cracked](#)

57. Cracked

58. Cracked

Task: Repair/Monitor

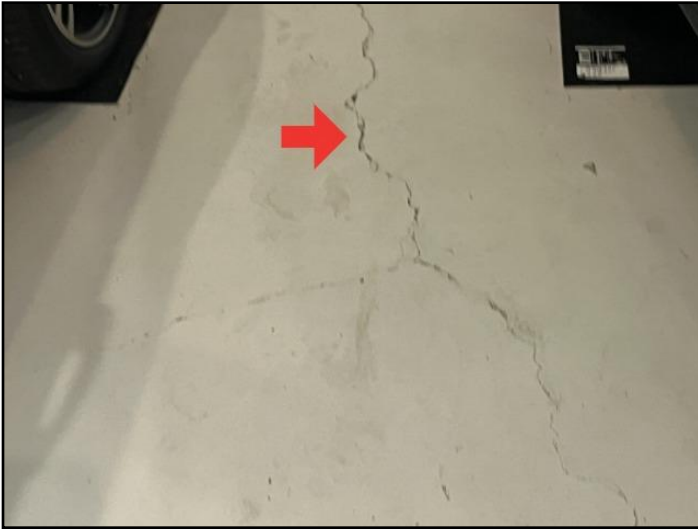
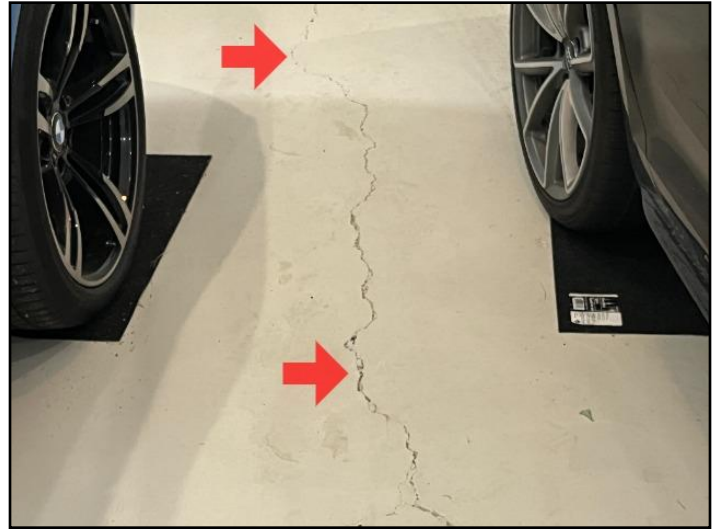
34. Condition: • [Cracked](#)

59. Cracked

60. Cracked

Task: Repair/Monitor

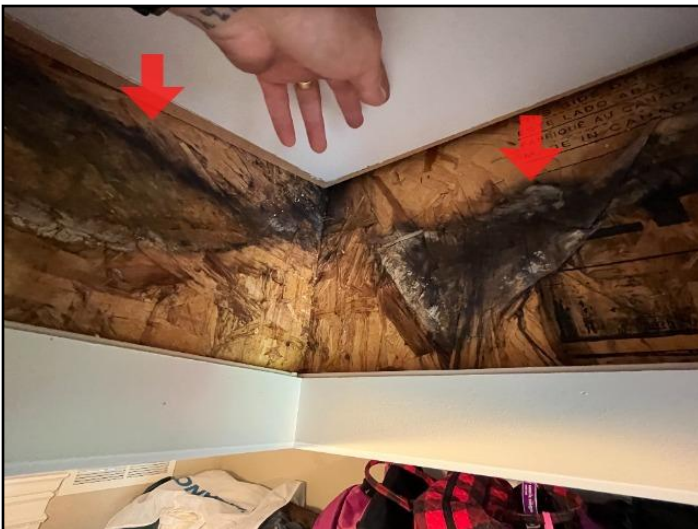
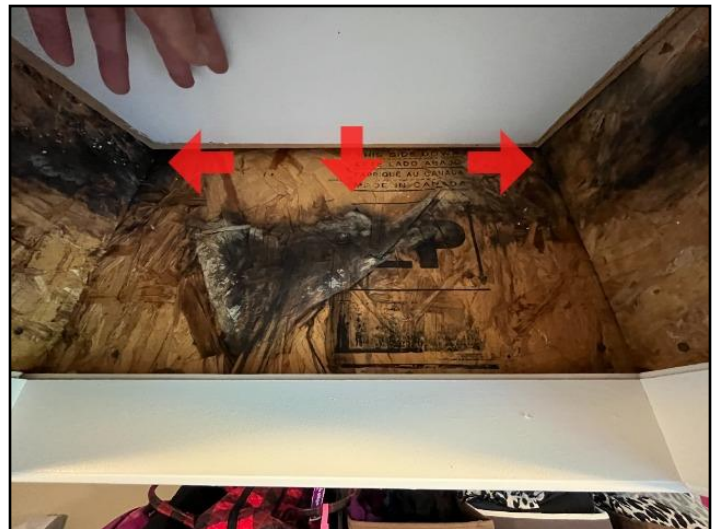
35. Condition: • Mold

Implication(s): Health hazard

61. Possible mold

62. Possible mold

Task: Verify/Correct
