PROPERTY CONDITION ASSESSMENT REPORT

FOR THE PROPERTY AT: 1234 No Road Nowhere, ON

INSPECTION DATE: Tuesday, April 4, 2023

RE: Report No. 1004 1234 No Road Nowhere, ON

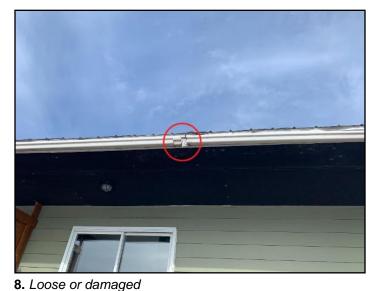
7. Loose or damaged

4. Condition: • Loose or damaged

Implication(s): Chance of water damage to structure, finishes and contents

Task: Repair or Replace

Time: As soon as possible

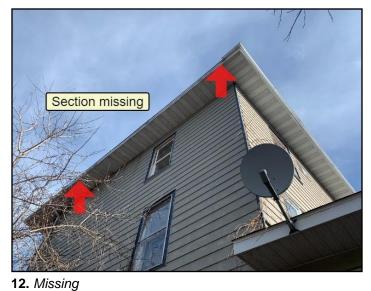
11. Missing

6. Condition: • Missing

Implication(s): Chance of water damage to structure, finishes and contents

Time: As soon as possible

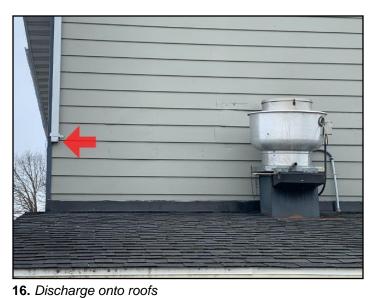
15. Discharge onto roofs

8. Condition: • Discharge onto roofs

Time: As soon as possible

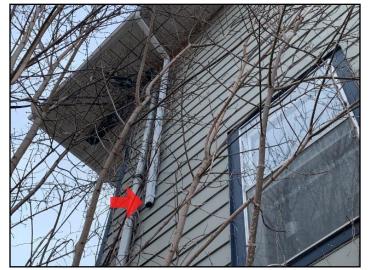
21. Discharge too close to building

Implication(s): Chance of water damage to structure, finishes and contents Location: Southwest corner

Task: Correct Time: As soon as possible

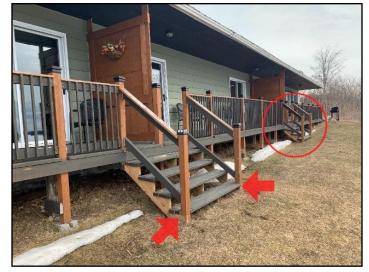
39. Wood/soil contact

20. Condition: • <u>Wood/soil contact</u> Implication(s): Insect damage | Rot Location: East side/Porch stairs Task: Improve

Time: As soon as practical

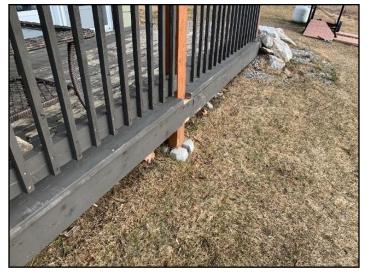
41. Settled

21. Condition: • Settled
Implication(s): Chance of movement | Weakened structure
Location: Throughout East side porches/Motel units
Task: Correct
Time: As soon as possible

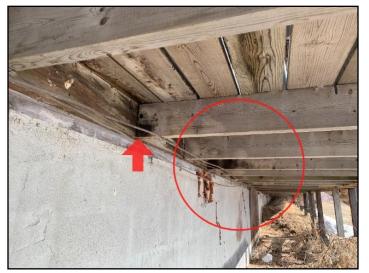
49. Joist hangers missing

25. Condition: • Joist hangers missing
Implication(s): Weakened structure | Chance of movement
Location: Throughout East side porches
Task: Provide
Time: Immediate

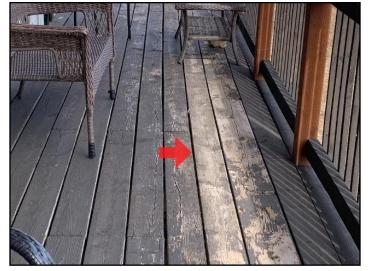
52. Paint or stain needed

26. Condition: • Paint or stain needed
Implication(s): Shortened life expectancy of material
Location: Throughout East porches/Motel units
Task: Provide
Time: As soon as possible

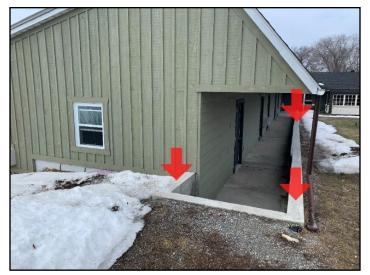
57. Missing

29. Condition: • Missing Implication(s): Fall hazard Location: Northwest/Motel units Task: Provide Time: Immediate

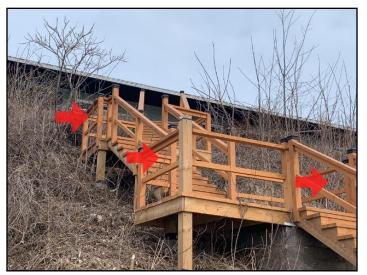
65. Spindles (balusters) missing

33. Condition: • <u>Spindles (balusters) missing</u>
Implication(s): Fall hazard
Location: East side/Throughout stairs leading to lake
Task: Provide
Time: Immediate

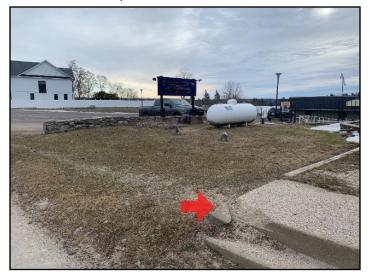
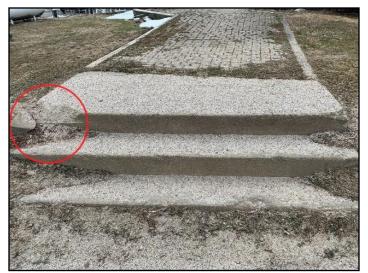
37. Condition: • <u>Cracked or damaged surfaces</u>
Implication(s): Trip or fall hazard
Location: West walkway
Task: Repair
Time: As soon as possible

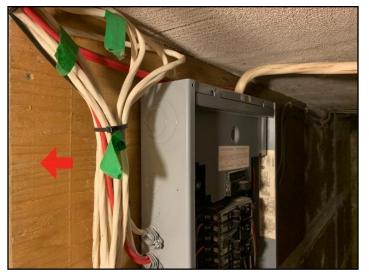
93. *Inappropriate mounting surface*

47. Condition: • Inappropriate mounting surface Implication(s): Fire hazard
Location: Main house basement/Utility room
Task: Correct
Time: Immediate

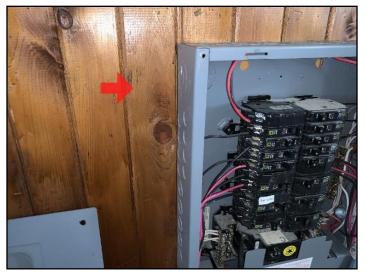
97. Inappropriate mounting surface

49. Condition: • Inappropriate mounting surface Implication(s): Fire hazard Location: South/First floor/Restaurant Task: Correct Time: Immediate

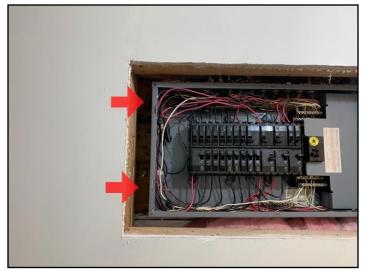
99. Inappropriate mounting surface

50. Condition: • Inappropriate mounting surface Implication(s): Fire hazard Location: North entrance Task: Correct Time: Immediate

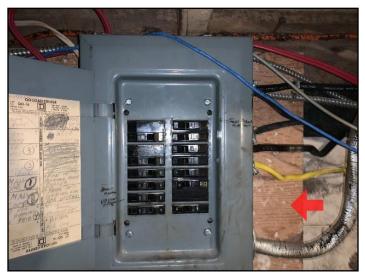
101. Inappropriate mounting surface

51. Condition: • Inappropriate mounting surface
Implication(s): Fire hazard
Location: Main house/basement/west utility rooms
Task: Correct
Time: Immediate

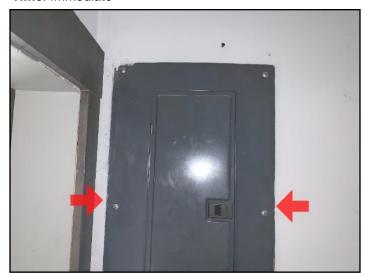
105. Poor access

53. Condition: • Poor access

Implication(s): Difficult to service Location: Main house/Second floor/at stairs Task: Correct Time: Immediate

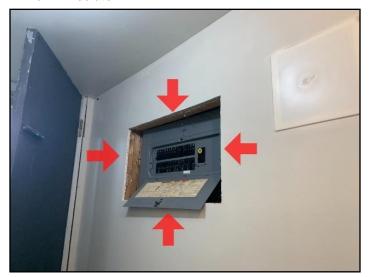
109. Poor access

55. Condition: • Poor access Implication(s): Difficult to service Location: North entrance Task: Correct Time: Immediate

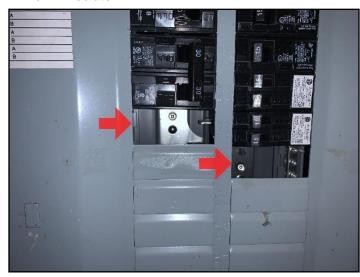
113. Openings in panel

57. Condition: • Openings in panel

Implication(s): Fire hazard | Electric shock Location: Southeast crawlspace/Restaurant Task: Correct Time: Immediate

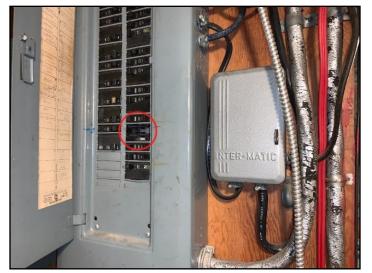
117. Openings in panel

59. Condition: • Openings in panel Implication(s): Fire hazard | Electric shock Location: West/Basement utility room Task: Correct Time: Immediate

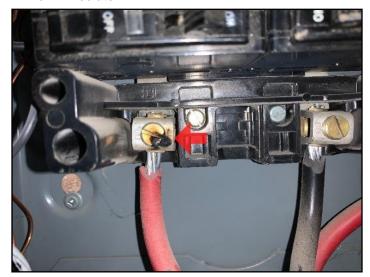
121. Overheating

61. Condition: • Overheating
Implication(s): Fire hazard
Location: Main house/West utility rooms
Task: Further evaluation
Time: Immediate

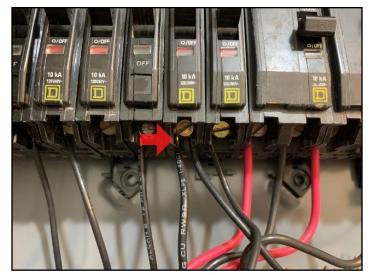
125. Double taps

63. Condition: • Double taps Implication(s): Fire hazard Location: North entrance Task: Correct Time: Immediate

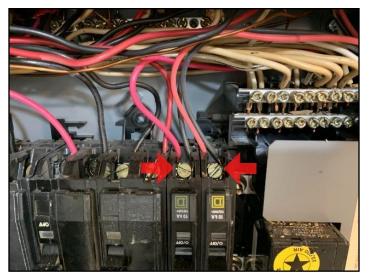
129. Double taps

65. Condition: • Double taps Implication(s): Fire hazard Location: North entrance Task: Correct Time: Immediate

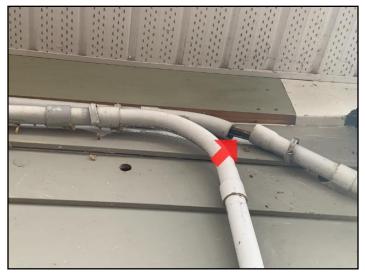
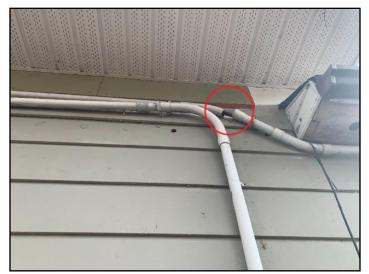
71. Condition: • Conduit damaged
Implication(s): Electric shock
Location: South side
Task: Repair or Replace
Time: Immediate

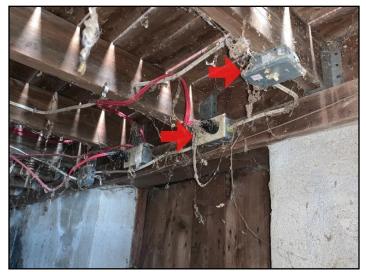
149. Not suitable for outdoor (exterior) use

75. Condition: • Not suitable for outdoor (exterior) use
Implication(s): Shock hazard or interruption of electrical service
Location: East/Under walkway
Task: Replace
Time: Immediate

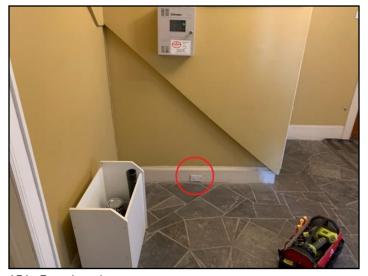
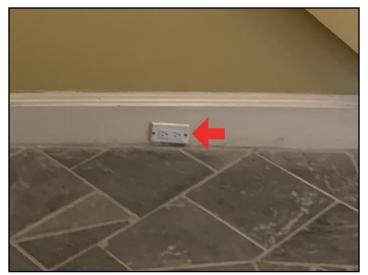
76. Condition: • Poor location
Implication(s): Electric shock
Location: Main house entrance/Lobby
Task: Correct
Time: Immediate

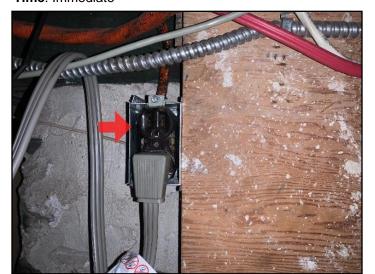
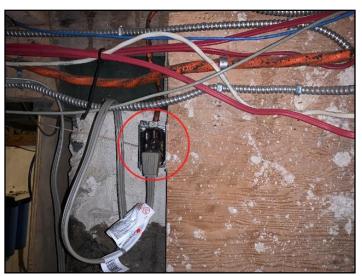
77. Condition: • <u>Missing</u> Implication(s): Electric shock Location: Basement/West utility rooms Task: Provide Time: Immediate

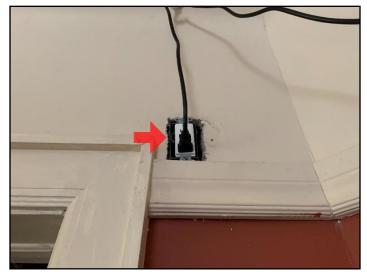
157. Missing

79. Condition: • Missing Implication(s): Electric shock Location: Food bank/West wall Task: Provide Time: Immediate

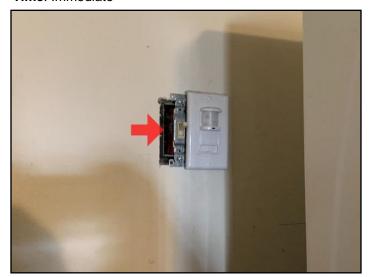
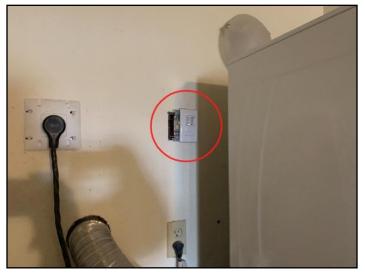
81. Condition: • For switch is missing Implication(s): Electric shock
Location: Southeast/Laundry room
Task: Provide
Time: Immediate

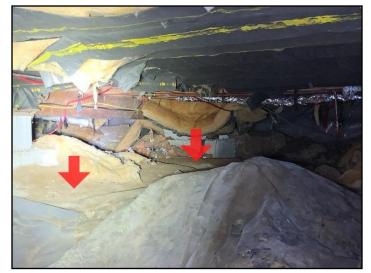
172. No vapor barrier

88. Condition: • <u>No vapor barrier</u>
Implication(s): Chance of condensation damage to finishes and/or structure
Location: East/Restaurant & Motel units crawlspace
Task: Improve
Time: As soon as possible

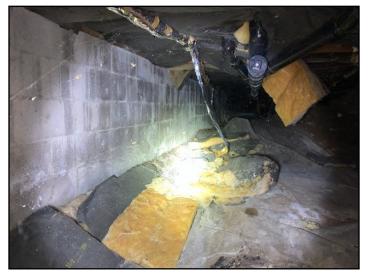
175. Debris in crawlspace

90. Condition: • Debris in crawlspace
Implication(s): Difficult to inspect, poor ventilation
Location: Throughout/Restaurant & Motel units crawlspace
Task: Remove
Time: As soon as practical

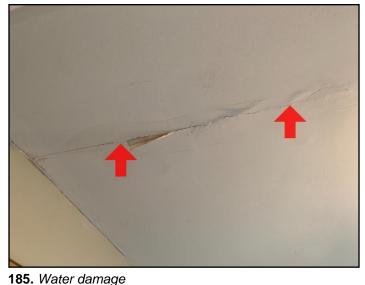
186. Water damage

95. Condition: • Water damage
Implication(s): Rot | Leakage | Chance of movement
Location: Main house/Southwest bedroom
Task: Repair/Monitor
Time: as soon as possible/Ongoing

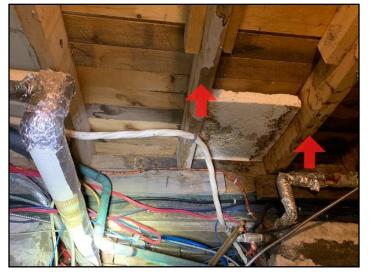
189. Water stains

97. Condition: • Water stains
Implication(s): Chance of water damage to structure, finishes and contents
Location: West/Utility rooms
Task: Monitor
Time: Ongoing

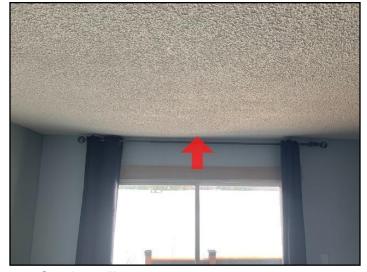
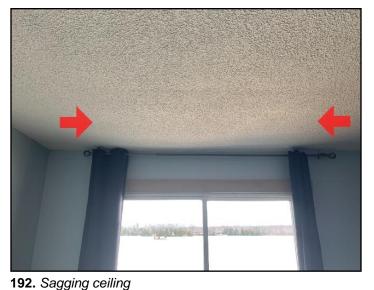
191. Sagging ceiling

98. Condition: • Sag
Implication(s): Chance of movement
Location: Motel unit 3
Task: Further investigate
Time: Immediate

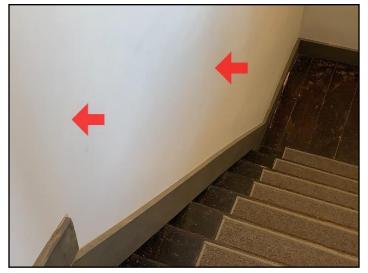
201. Missing

103. Condition: • Missing
Implication(s): Fall hazard
Location: Interior staircase to Main house
Task: Provide
Time: Immediate

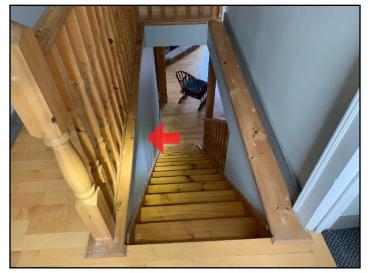
205. Missing

105. Condition: • Missing Implication(s): Fall hazard Location: Main house/Staircase to second floor Task: Provide Time: Immediate

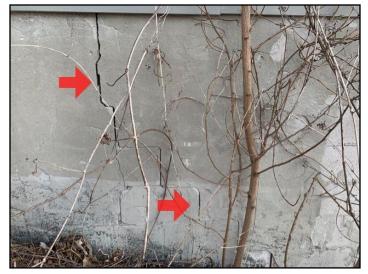
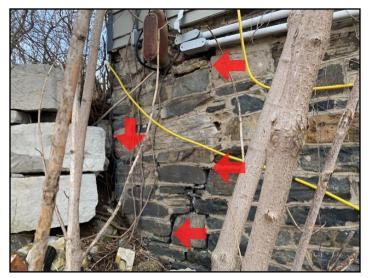
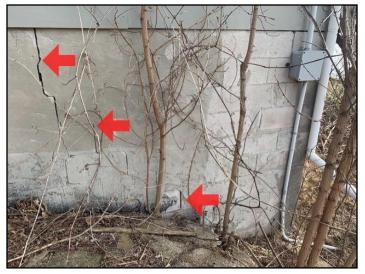
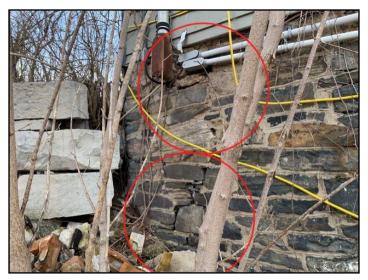
118. Condition: • Significant settlement was notedLocation: Main house and MotelTask: Further evaluationTime: Immediate
