INSPECTION REPORT

For the Property at:
123 NO ROAD
NOWHERE, ON H2OH20

Prepared for: JOHN DOE
Inspection Date: Saturday, October 5, 2019
Prepared by: Daniel Ducheneaux

RE: Report No. 1015, v.4
123 No road
Nowhere, ON
H2OH20

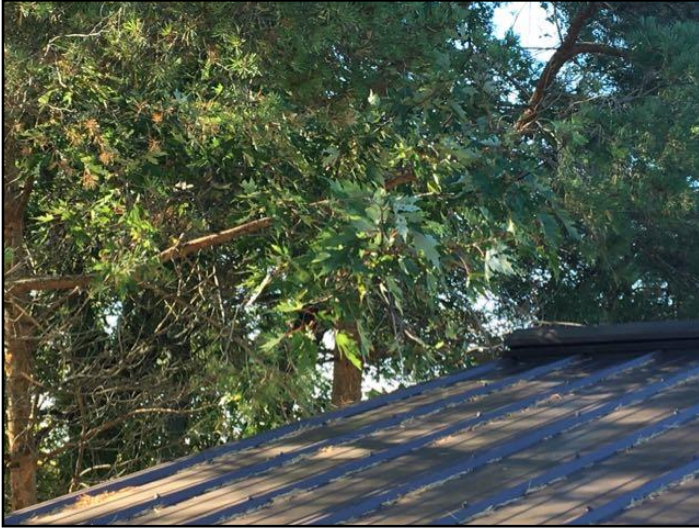
Implication(s): Wear of roofing material/clogging of gutters

1. Too close to roof

Task: Improve

Time: As soon as possible

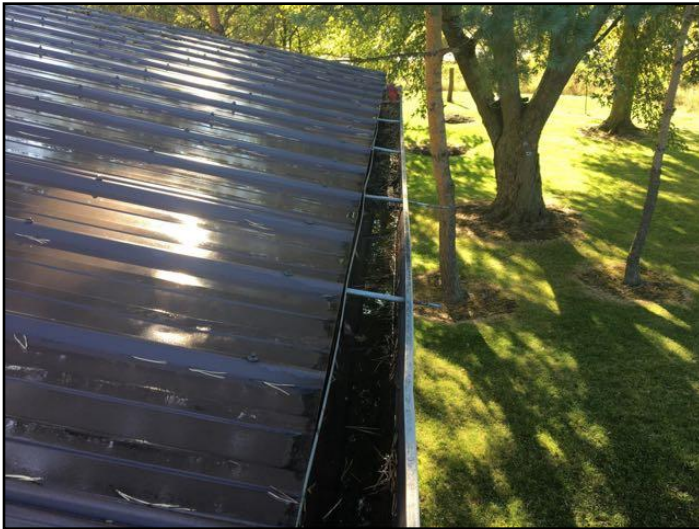
Condition: • [Clogged](#)

Implication(s): Chance of water damage to contents, finishes and/or structure

9. Clogged

Time: Immediate

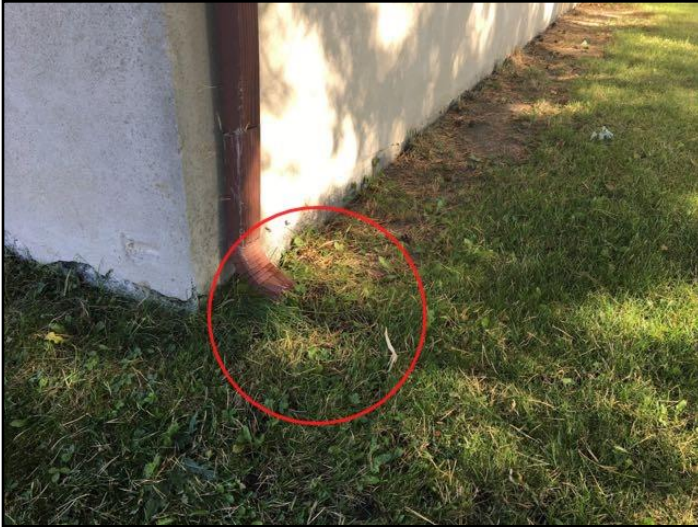
Condition: • [Discharge too close to building](#)

Implication(s): Chance of water damage to contents, finishes and/or structure

13. Discharge too close to building

Time: As soon as practical

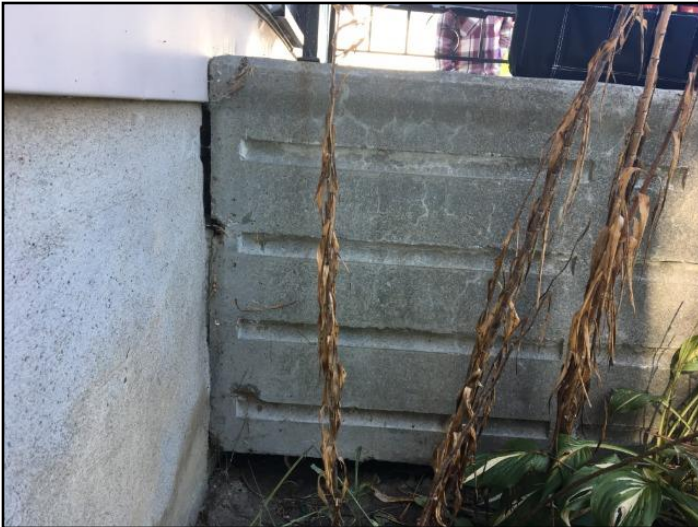
29. Settlement

Task: Monitor

Time: Ongoing

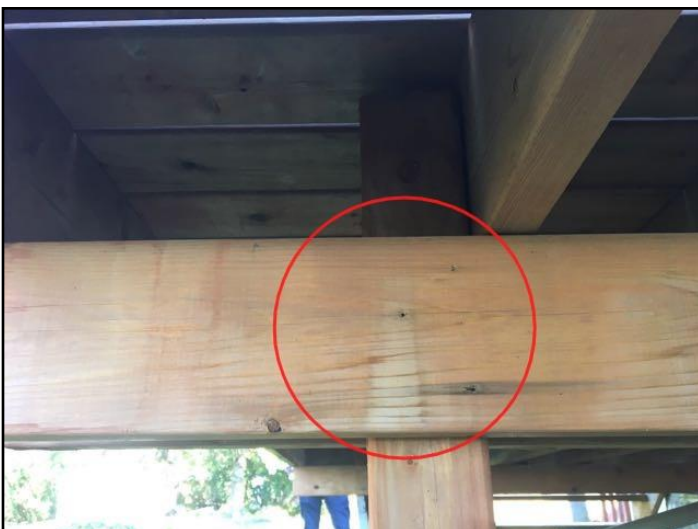
Condition: • [Connections weak](#)

Weak connections to posts noted throughout

31. Connections weak

Task: Improve

Time: Immediate

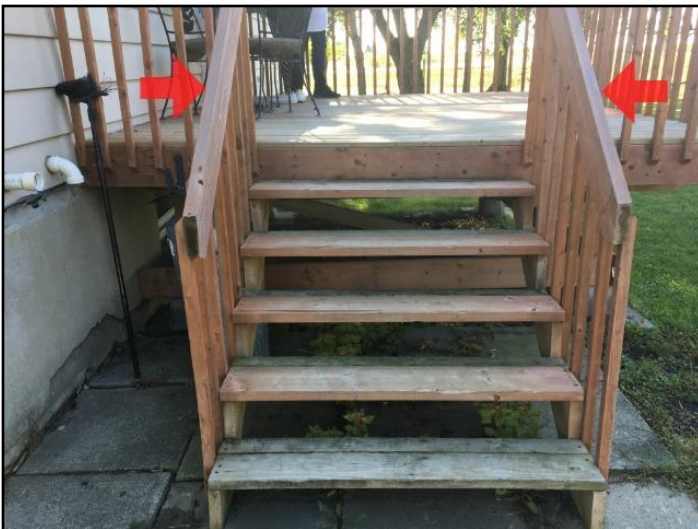
35. Hard to hold

Task: Improve

Time: Immediate

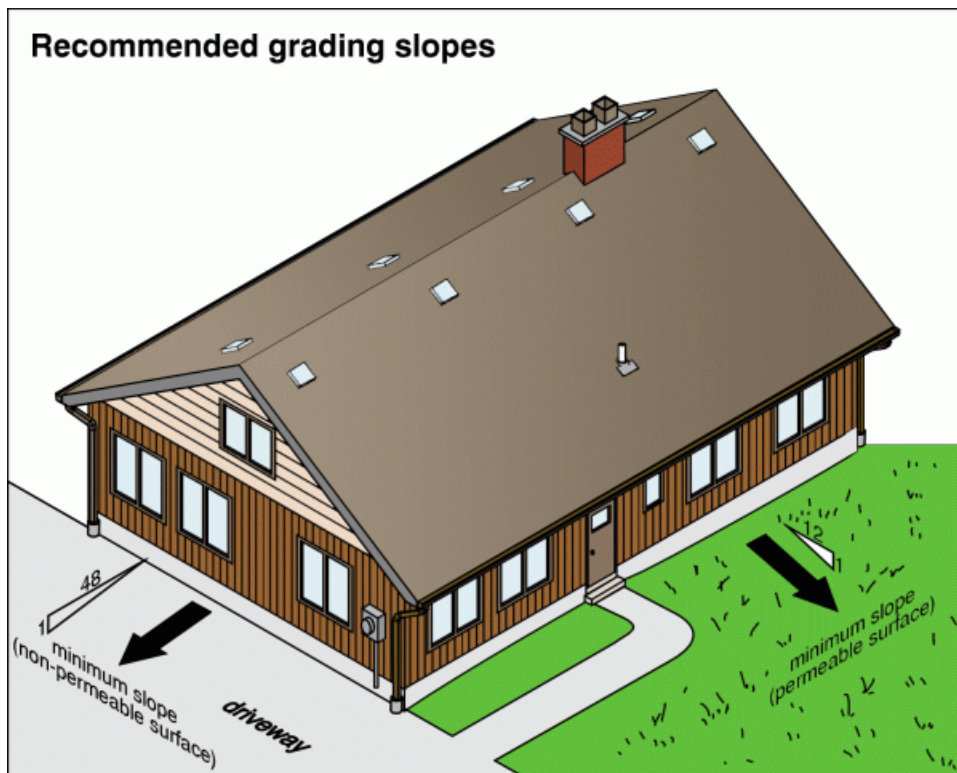
Condition: • [Improper slope or drainage](#)

Patio stones have settled causing water to drain towards foundation. Signs of efflorescence were visible on the interior foundation wall.

Implication(s): Chance of water damage to contents, finishes and/or structure

41. Improper slope or drainage

Task: Repair/Improve

Time: as soon as possible

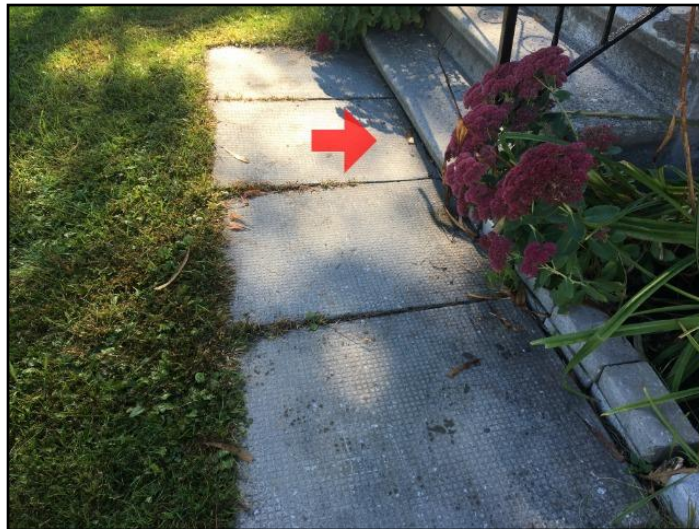
43. Settlement

Task: Monitor

Time: Ongoing

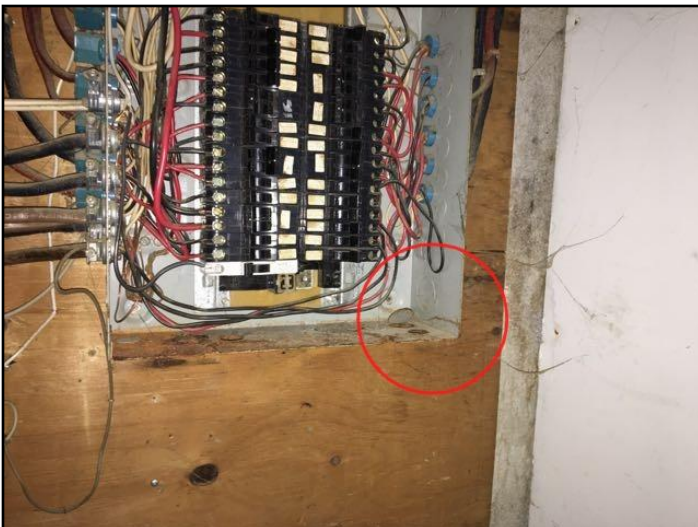
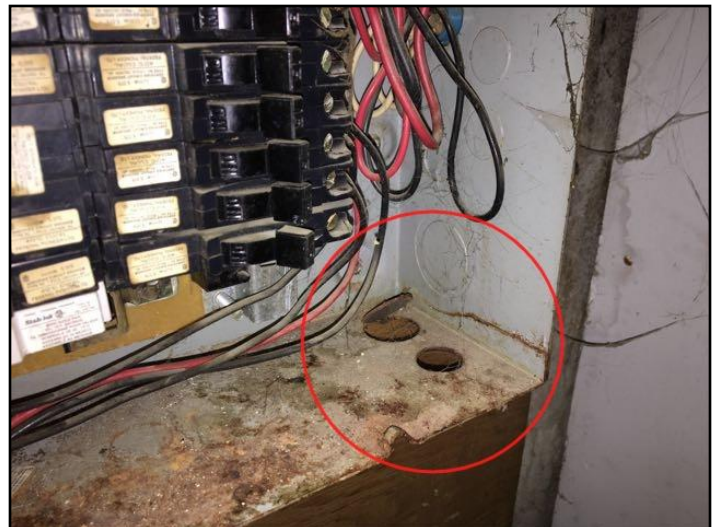
Condition: • [Unprotected openings](#)

Further evaluation of electrical system by a specialist

Implication(s): Electric shock**Location:** North Basement**Task:** Correct**Time:** Immediate

48. Unprotected openings

49. Unprotected openings

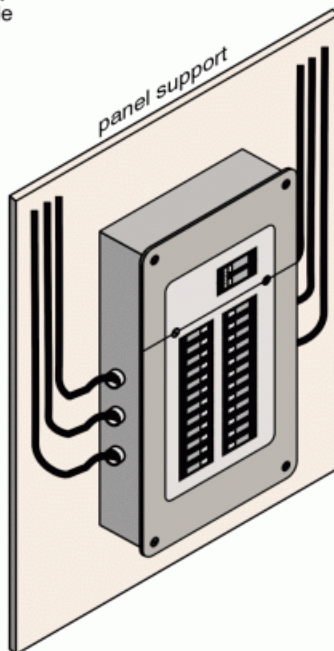
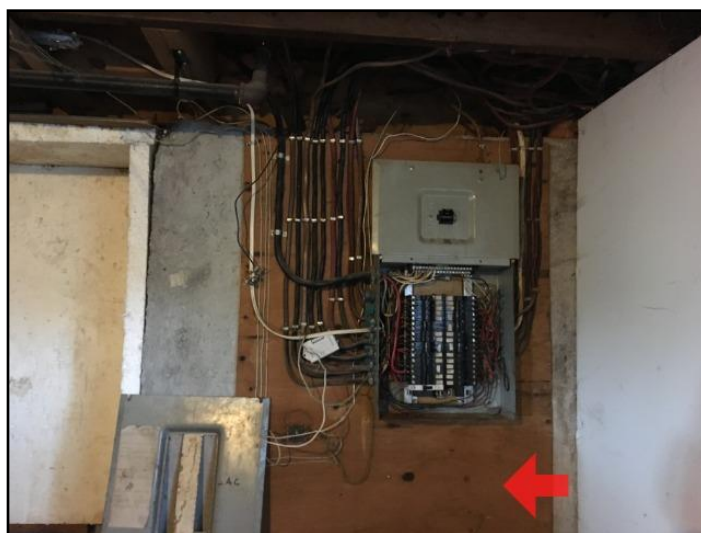
Condition: • [Inappropriate mounting surface](#)

Recommend further evaluation of electrical system by a specialist

Implication(s): Fire hazard

in many jurisdictions, the panel support (or back-up) must be a non-combustible material such as drywall

plywood or wood planking were commonly used for panel support in older installations

52. Inappropriate mounting surface

Task: Replace

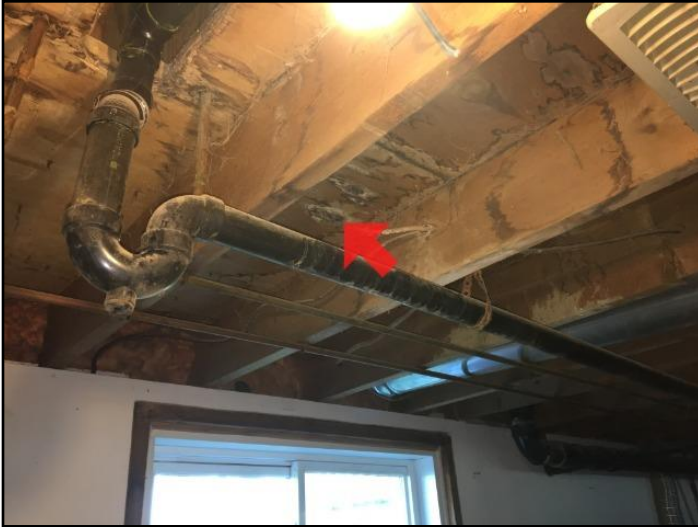
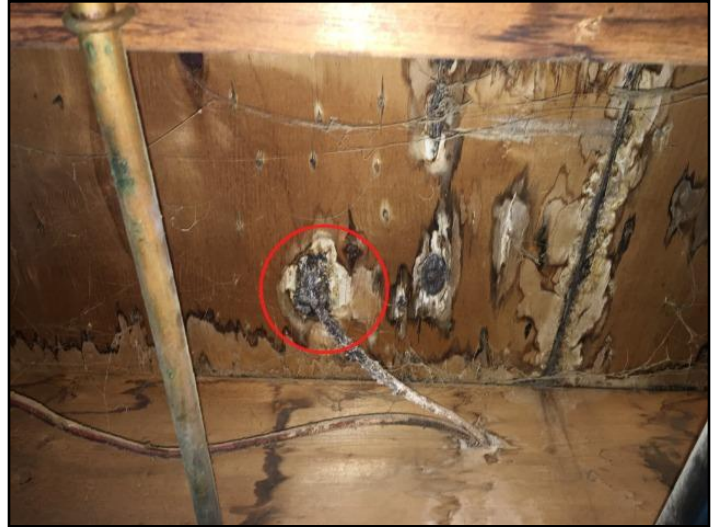
Condition: • Electrical wire coming through sub-floor is exposed to excessive moisture. This is likely the electrical supply to the bathroom baseboard. Further evaluation by a specialist

53. Electrical wiring in damp area

54. Electrical wiring in damp area

Task: Correct

Time: Immediate

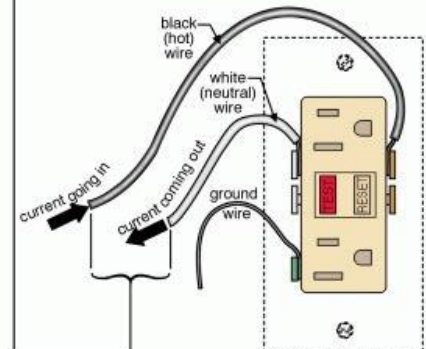
if the GFI is in the panel, the entire circuit will be shut down

62. GFCI/GFI (Ground Fault Circuit...

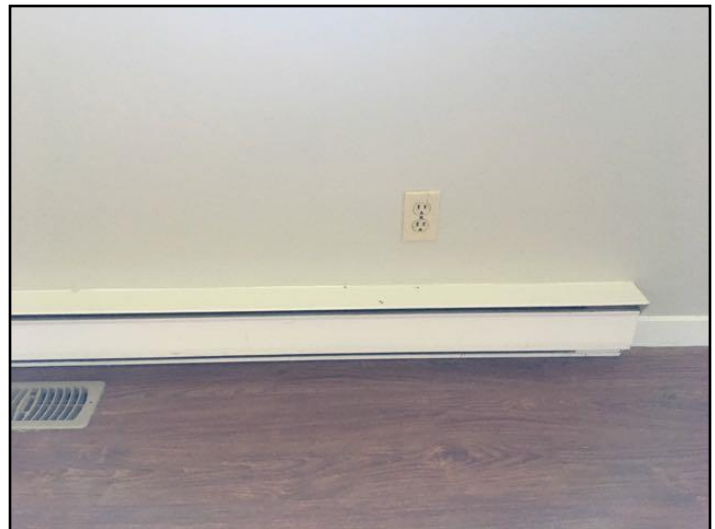
DISTRIBUTION SYSTEM \ Outlets (receptacles) - number or location**Condition:** • [Above electric baseboard heaters](#)**Implication(s):** Increased fire hazard**Location:** Throughout First Floor Bedrooms**Task:** Correct**Time:** Immediate

64. Receptacle poor location

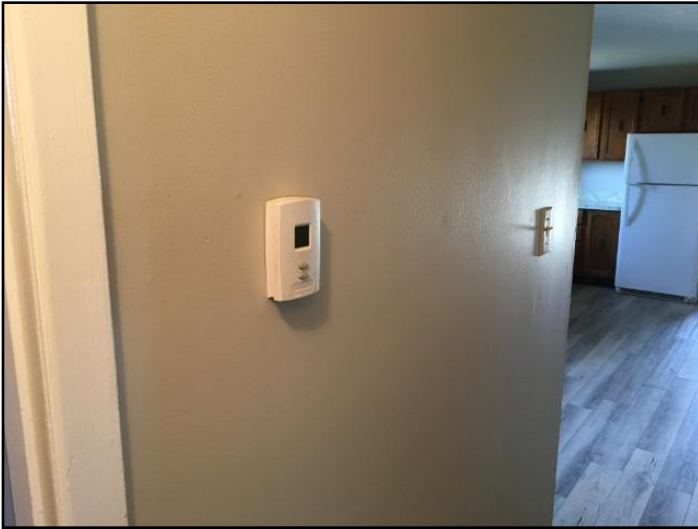
65. Inoperative

Task: Further evaluation

Time: Immediate

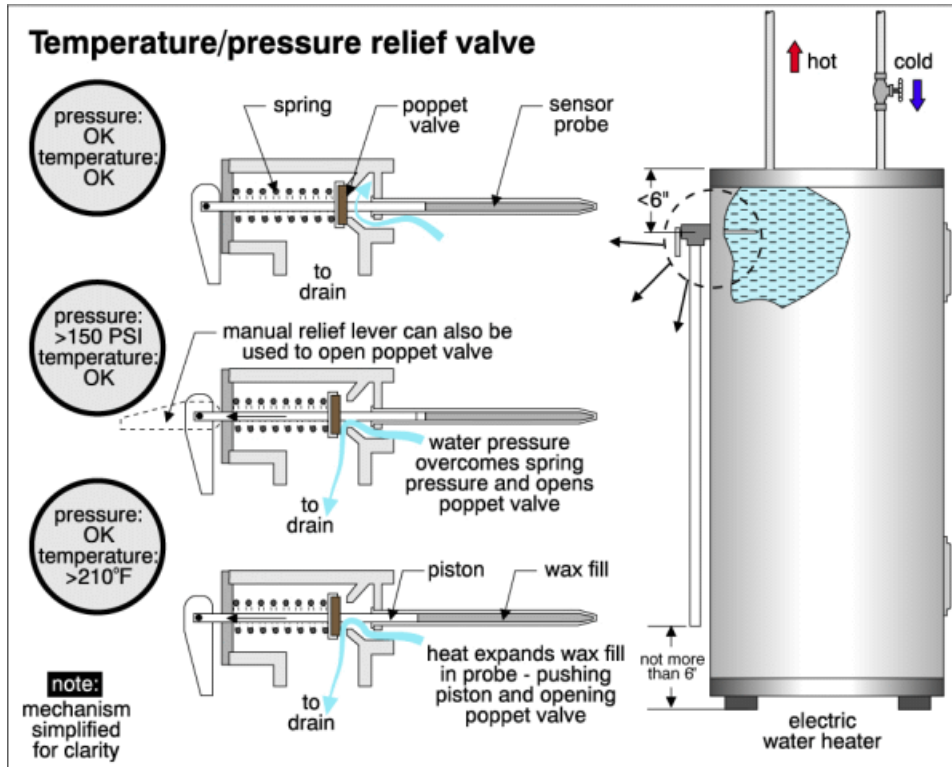
Condition: • [Discharge tube missing](#)

67. Discharge tube missing

Task: Provide

Time: Immediate

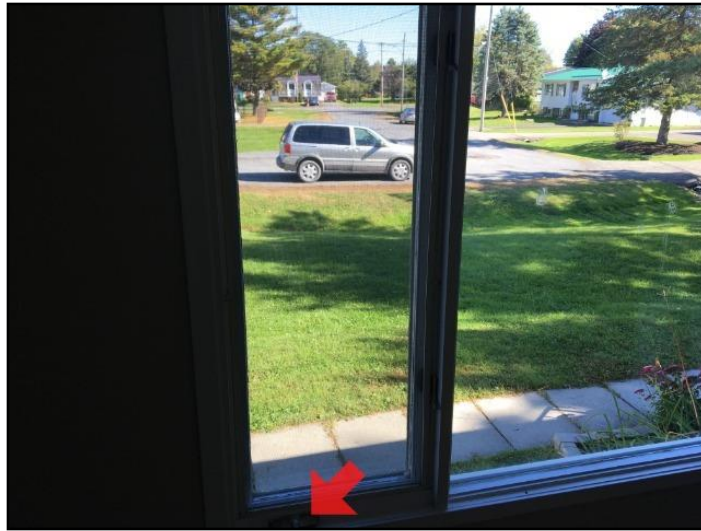
71. Inoperative

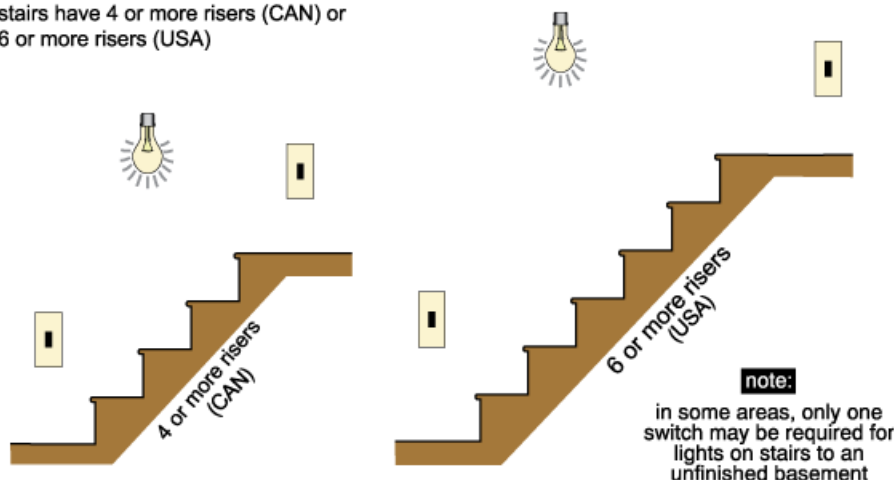
Basement staircase has inadequate lighting and is missing a light switch at the bottom

stairway lighting requires switches at both the top and bottom of the stairs when the stairs have 4 or more risers (CAN) or 6 or more risers (USA)

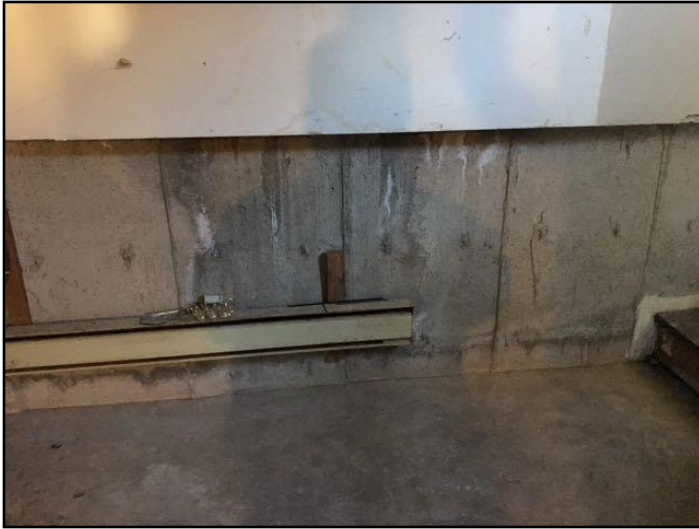
79. Efflorescence

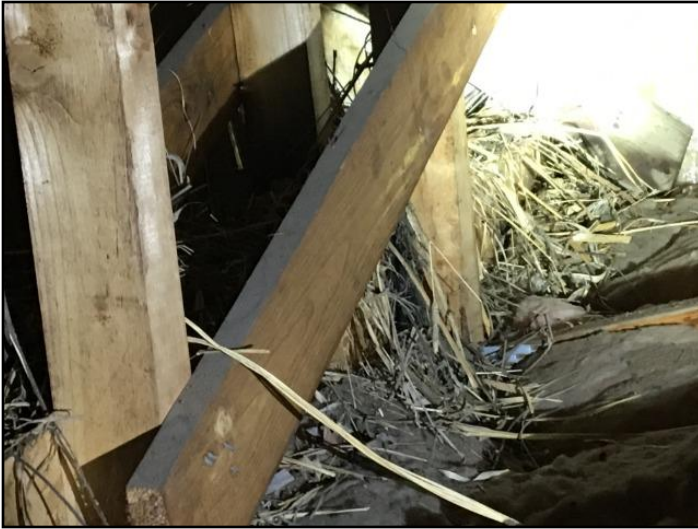
83. Animal/pest entry
