PROPERTY CONDITION ASSESSMENT REPORT

FOR THE PROPERTY AT: 1234 No Road Nowhere, ON

INSPECTION DATE: Tuesday, April 4, 2023

RE: Report No. 1004 1234 No Road Nowhere, ON

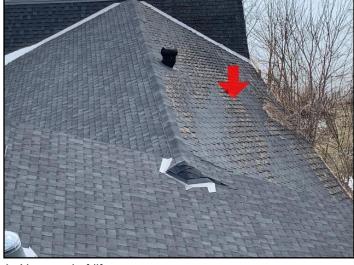
1. Near end of life expectancy

Task: Replace

Time: as soon as possible

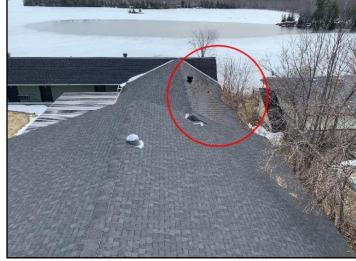
2. Near end of life expectancy

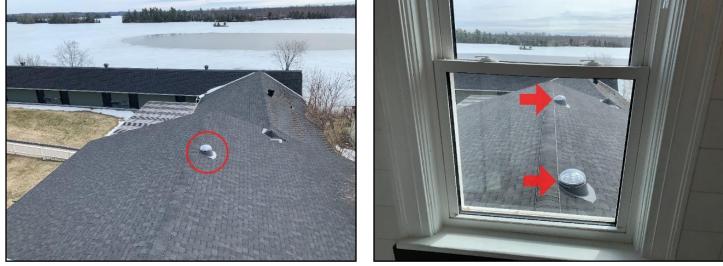
3. Vulnerable areas

4. Vulnerable areas

Task. Monitor

Time: Ongoing

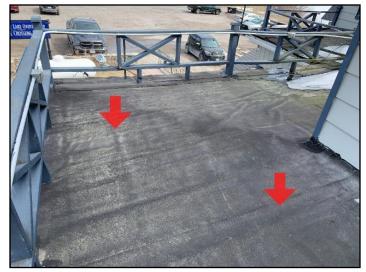
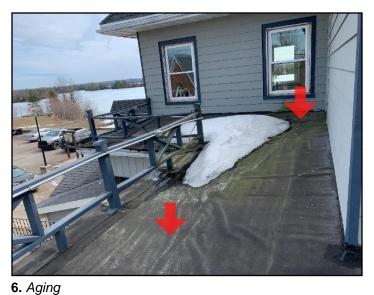
5. Aging

Task: Monitor

Time: Ongoing

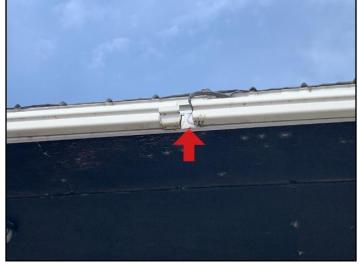
7. Loose or damaged

5. Condition: • Loose or damaged

Implication(s): Chance of water damage to structure, finishes and contents Location: South side Task: Repair or Replace Time: As soon as possible

Task: Repair or Replace

Time: As soon as possible

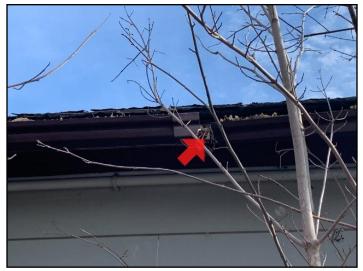
9. Loose or damaged

10. Loose or damaged

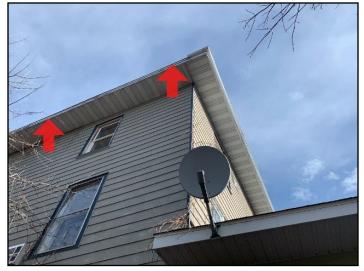
11. Missing

Task: Provide

Time: As soon as possible

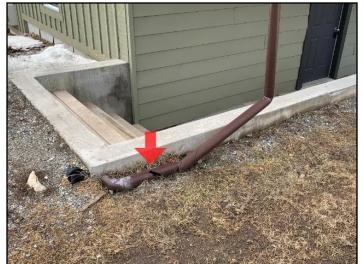
7. Condition: • Damage
Implication(s): Chance of water damage to structure, finishes and contents
Location: Northwest/Motel units
Task: Repair or Replace
Time: As soon as practical

13. Damage

14. Damage

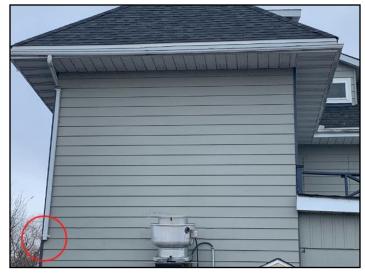
15. Discharge onto roofs

Task: Correct

Time: As soon as possible

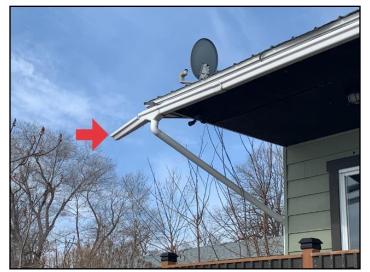
17. Discharge too close to building

Task: Correct

Time: immediate

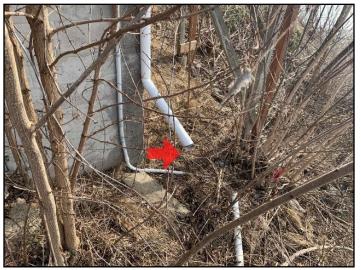
18. Discharge too close to building

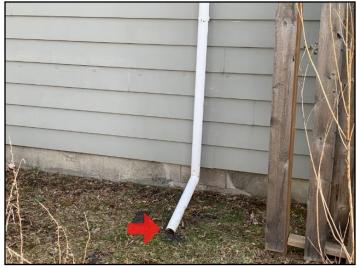
19. Discharge too close to building

Task: Correct

Time: As soon as possible

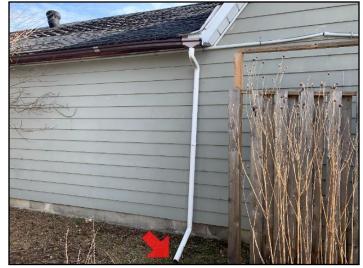
20. Discharge too close to building

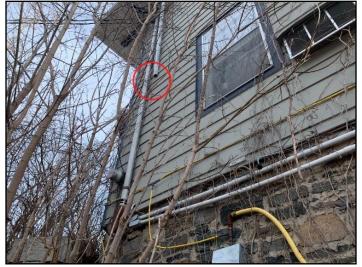
22. Discharge too close to building

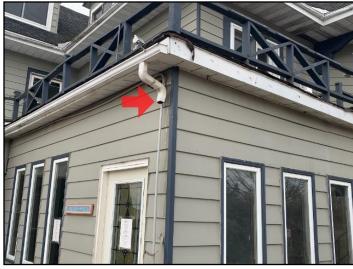
23. Discharge too close to building

Task: Correct

Time: As soon as possible

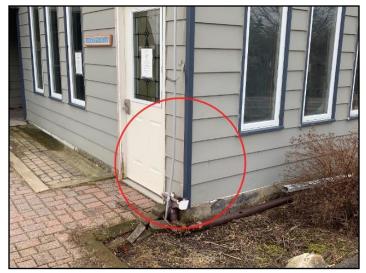
24. Discharge too close to building

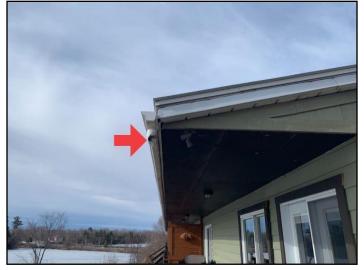
Implication(s): Chance of water damage to structure, finishes and contents Location: Northeast corner/Motel units Task: Provide

25. Missing

Time: As soon as possible

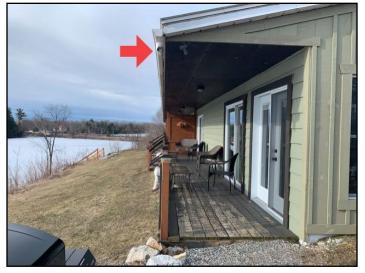
26. Missing

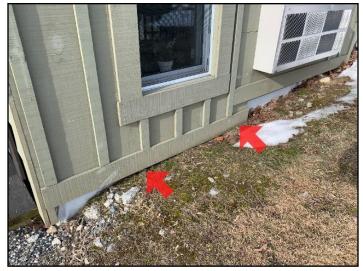
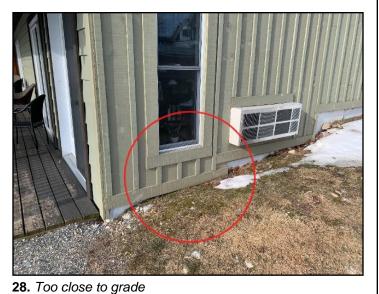
27. Too close to grade

Task: Correct

Time: As soon as possible

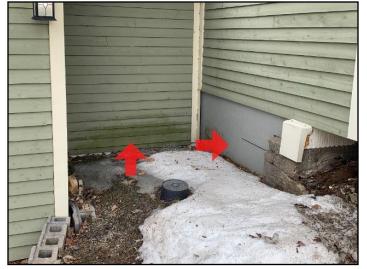
15. Condition: • <u>Too close to grade</u>

29. Too close to grade

Task: Improve

Time: As soon as possible

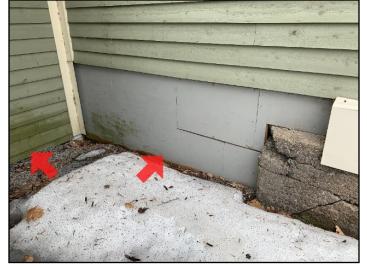
30. Too close to grade

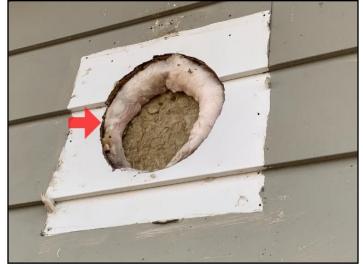
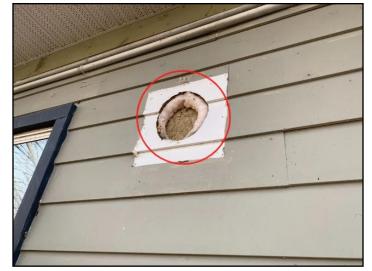
31. Loose or missing pieces

32. Loose or missing pieces

Task: Repair

Time: As soon as possible

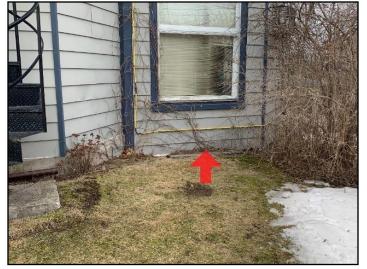
17. Condition: • Too close to grade

33. Too close to grade

Task: Improve

Time: As soon as possible

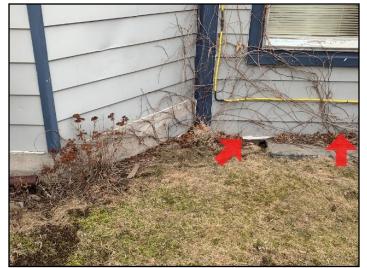
34. Too close to grade

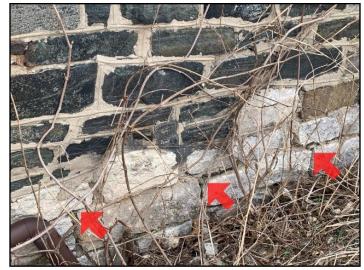
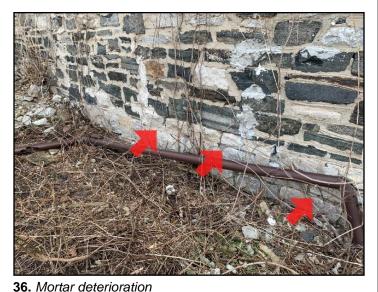
Condition: • Mortar deterioration Implication(s): Weakened structure | Chance of structural movement | Chance of water entering building Location: Throughout Southwest side Task: Repair Time: As soon as possible

35. Mortar deterioration

Task: Repair

Time: As soon as possible

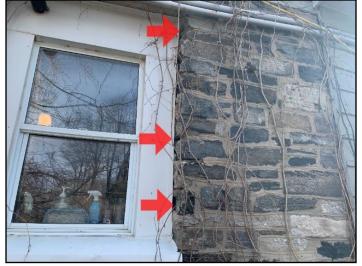
19. Condition: • Mortar deterioration

37. Mortar deterioration

Task: Repair

Time: As soon as possible

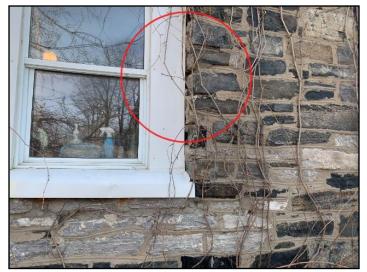
38. Mortar deterioration

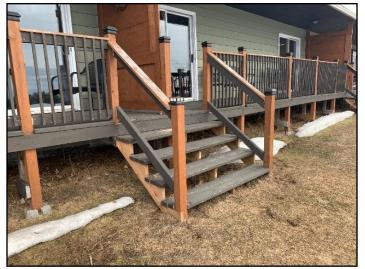
40. Wood/soil contact

Time: As soon as practical

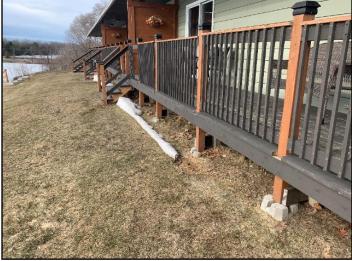
42. Settled

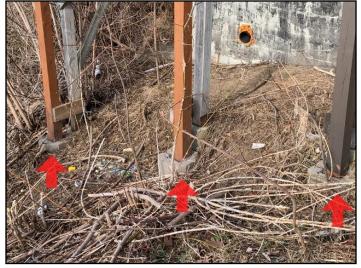
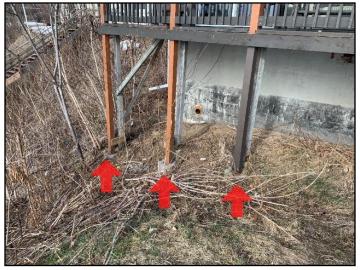
Implication(s): Weakened structure | Chance of movement Location: Throughout/Southeast corner/Motel units Task: Correct Time: Immediate

43. Settled

44. Settled

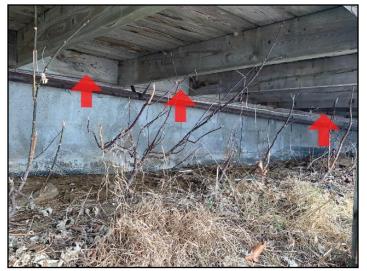
23. Condition: • Ledgerboard problems Implication(s): Weakened structure | Chance of movement Location: East side/Throughout Task: Correct Time: As soon as possible

45. Ledgerboard problems

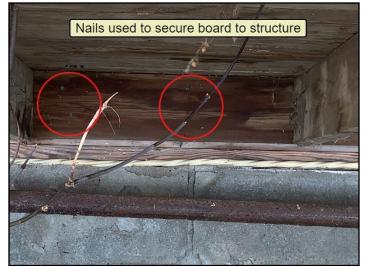
46. Ledgerboard problems

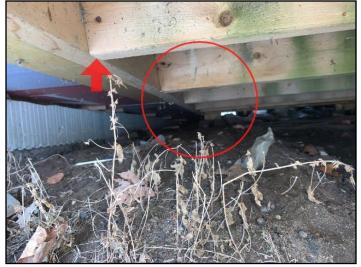
48. Joist hangers missing

Task: Provide

Time: Immediate

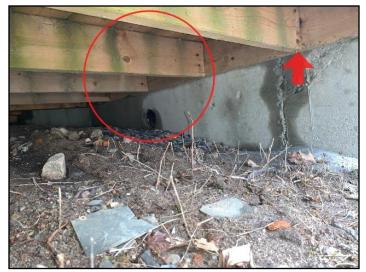
25. Condition: • Joist hangers missing
Implication(s): Weakened structure | Chance of movement
Location: Throughout East side porches
Task: Provide
Time: Immediate

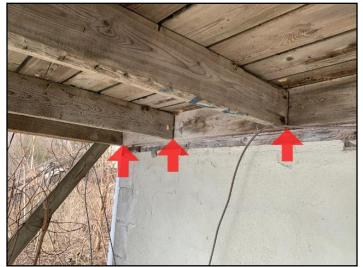
50. Joist hangers missing

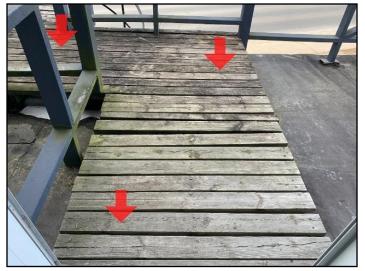
27. Condition: • Paint or stain needed

Implication(s): Shortened life expectancy of material Location: Throughout/Second Floor exterior deck Task: Provide

53. Paint or stain needed

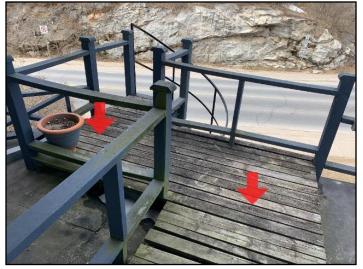
54. Paint or stain needed

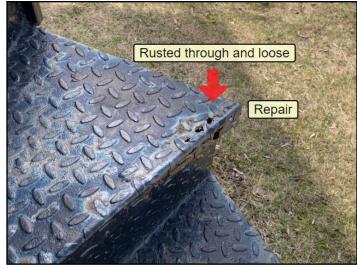
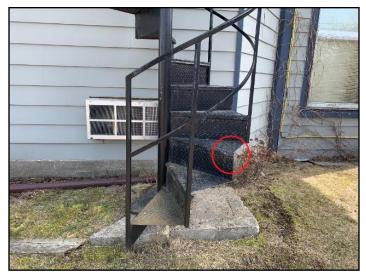
28. Condition: • Paint or stain needed Implication(s): Material deterioration

55. Repair-Paint needed

56. Repair-Paint needed

Task: Repair/Paint

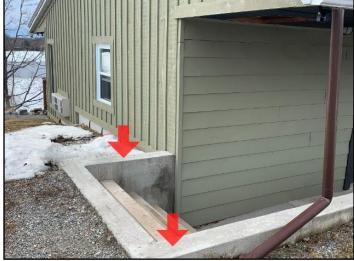
29. Condition: • Missing Implication(s): Fall hazard Location: Northwest/Motel units Task: Provide Time: Immediate

58. Missing

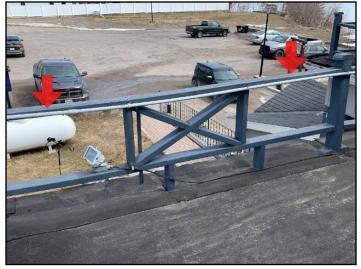
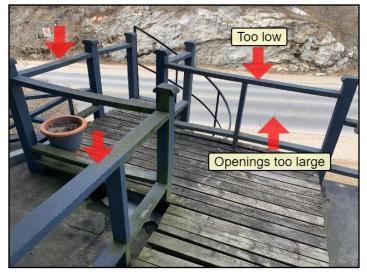
30. Condition: • <u>Too low</u>

Implication(s): Fall hazard Location: Main house/Throughout second floor deck Task: Correct

60. Too low

59. Too low

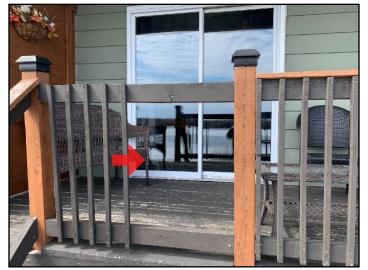
31. Condition: • <u>Spindles (balusters) missing</u>
Implication(s): Fall hazard
Location: East side deck/Motel units
Task: Provide
Time: Immediate

61. Spindles (balusters) missing

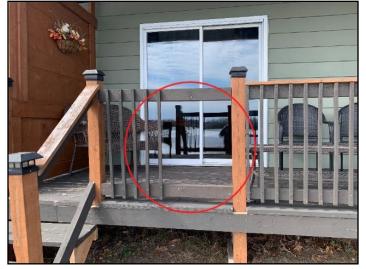
62. Spindles (balusters) missing

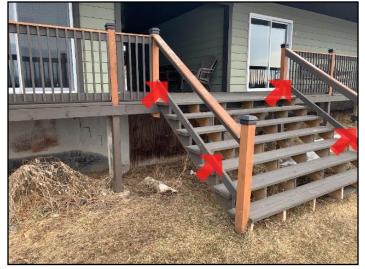
32. Condition: • Spindles (balusters) missing

Implication(s): Fall hazard

63. Spindles (balusters) missing

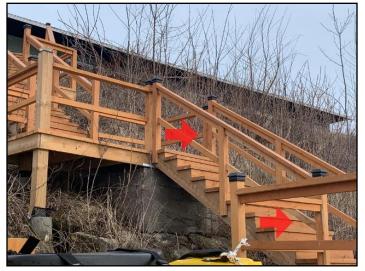
33. Condition: • <u>Spindles (balusters) missing</u>
Implication(s): Fall hazard
Location: East side/Throughout stairs leading to lake
Task: Provide
Time: Immediate

66. Spindles (balusters) missing

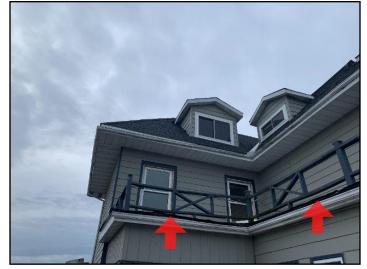
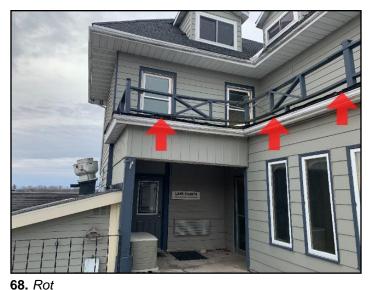
34. Condition: • Rot

67. Rot

Task: Monitor/replace

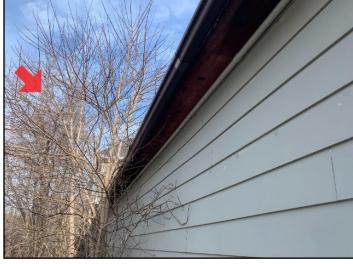
35. Condition: • Trees or shrubs too close to building

Implication(s): Chance of water damage to structure, finishes and contents | Material deterioration **Location**: South side

69. Trees or shrubs too close to building

Task: Remove

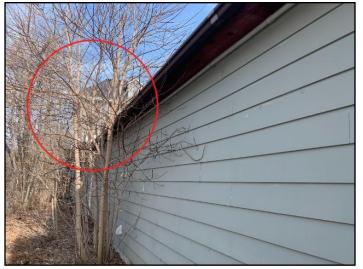
70. Trees or shrubs too close to building

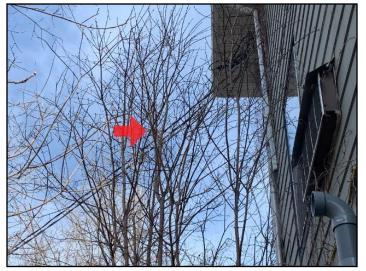
36. Condition: • Branches interfering with wires

Implication(s): Damage to wire, Electric shock, Interruption of electrical service

71. Branches / vines interfering with wires

Task: Remove

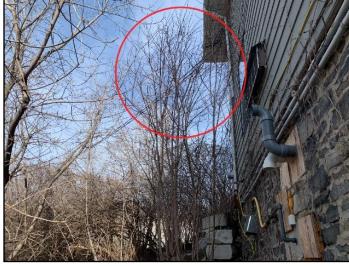
72. Branches / vines interfering with wires

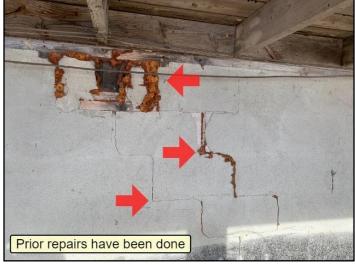
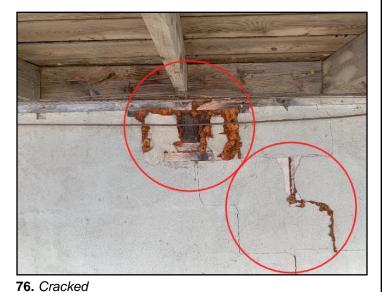
38. Condition: • <u>Cracked</u>

Implication(s): Weakened structure | Chance of water damage to structure, finishes and contents

75. Cracked

Task: Repair/Monitor

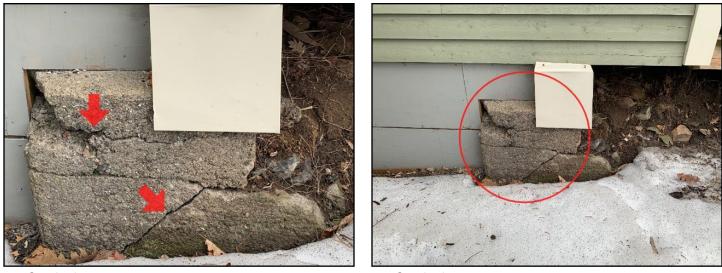
39. Condition: • Cracked

Implication(s): Weakened structure | Chance of water damage to structure, finishes and contents **Location**: North/kitchen entrance area

77. Cracked

78. Cracked

Task: Repair/Further evaluate

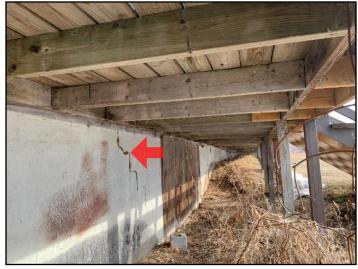
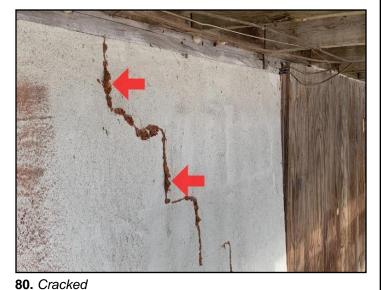
40. Condition: • Cracked

Implication(s): Weakened structure | Chance of water damage to structure, finishes and contents Location: East side Task: Repair/Further evaluate

79. Cracked

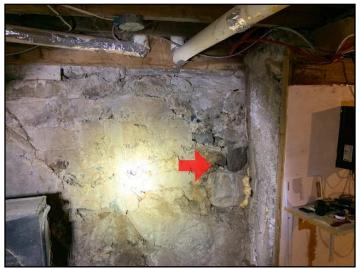
41. Condition: • Spalling, crumbling or broken material

Implication(s): Chance of structural movement | Weakened structure Location: Main house/Basement/West utility rooms Task: Repair

81. Spalling, crumbling or broken material

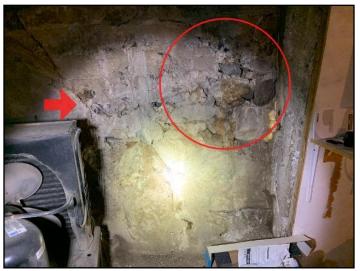
82. Spalling, crumbling or broken material

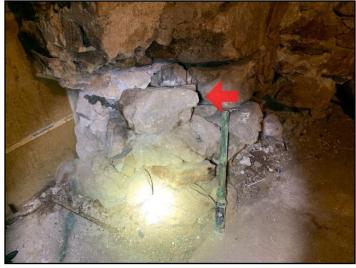
42. Condition: • Spalling, crumbling or broken material

83. Spalling, crumbling or broken material

Task: Repair/Further evaluate

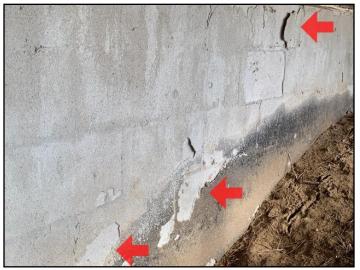
43. Condition: • Parging damaged or missing

Implication(s): Shortened life expectancy of material | Chance of damage to structure Location: Throughout East side/Motel units Task: Repair

85. Parging damaged or missing

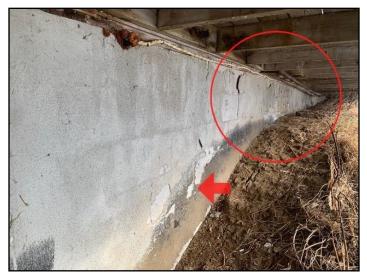
86. Parging damaged or missing

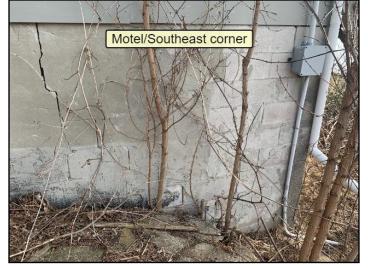
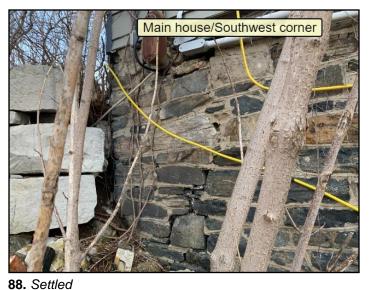
44. Condition: • Settled

Implication(s): Chance of structural movement Location: Main house and Motel Task: Further evaluation Time: Immediate

87. Settled

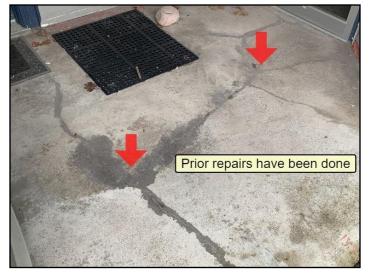
45. Condition: • <u>Cracked</u> **Implication(s)**: Chance of water damage to structure, finishes and contents | Trip or fall hazard

89. Cracked

Task: Monitor/Repair

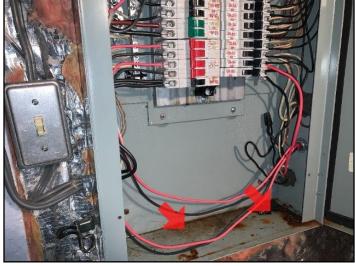
46. Condition: • Rust or water in panel

Implication(s): Fire hazard | Electric shock

91. Rust or water in panel

Task: Correct

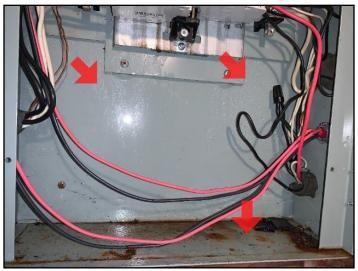
92. Rust or water in panel

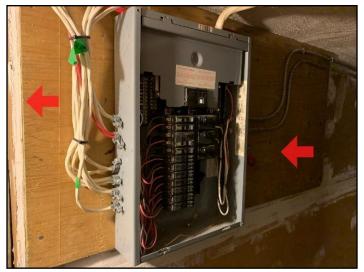
47. Condition: • Inappropriate mounting surface Implication(s): Fire hazard
Location: Main house basement/Utility room
Task: Correct
Time: Immediate

94. Inappropriate mounting surface

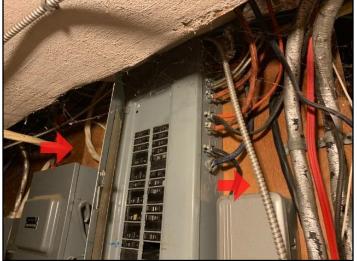
48. Condition: • Inappropriate mounting surface

Implication(s): Fire hazard

95. Inappropriate mounting surface

Task: Correct

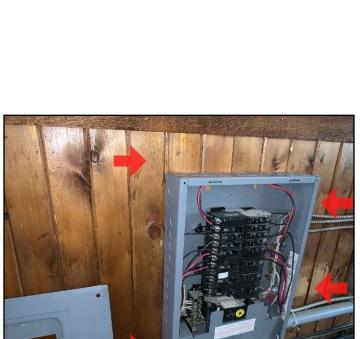
49. Condition: • Inappropriate mounting surface Implication(s): Fire hazard Location: South/First floor/Restaurant Task: Correct Time: Immediate

98. Inappropriate mounting surface

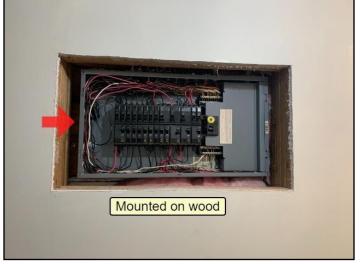
51. Condition: • Inappropriate mounting surface
Implication(s): Fire hazard
Location: Main house/basement/west utility rooms
Task: Correct
Time: Immediate

100. Inappropriate mounting surface

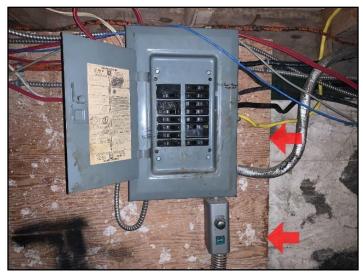
102. Inappropriate mounting surface

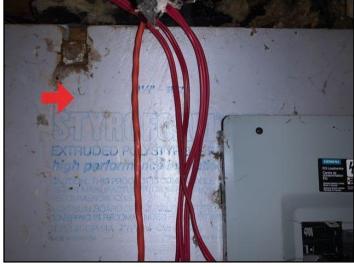
52. Condition: • Inappropriate mounting surface

Implication(s): Fire hazard Location: Restaurant/crawlspace Task: Correct

103. Inappropriate mounting surface

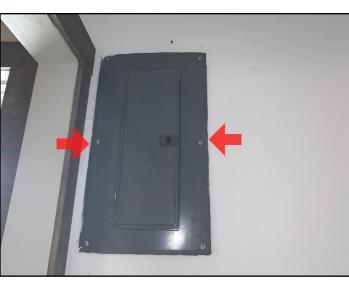
105. Poor access

53. Condition: • Poor access

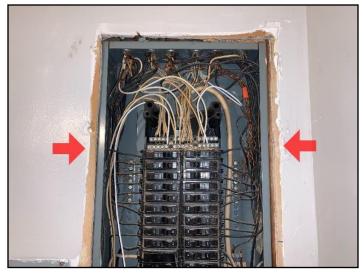
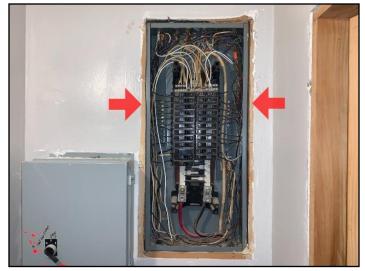
54. Condition: • Poor access

Implication(s): Difficult to service Location: North/cleaning supply room Task: Correct

Time: Immediate

108. Poor access

107. Poor access

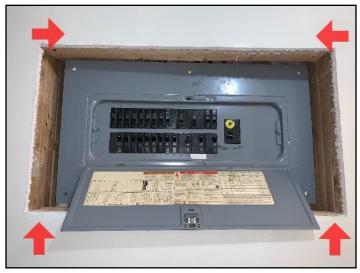
55. Condition: • Poor access Implication(s): Difficult to service Location: North entrance Task: Correct Time: Immediate

110. Poor access

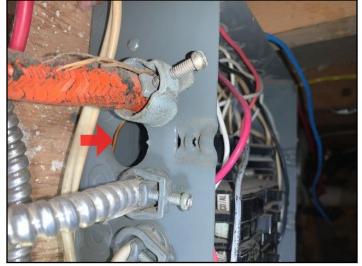
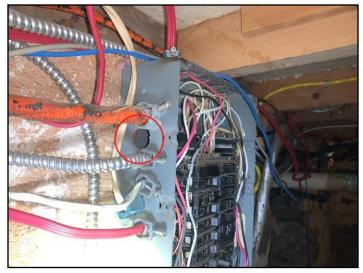
56. Condition: • Openings in panel

Implication(s): Electric shock | Fire hazard Location: Basement/Main house/West utility rooms Task: Correct Time: Immediate

112. Openings in panel

111. Openings in panel

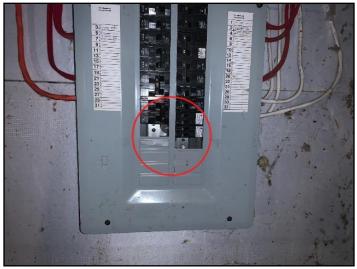
57. Condition: • Openings in panel

Implication(s): Fire hazard | Electric shock Location: Southeast crawlspace/Restaurant Task: Correct Time: Immediate

114. Openings in panel

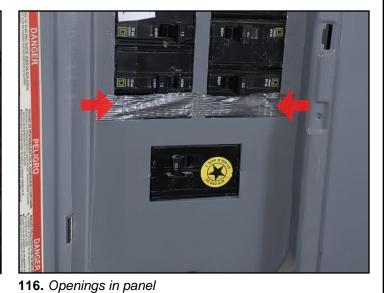
58. Condition: • Openings in panel

Implication(s): Fire hazard | Electric shock Location: East wall/Restaurant Task: Correct Time: Immediate

..... . 115. Openings in panel

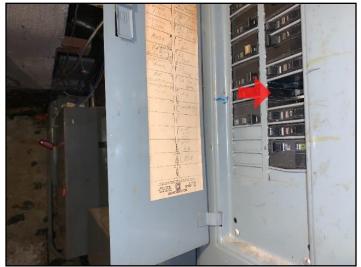
59. Condition: • Openings in panel Implication(s): Fire hazard | Electric shock Location: West/Basement utility room Task: Correct Time: Immediate

118. Openings in panel

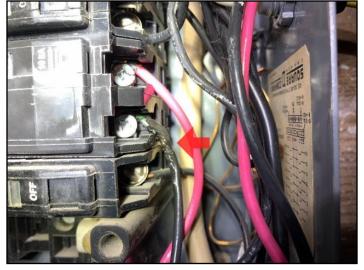
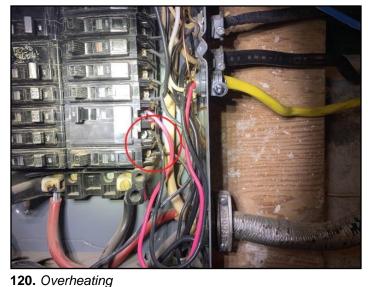
60. Condition: • Overheating

Implication(s): Fire hazard Location: Main house/West utility room Task: Correct/Further evaluate

Time: Immediate

119. Overheating

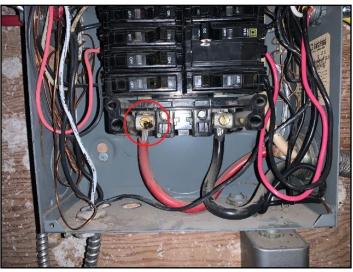
61. Condition: • Overheating
Implication(s): Fire hazard
Location: Main house/West utility rooms
Task: Further evaluation
Time: Immediate

122. Overheating

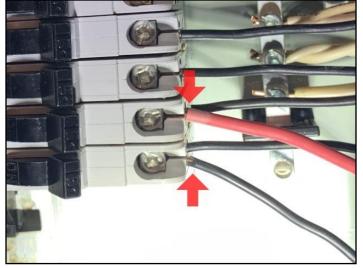
62. Condition: • Double taps

Implication(s): Fire hazard Location: East/Crawlspace/Motel units Task: Correct Time: Immediate

123. Double taps

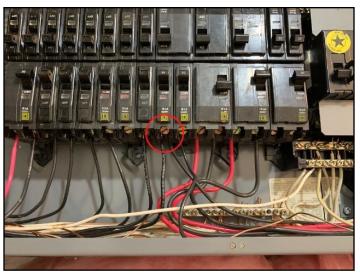
63. Condition: • Double taps Implication(s): Fire hazard Location: North entrance Task: Correct Time: Immediate

126. Double taps

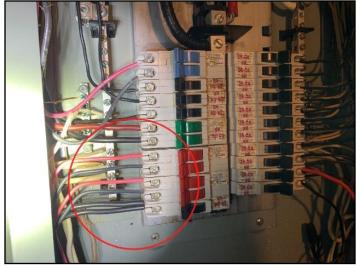
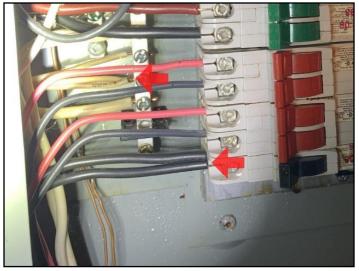
64. Condition: • Double taps

Implication(s): Fire hazard Location: East/Crawlspace/Motel units Task: Correct

Time: Immediate

128. Double taps

127. Double taps

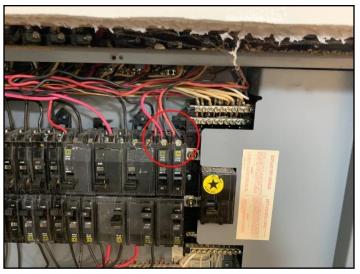
65. Condition: • Double taps Implication(s): Fire hazard Location: North entrance Task: Correct Time: Immediate

130. Double taps

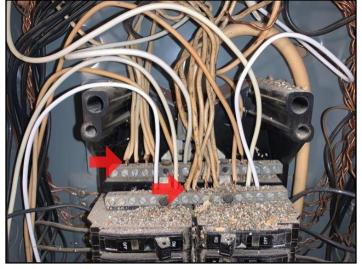
66. Condition: • Double taps

Implication(s): Fire hazard Location: North/cleaning supply room Task: Correct

Time: Immediate

131. Double taps

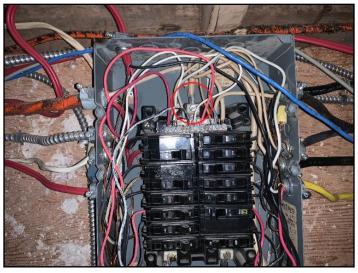
67. Condition: • <u>Anti-oxidant compound - missing</u> Implication(s): Fire hazard
Location: Throughout all distribution panels
Task: Provide
Time: Immediate

134. Anti-oxidant compound - missing

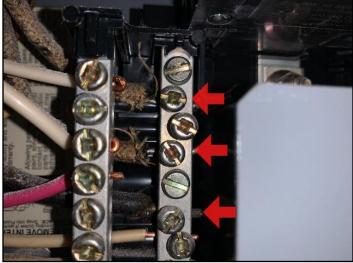
68. Condition: • Anti-oxidant compound - missing

Implication(s): Fire hazard

Task: Provide

Time: Immediate

135. Anti-oxidant compound - missing

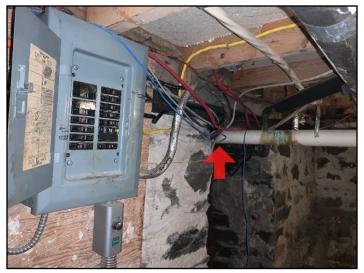
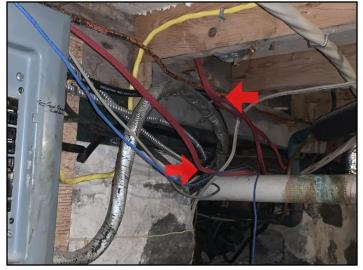
DISTRIBUTION SYSTEM \ Wiring (wires) - installation 69. Condition: • Not well secured Implication(s): Electric shock | Fire hazard Location: Throughout basement/Main house Task: Correct Time: Immediate

137. Not well secured

138. Not well secured

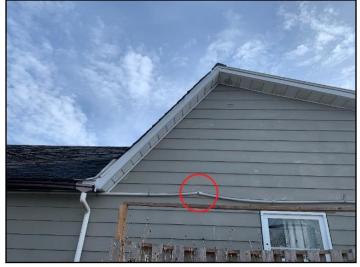
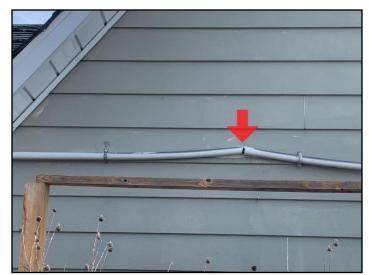
70. Condition: • Conduit damaged

Task: Repair or Replace

Time: Immediate

140. Conduit damaged

139. Conduit damaged

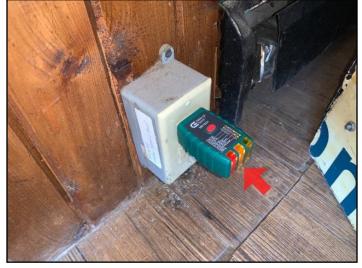
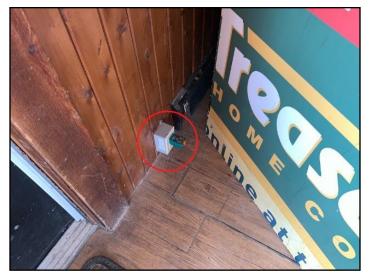
72. Condition: • <u>Reversed polarity</u> Implication(s): Electric shock Location: Restaurant/North wall at door Task: Correct

Time: Immediate

144. Reversed polarity

143. Reversed polarity

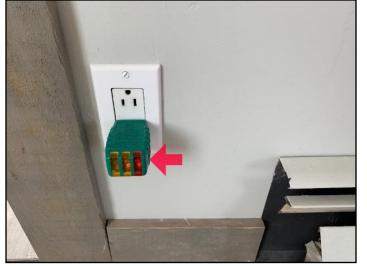
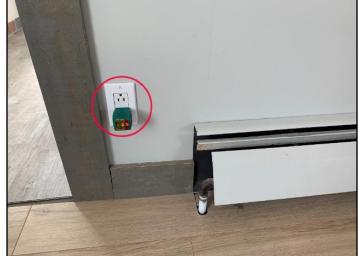
73. Condition: • <u>Reversed polarity</u>
Implication(s): Electric shock
Location: Main house/Northeast bedroom at bathroom entrance
Task: Correct
Time: Immediate

145. Reversed polarity

146. Reversed polarity

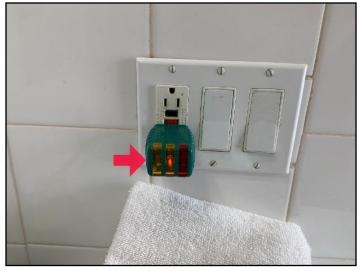
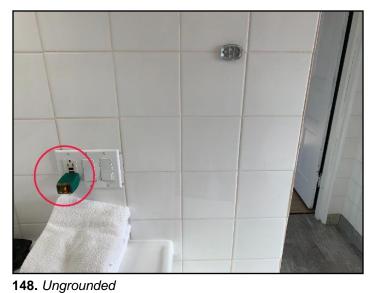
74. Condition: • <u>Ungrounded</u>

Task: Correct

Time: Immediate

147. Ungrounded

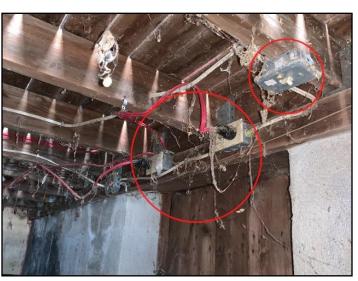
75. Condition: • Not suitable for outdoor (exterior) use
Implication(s): Shock hazard or interruption of electrical service
Location: East/Under walkway
Task: Replace
Time: Immediate

150. Not suitable for outdoor (exterior) use

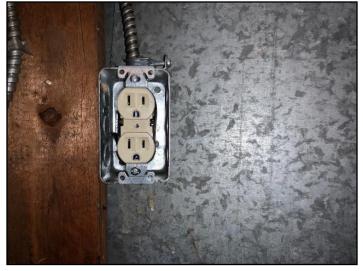
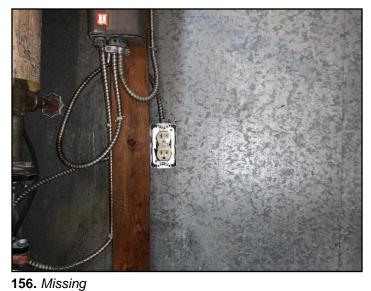
78. Condition: • Missing

Implication(s): Electric shock Location: Boiler room Task: Provide Time: Immediate

155. Missing

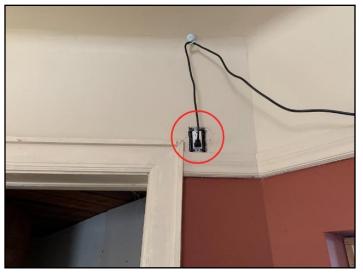
79. Condition: • Missing Implication(s): Electric shock Location: Food bank/West wall Task: Provide Time: Immediate

158. Missing

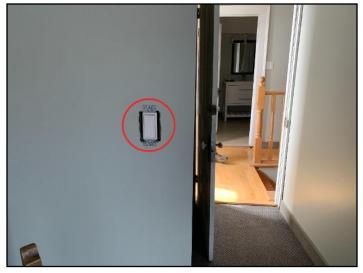
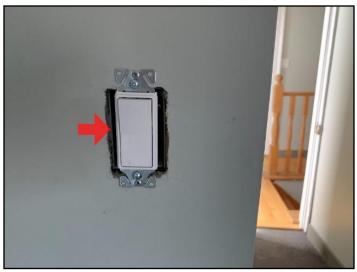
80. Condition: • For switch is missing

Task: Provide

Time: Immediate

160. For switch is missing

159. For switch is missing

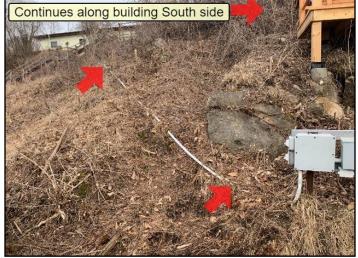
82. Condition: • Exposed electrical conduit Implication(s): Electric shock Location: East side Task: Correct Time: Immediate

163. Exposed electrical conduit

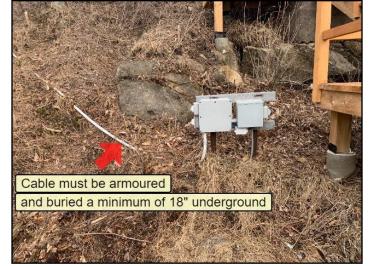
164. Exposed electrical conduit

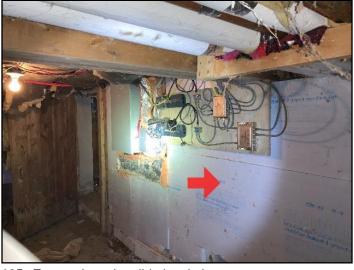
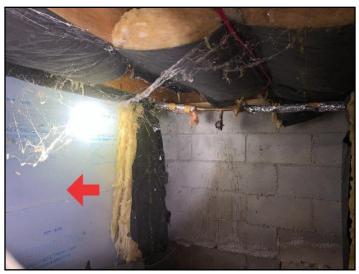
85. Condition: • Exposed combustible insulation Implication(s): Fire hazard Location: East crawlspace/Motel units Task: Protect or remove Time: Immediate

165. Exposed combustible insulation

166. Exposed combustible insulation

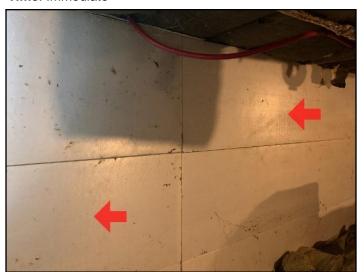
86. Condition: • Exposed combustible insulation
Implication(s): Fire hazard
Location: Southeast crawlspace/Restaurant
Task: Protect or Remove
Time: Immediate

167. Exposed combustible insulation

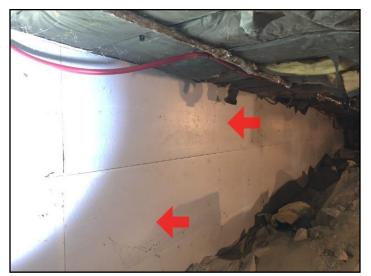
168. Exposed combustible insulation

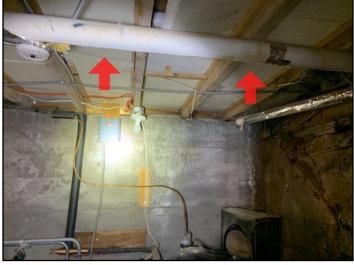
87. Condition: • Exposed combustible insulation Implication(s): Fire hazard Location: West/Utility rooms Task: Remove/Protect

169. Exposed combustible insulation

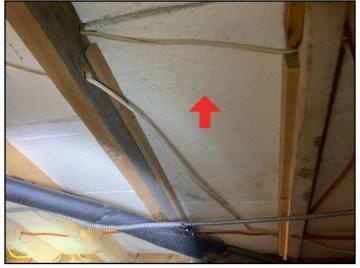
170. Exposed combustible insulation

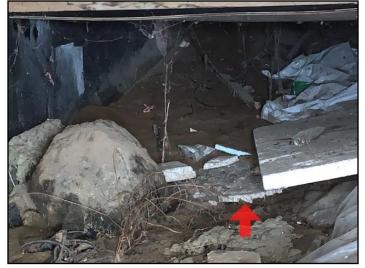
89. Condition: • Debris in crawlspace

Implication(s): Difficult to inspect, poor ventilation Location: Throughout/East crawlspace/Under walkway Task: Remove Time: As soon as practical

173. Debris in crawlspace

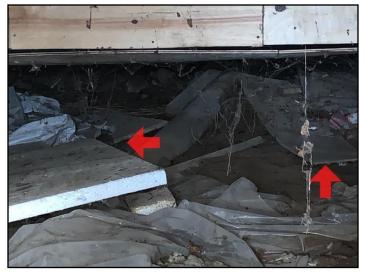
174. Debris in crawlspace

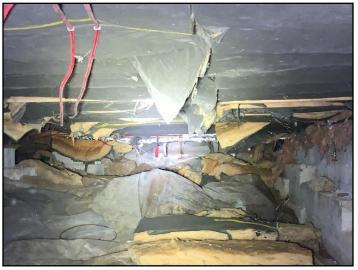
90. Condition: • Debris in crawlspace
Implication(s): Difficult to inspect, poor ventilation
Location: Throughout/Restaurant & Motel units crawlspace
Task: Remove
Time: As soon as practical

176. Debris in crawlspace

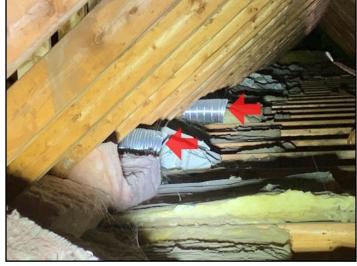
91. Condition: • Discharging into the attic / ceiling space Implication(s): Chance of condensation damage to finishes and/or structure Location: East/Motel units Task: Correct

177. Discharging into the attic / ceiling space

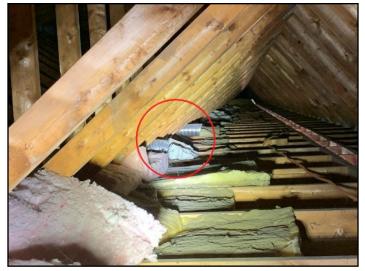
178. Discharging into the attic / ceiling space

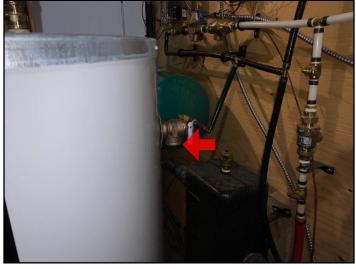
92. Condition: • Discharge tube missing

179. Discharge tube missing

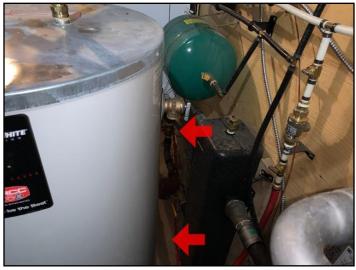
180. Discharge tube missing

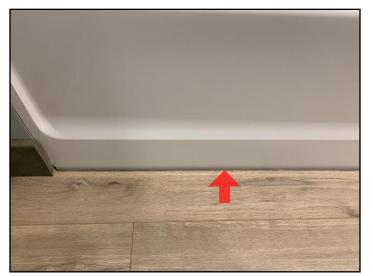
FIXTURES AND FAUCETS \ Bathtub enclosure 93. Condition: • Caulking loose, missing or deteriorated Implication(s): Chance of water damage to structure, finishes and contents Location: Main house/Second floor/Bathroom Task: Provide Time: As soon as possible

181. Caulking loose, missing or deteriorated

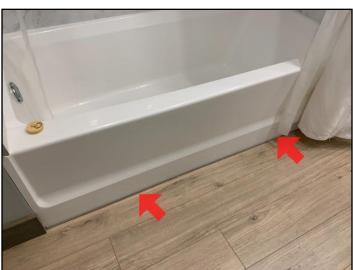
182. Caulking loose, missing or deteriorated

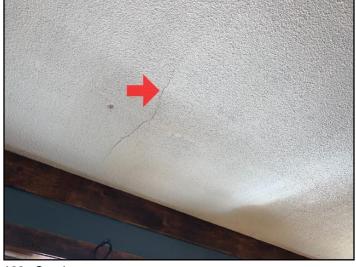
94. Condition: • Cracks

Implication(s): Damage or physical injury due to falling materials

183. Cracks

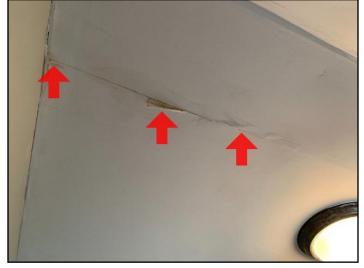
95. Condition: • Water damage
Implication(s): Rot | Leakage | Chance of movement
Location: Main house/Southwest bedroom
Task: Repair/Monitor
Time: as soon as possible/Ongoing

186. Water damage

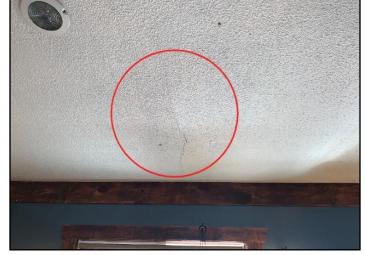
184. Cracks

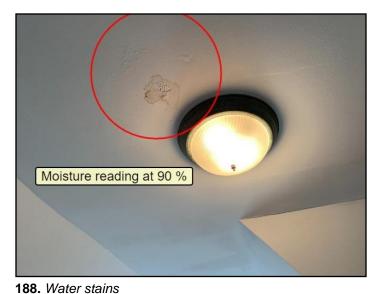
96. Condition: • Water stains

Implication(s): Chance of water damage to structure, finishes and contents

187. Water stains

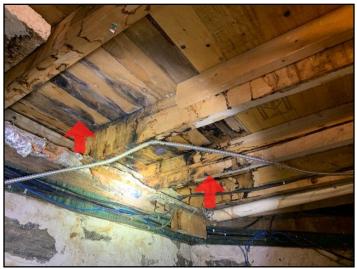
97. Condition: • Water stains
Implication(s): Chance of water damage to structure, finishes and contents
Location: West/Utility rooms
Task: Monitor
Time: Ongoing

190. Water stains

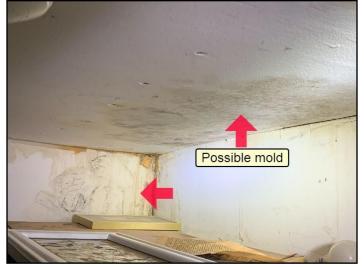
99. Condition: • Water stains
Implication(s): Chance of water damage to structure, finishes and contents
Location: North/Main house/Second floor/Small office
Task: Monitor
Time: Ongoing

193. Water stains

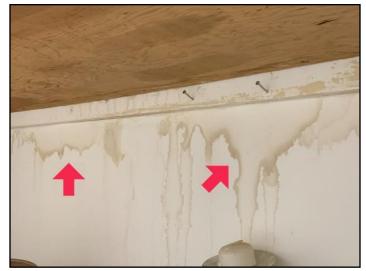
194. Water stains

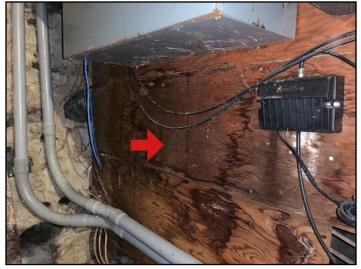
100. Condition: • Water stains

Implication(s): Chance of water damage to structure, finishes and contents

195. Water stains

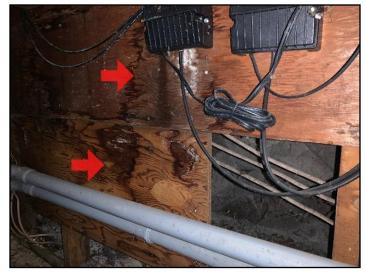
196. Water stains

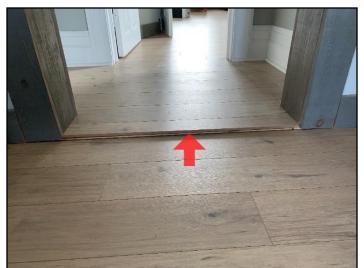
101. Condition: • <u>Trip hazard</u>
Implication(s): Physical injury
Location: Main house/Living room
Task: Correct
Time: Immediate

197. Trip hazard

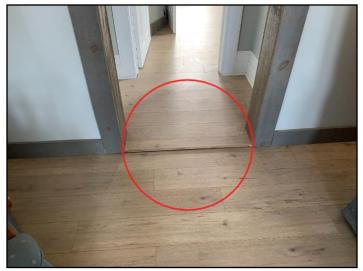
198. Trip hazard

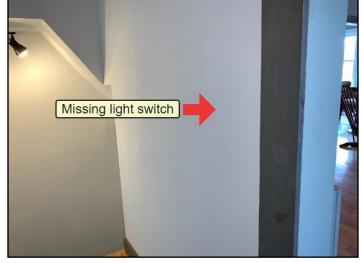
102. Condition: • Not controlled by three way switch Implication(s): Trip or fall hazard Location: Interior staircase to Main house Task: Correct Time: Immediate

199. Not controlled by three way switch

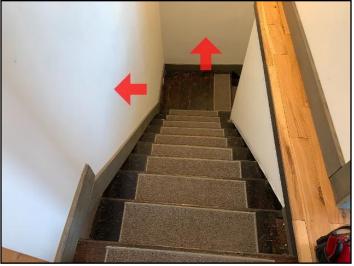
103. Condition: • Missing
Implication(s): Fall hazard
Location: Interior staircase to Main house
Task: Provide
Time: Immediate

202. Missing

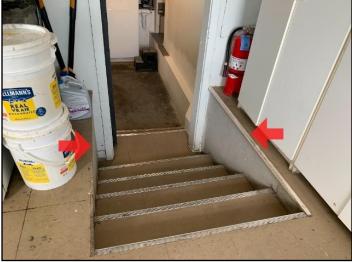
104. Condition: • Missing Implication(s): Fall hazard

Location: North/Entrance to kitchen Task: Provide Time: Immediate

203. Handrail and guardrail missing

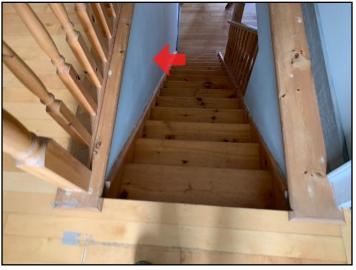
105. Condition: • Missing Implication(s): Fall hazard Location: Main house/Staircase to second floor Task: Provide Time: Immediate

206. Missing

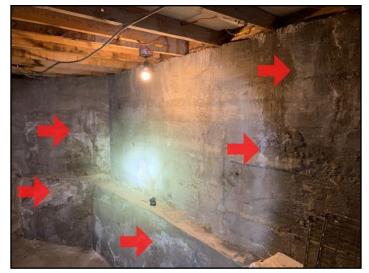
106. Condition: • Efflorescence

Implication(s): Chance of water damage to structure, finishes and contents

207. Efflorescence

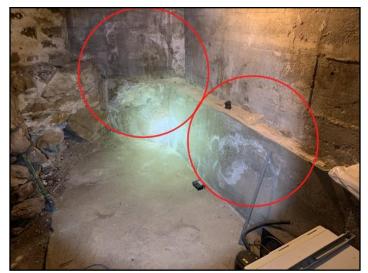
208. Efflorescence

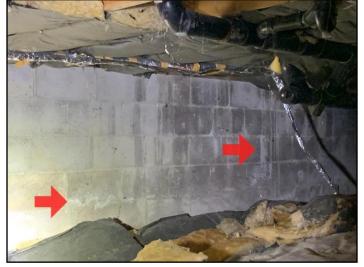
107. Condition: • Efflorescence

Implication(s): Chance of water damage to structure, finishes and contents **Location**: East/Crawlspace/Motel units

209. Efflorescence

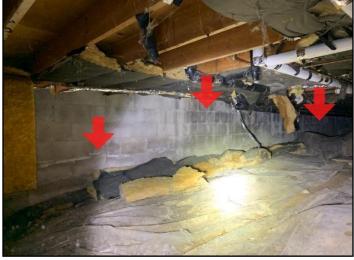
210. Efflorescence

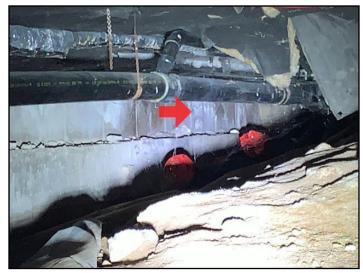
108. Condition: • Efflorescence

Implication(s): Chance of water damage to structure, finishes and contents

211. Efflorescence

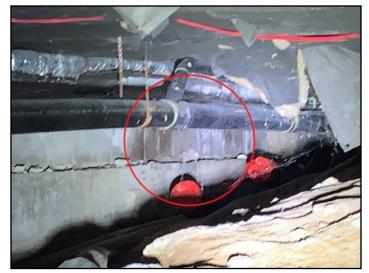
212. Efflorescence
